**Docket No. 272 – Development and Management Plan Inspection**

**Underground Line Watercourse and Railroad Crossings**

**Date:** June 6, 2008

**Location:** Crossings of Watercourses and Railroads in Segments 3, 4a and 4b

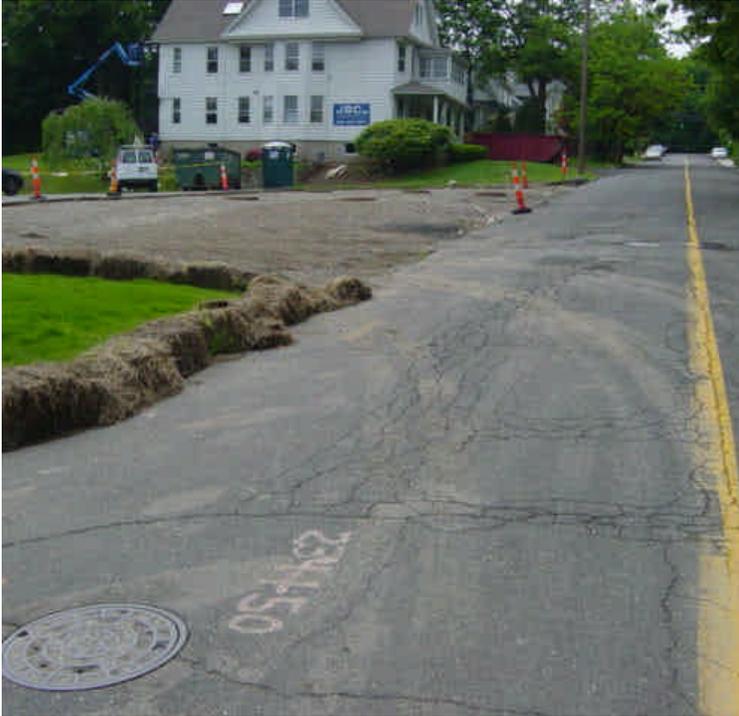
**Vehicles are traveling through the exposed soil near sta. #234 and tracking sediment onto Lincoln St.**

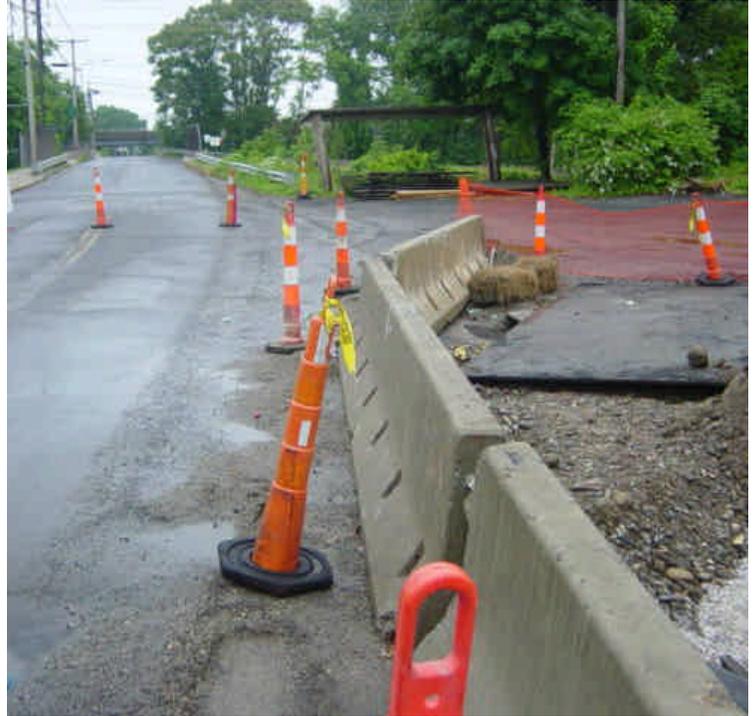
**Sediment is accumulating along the edge of Naugatuck Ave. near the concrete barrier curb. The catch basin adjacent to the work remains unprotected.**

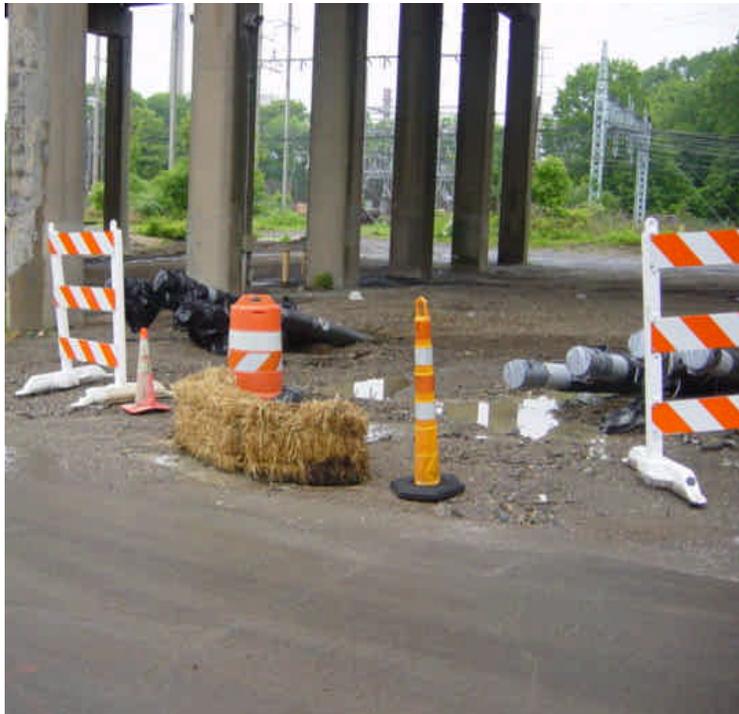
<p><b>Hay bales remain in place in one location to contain any potential residual slurry material. A minor amount of drilling slurry has seeped under the hay bale barrier. 6/6/08</b></p>	<p><b>Increase controls as necessary to contain drilling slurry. Stabilize or remove the material as soon as possible. 6/6/08</b></p>	<p><b>Needs attention.</b></p>
	<p><b>Hay bales were removed from around a catch basin near the staging area along Naugatuck Ave. and the basin was no longer protected (since 5/15). Accumulated sediment was also observed along the edge of the roadway and along the concrete barrier curbs. 5/29-6/6/08</b></p> <p><b>Work to attach the conduit bank to the bridge deck appears to have been completed. 6/6/08</b></p>	<p><b>If hay bales had to be moved to accommodate work, a silt sack should be installed directly within the grate or the contractor needs to clean the catch basin as soon as work is complete. 5/15-6/6/08</b></p> <p><b>Remove accumulated sediment from the roadway. 6/6/08</b></p> <p><b>Ensure that controls are in place to catch/contain any debris from falling into the river as indicated in the D&amp;M plan. 6/6/08</b></p>	<p><b>Needs attention.</b></p> <p><b>Continue to monitor.</b></p>

**The drilling pit on the south side has been partially backfilled and stabilized and all drilling equipment has been removed from the area. Hay bales remain in place in one location to contain any potential residual material. A minor amount of drilling slurry has seeped under the hay bale barrier.**
