Docket No. 272 – Development and Management Plan Inspection

Underground Line Watercourse and Railroad Crossings

Date: June 20, 2008

Location: Crossings of Watercourses and Railroads in Segments 3, 4a and 4b

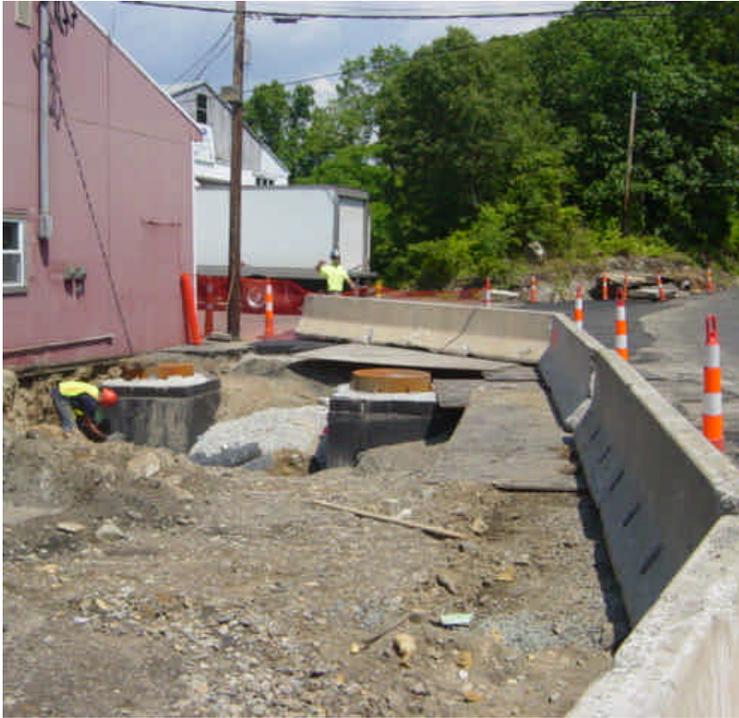
Tie-in work for both circuits has been completed on the north side of the Metro North R.R. Crossing. The drilling pit has been partially backfilled.

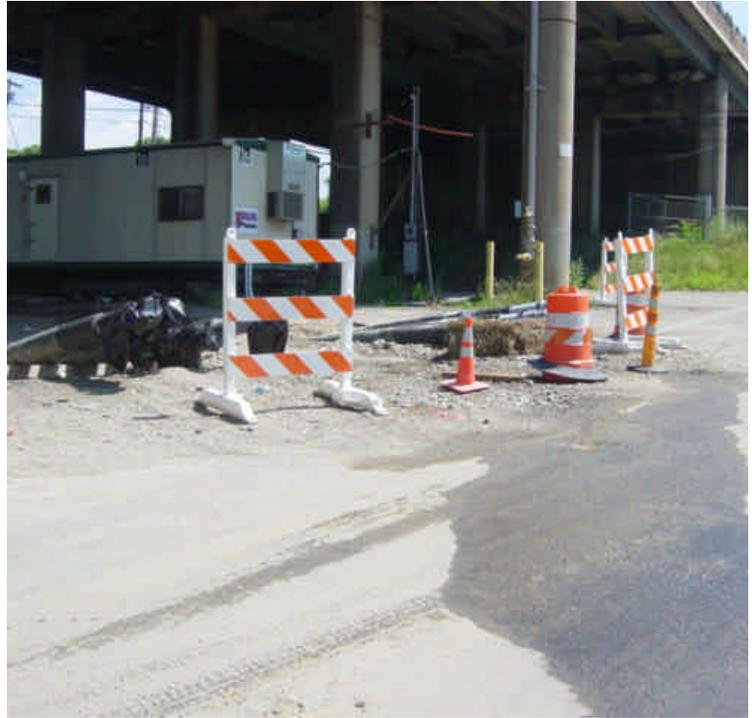
The staging area on the south side of the Metro North R.R. Crossing has been demobilized and the perimeter controls have been removed. Hay bales remain in one location near the drill pit where a minor amount groundwater was observed seeping under the barrier. The runoff was generally clean and was flowing back towards the adjacent trench work.

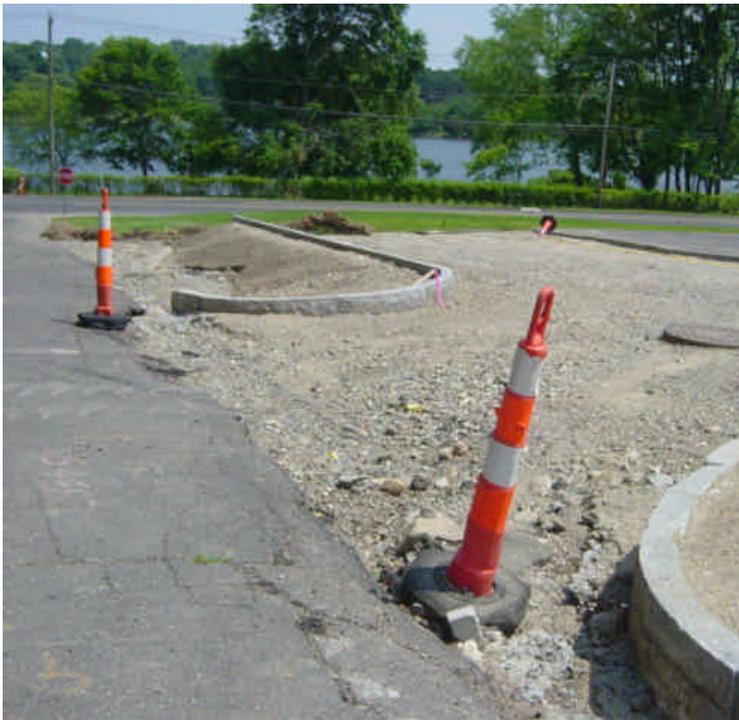
Stone curbing has been set near sta. #234. The adjacent areas have been partially re-graded and some of the material had eroded and accumulated at the intersection of Lincoln St. and Riverside Ave. Sweep this area as needed.
