**Docket No. 272 – Development and Management Plan Inspection**

**The Connecticut Light and Power Company Certificate of Environmental Compatibility and Public Need for the construction of a new 345-kV electric transmission line and associated facilities between Scovill Rock Switching Station in Middletown and Norwalk Substation in Norwalk, Connecticut, including reconstruction of portions of existing 115-kV and 345-kV electric transmission line, the construction of Beseck Switching Station in Wallingford, East Devon Substation in Milford, (and Singer Substation in Bridgeport), modifications at Scovill Rock Switching Station and Norwalk Substation, and the reconfiguration of certain interconnections.**

**Underground Line Watercourse and Railroad Crossings**

**Date:** August 14, 2008

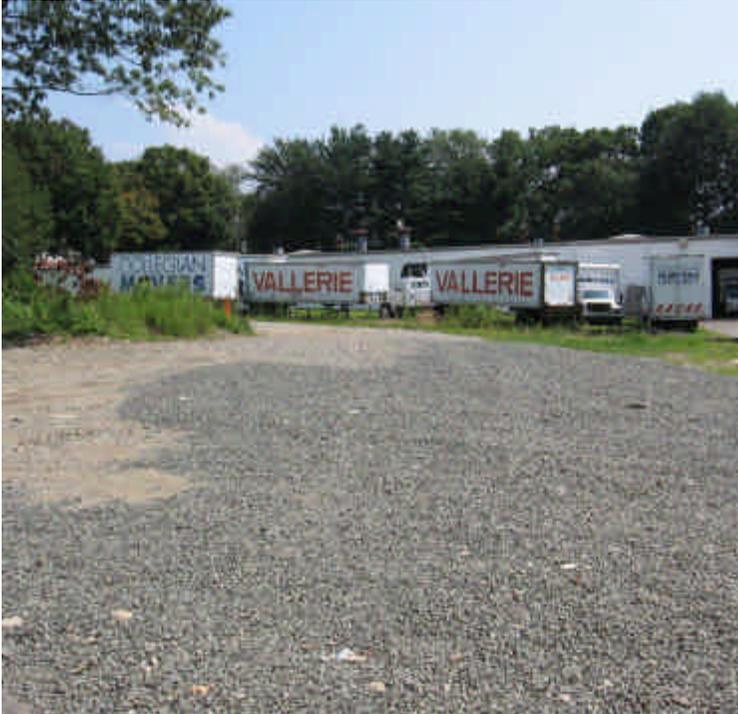
**The staging area on the south side of the Metro North R.R. – Milford remains partially restored. Silt fence remains around the temporary access road, which no longer provides access to the boat launch.**

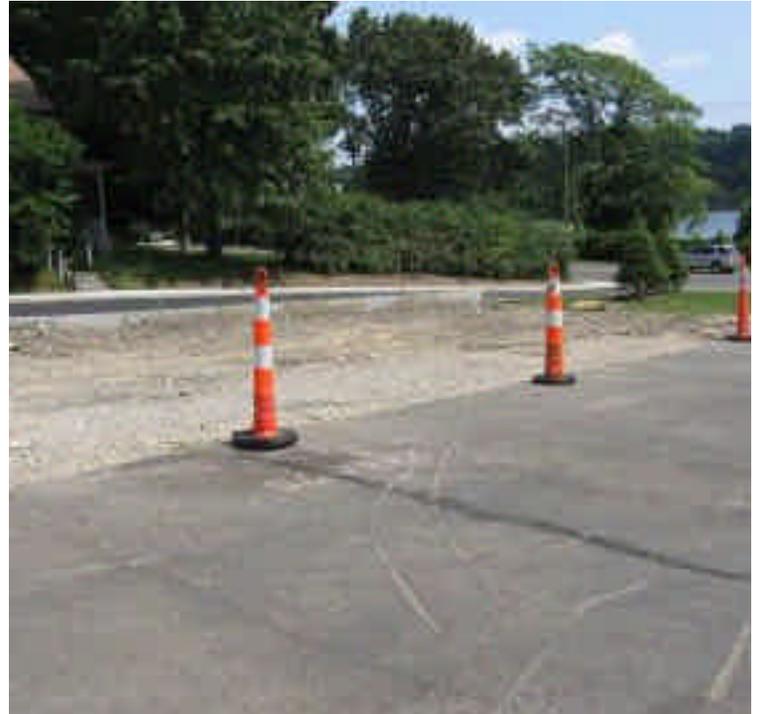
**On the west side of the Saugatuck River, portions of the work area have re-vegetated. The adjacent area is still waiting to be paved (since 3/20). Stone curbing has been set and process has been spread in some areas.**

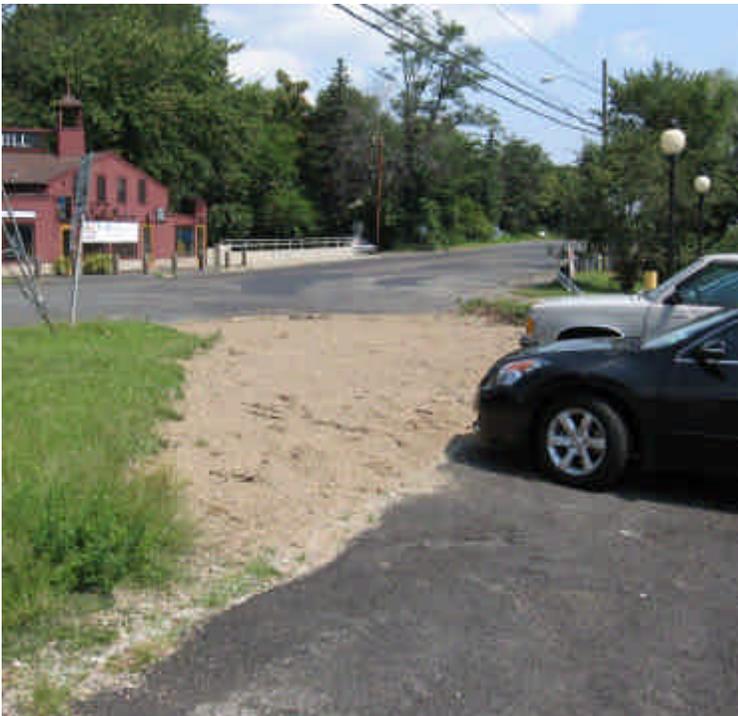
**Tie-in work appears to be complete on the bridge over Sasco Creek near sta. #434. Final stabilization is still required near the tie-in locations.**
