**Docket No. 272 – Development and Management Plan Inspection**

**Underground Line Watercourse and Railroad Crossings**

**Date:** August 29, 2008

**Location:** Crossings of Watercourses and Railroads in Segments 3, 4a and 4b

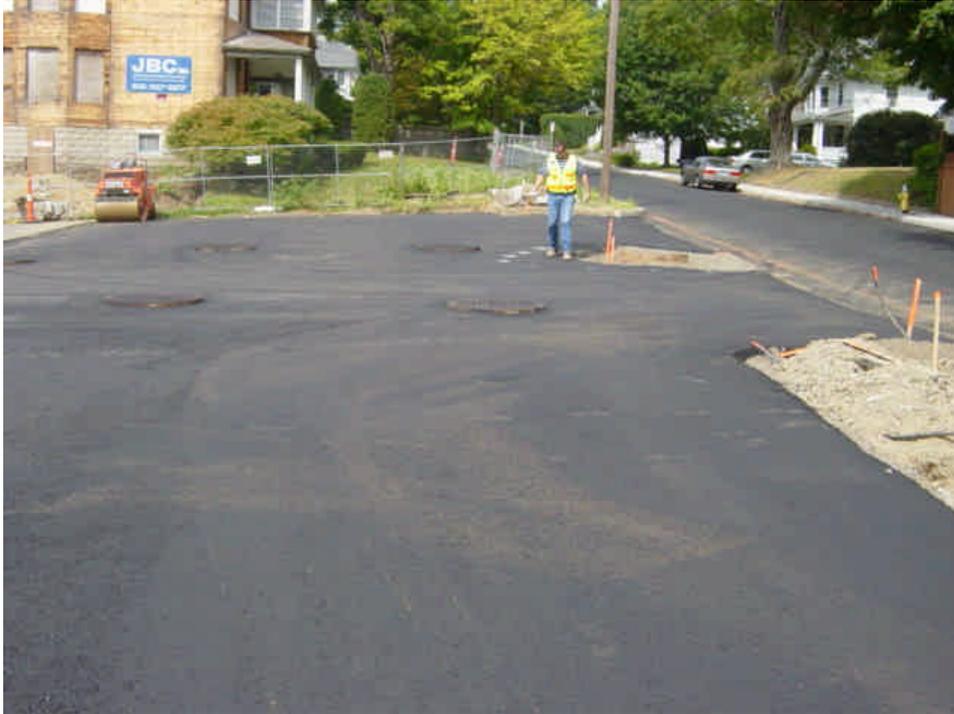
<b>Areas of Inspection</b>	<b>Observation</b>	<b>Recommended Action</b>	<b>Corrected Action</b>
<b>Access Roads and Adjacent Roadways Saugatuck River</b>	<b>On the west side of the Saugatuck River the curbing has been removed and the base coat of pavement has been placed over the backfilled area which had previously been exposed since 3/20. 8/29/08</b>	<b>Coordinate final restoration efforts/ responsibilities. The area had been waiting for pavement since 3/20 and now has a base coat of pavement. 8/29/08</b>	<b>A base of pavement was provided; continue to finalize.</b>
<b>Housatonic River</b>	<b>HDD work is complete. The east side is ready to be paved. 8/29/08</b>	<b>Continue to monitor the area. Final restoration efforts are on hold until after a planned DOT drainage project. See Erosion and Sediment Control section for more details. 8/29/08</b>	<b>Not Applicable (NA)</b>
<b>Metro North R.R. - Milford</b>	<b>Staging areas are partially restored on the north and south side of the Metro North R.R. off Naugatuck Ave. The temporary access road is no longer in use as the entrance to the boat ramp has been reopened. 8/29/08</b>	<b>Continue to monitor the area. Final restoration efforts are on hold until after a planned DOT drainage project. See Erosion and Sediment Control section for more details. 8/29/08</b>	<b>NA</b>

**On the west side of the Saugatuck River, previously placed stone curbing has been removed. A base coat of pavement is in place in the parking lot.**

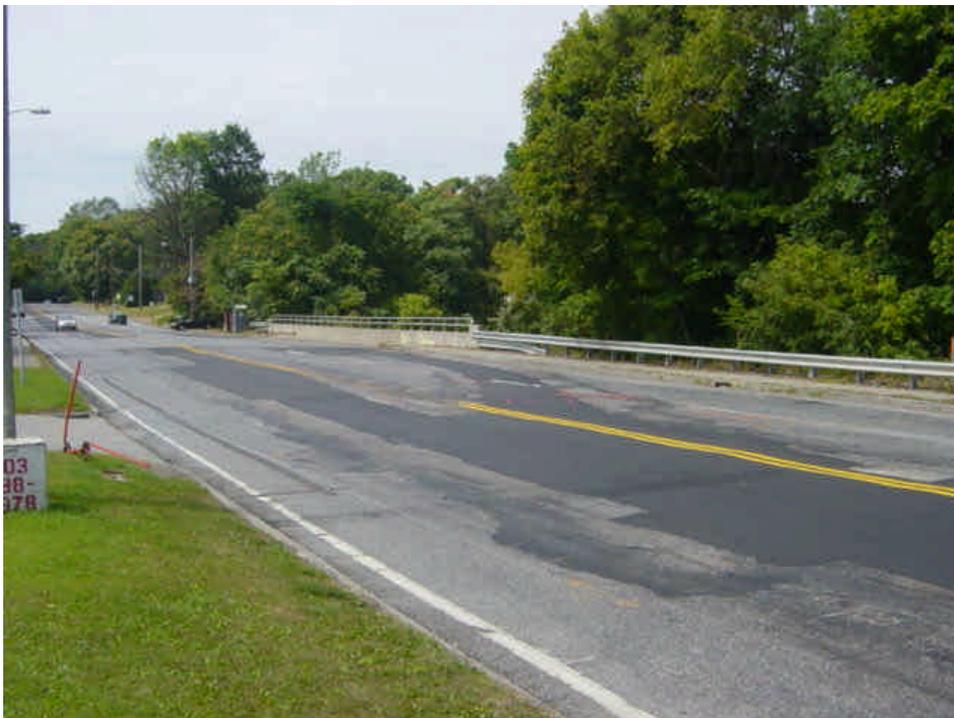
**Portions of Post Road near the Mill River (Southport Harbor) Bridge Attachment have been backfilled and temporarily paved.**
