Docket No. 272 – Development and Management Plan Inspection

Underground Line Watercourse and Railroad Crossings

Date: September 19, 2008

Location: Crossings of Watercourses and Railroads in Segments 3, 4a and 4b

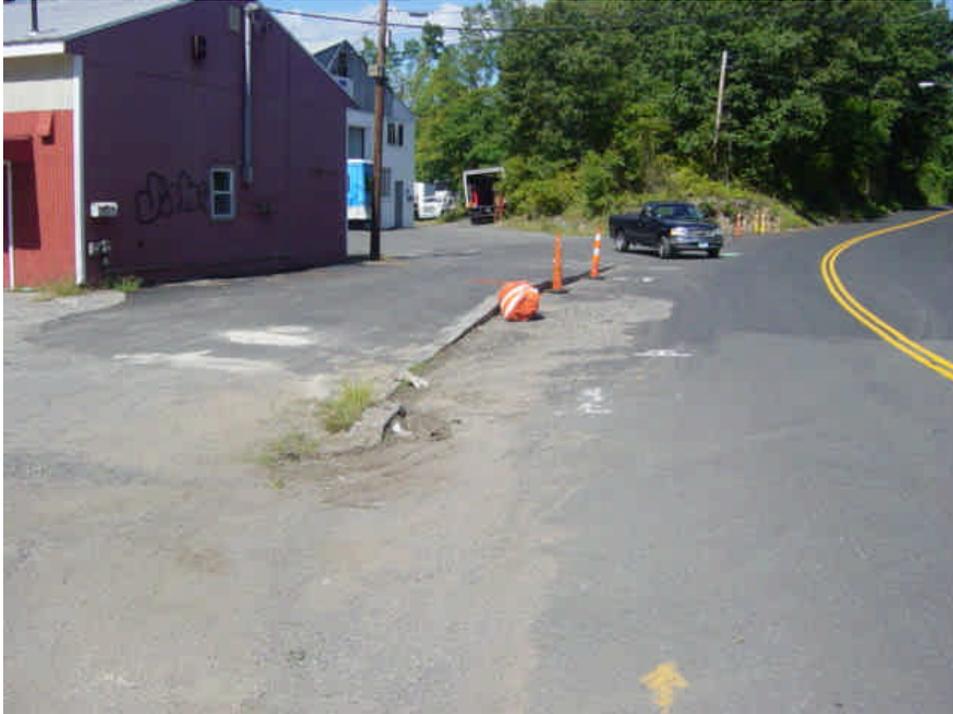
Sediment has accumulated along the edge of the road near the staging area for the Metro North HDD work on Naugatuck Ave. The catch basin here still needs to be cleaned.

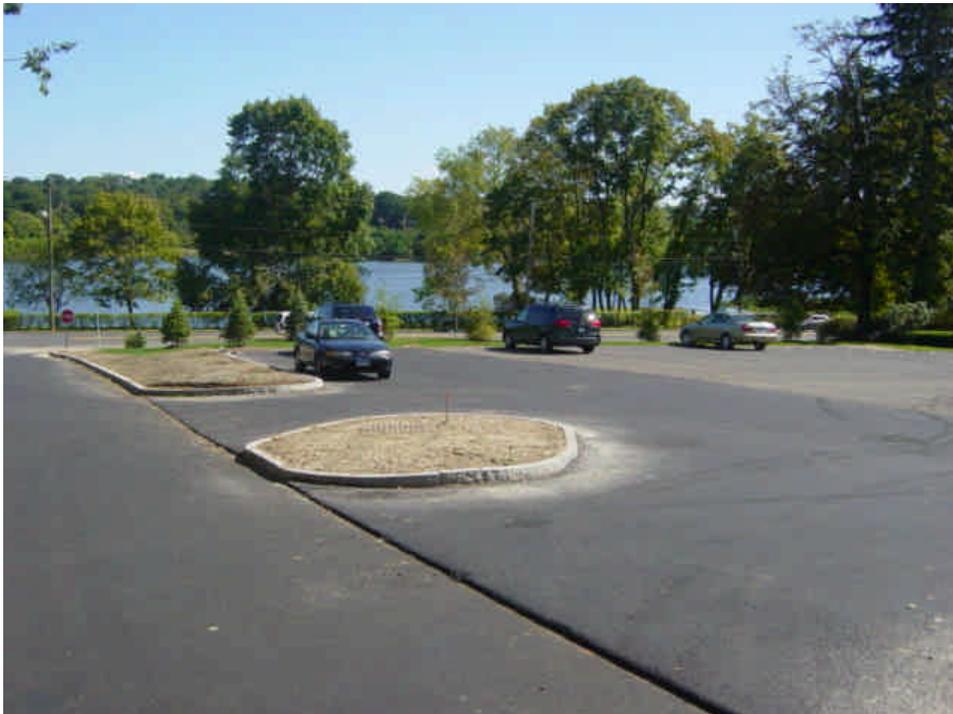
On the west side of the Saugatuck River the parking lot has been repaved. Exposed soil in the island areas needs to be stabilized. Monitor for vegetative cover/plantings.
