Docket No. 272 – Development and Management Plan Inspection

Beseck Switching Station Inspection

Date: April 3, 2007

Location: Beseck Switching Station

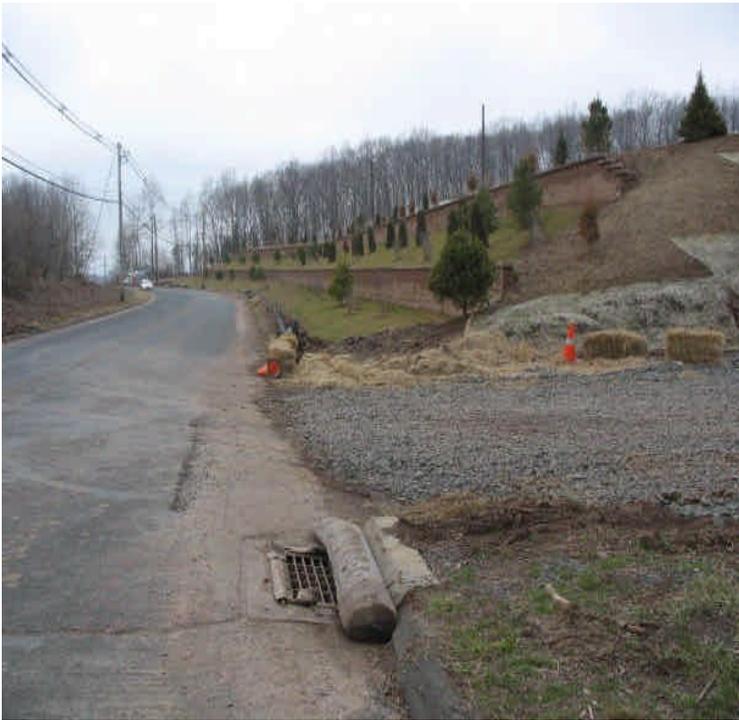
Haybales at the exit to the site should be replaced again. Minor amounts of fine sediment/dust tracking are still noted but efforts have been good to keep the area controlled.

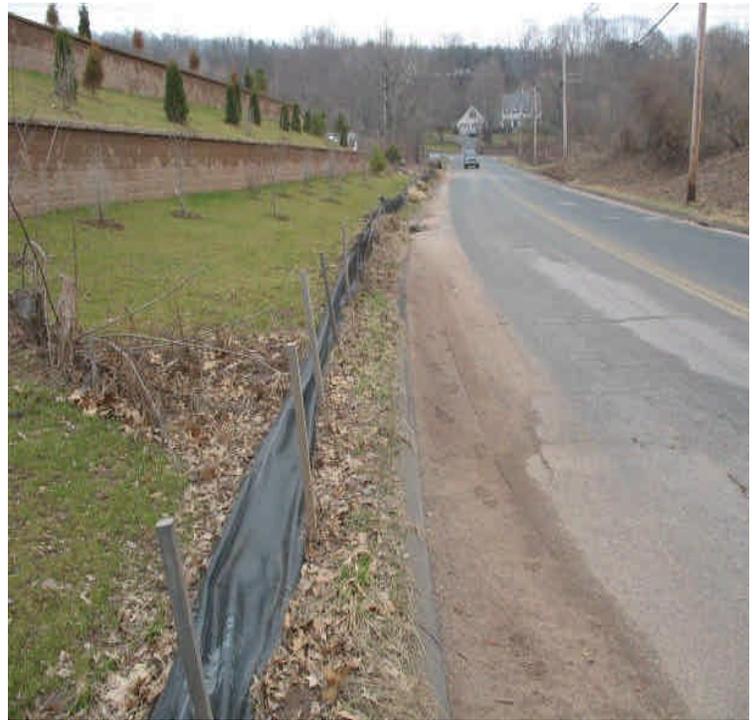
View of Carpenter Lane and retaining walls. Some sedimentation (as well as sand from town sanders) was noted along the gutters. Larger accumulations of sediment should be removed by hand if needed.

Gutters contained accumulated sand from town snow removal and some sedimentation from the site. (noted since	Clean/sweep roadway regularly. Sediment accumulation needs to be removed from the gutters. Remove by hand if	Needs attention.

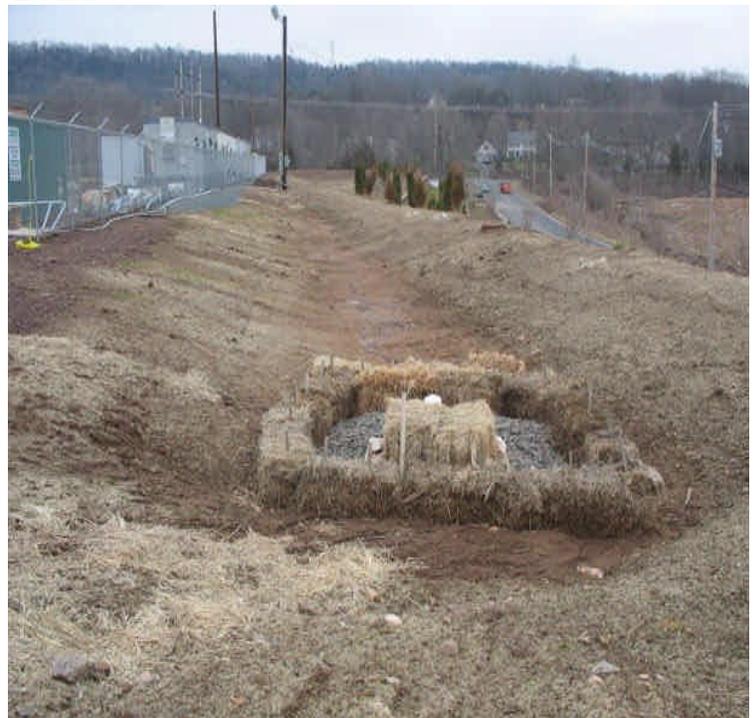
Haybales and controls remain in place at the inlet of the detention basin. Sediment from run-off was contained effectively the last few weeks.

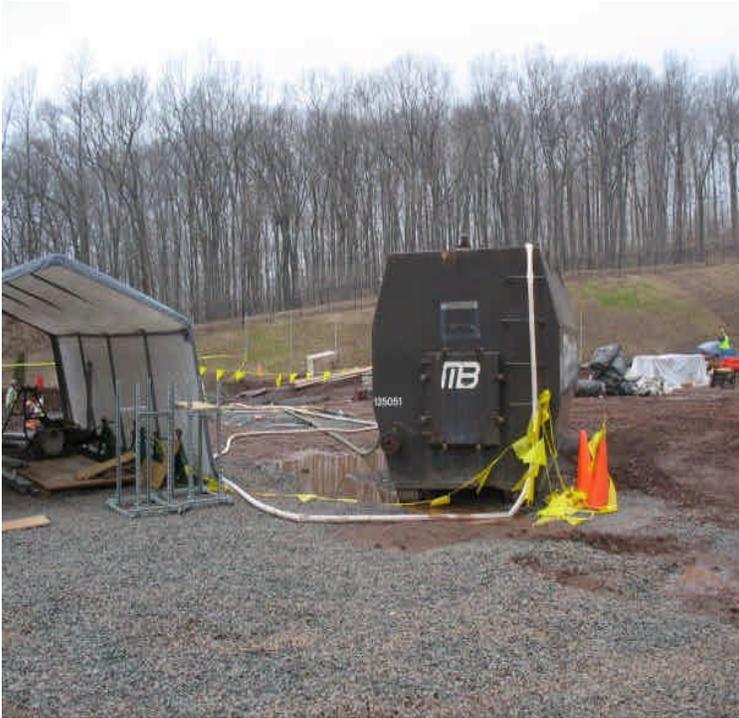
View of settling tank. Foundation pits were filled with rainwater and were being dewatered appropriately to the tank.

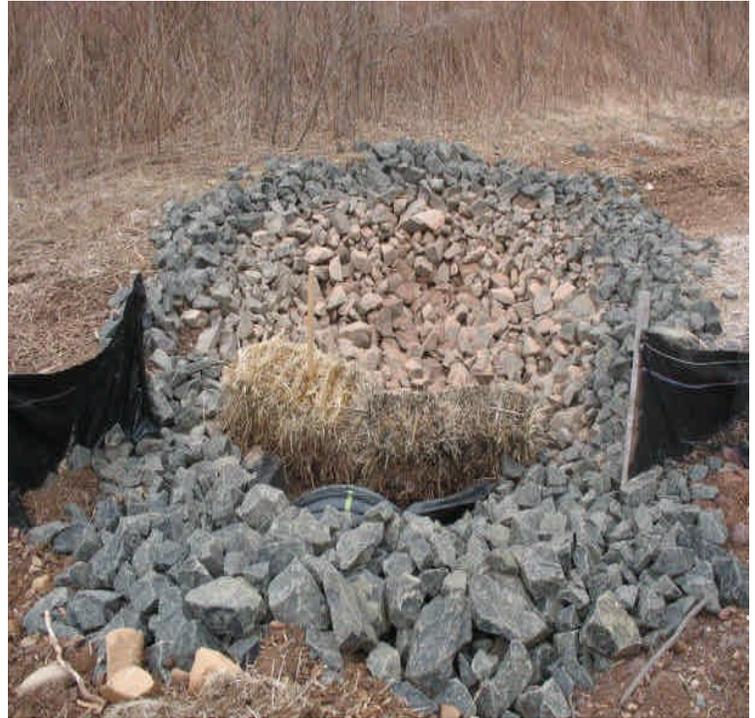
View of the culvert and sediment trap under the access road to the ROW. Sediment appears to be contained.

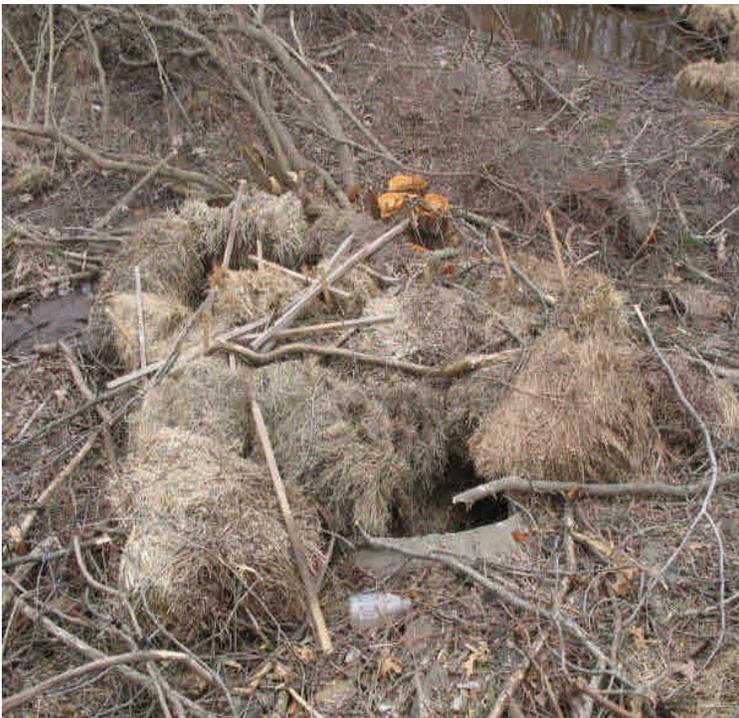
Storm drain outlet across Carpenter Lane has clear water flowing through the haybales. Trees have been cleared in the wetland for Segment 2a work.

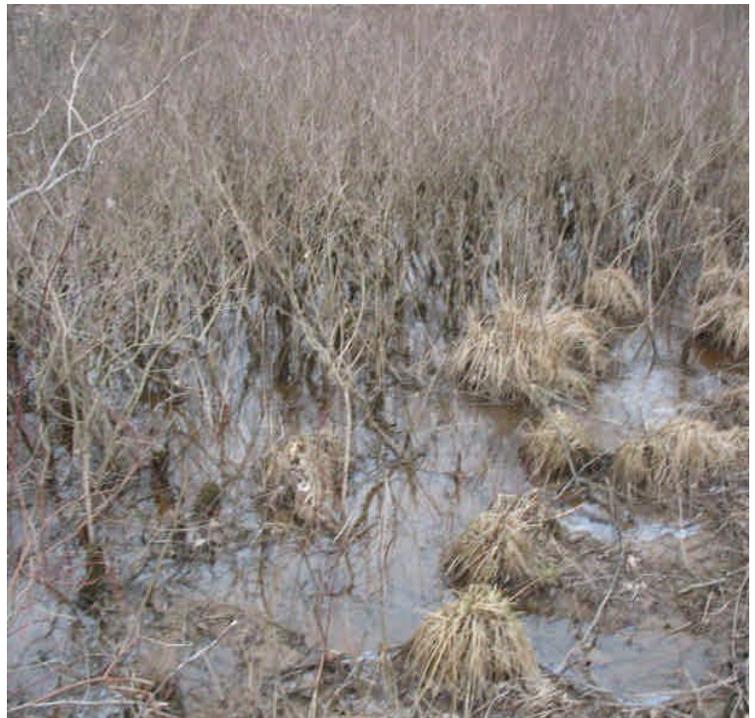
Clear water was observed leaving the haybales and entering the wetland. Evaluate whether the amount of sediment accumulation justifies the minor disturbance needed to remove it, once the water subsides. Timber harvesting/clearing within the wetlands for 2A is complete.

<p>Inland Wetland and Watercourse encroachment and mitigation</p>	<p>Clear water was observed leaving the outlet across Carpenter Lane and entering wetlands. 4/3/07</p>	<p>Several areas in the wetland have sediment accumulation. Sediment should be removed from the outlet and adjacent areas when water levels recede 12/26/06- 4/3/07. It will be evaluated whether the accumulation justifies the minor disturbance required to remove it. 1/23-4/3/07</p>	<p>Continue to evaluate and add controls as needed.</p>
