Docket No. 272 – Development and Management Plan Inspection

Beseck Switching Station Inspection

Date: April 10, 2007

Location: Beseck Switching Station

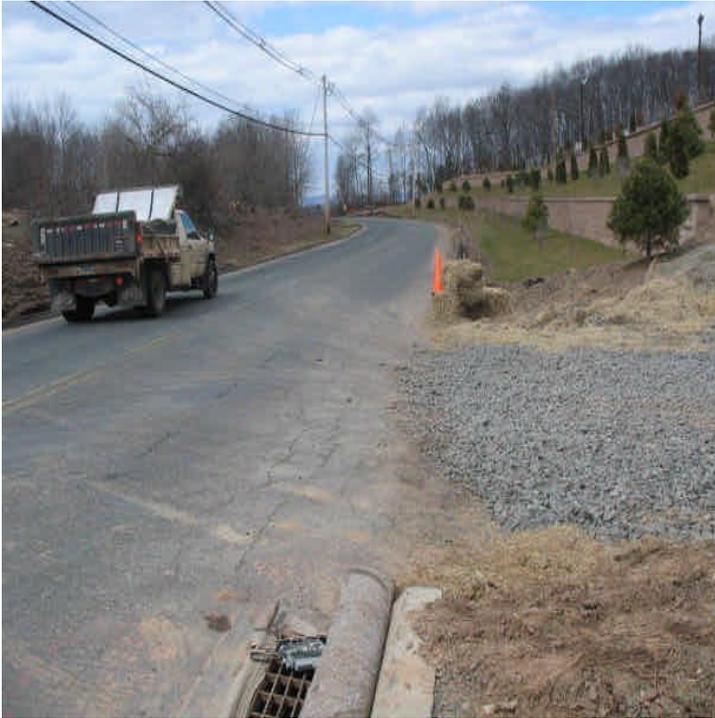
Haybales at the exit to the site should be replaced again. Minor amounts of fine sediment/dust tracking are still noted but efforts have been good to keep the area controlled.

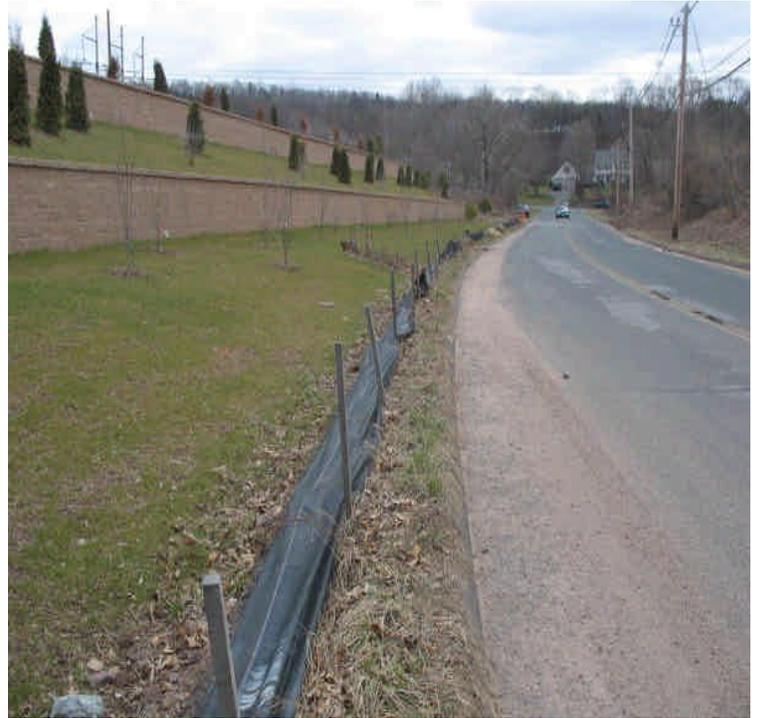
View of Carpenter Lane and retaining walls. Some sedimentation (as well as sand from town sanders) was noted along the gutters. Larger accumulations of sediment should be removed (by hand if necessary)

Gutters contained accumulated sand from town snow removal and some sedimentation from	Clean/sweep roadway regularly. Sediment accumulation needs to be removed from the gutters.	Needs attention.

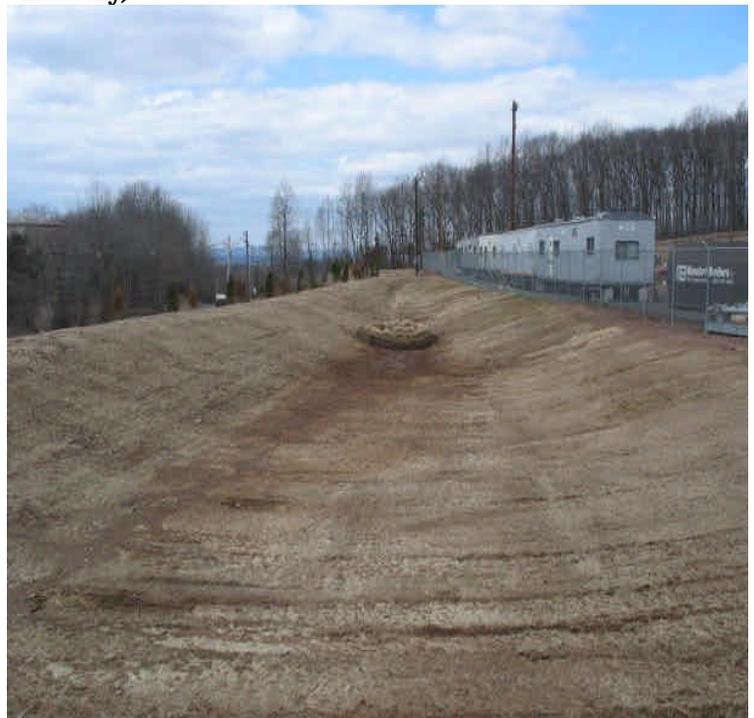
Haybales and controls remain in place at the inlet of the detention basin. Sediment from run-off was contained effectively the last few weeks.

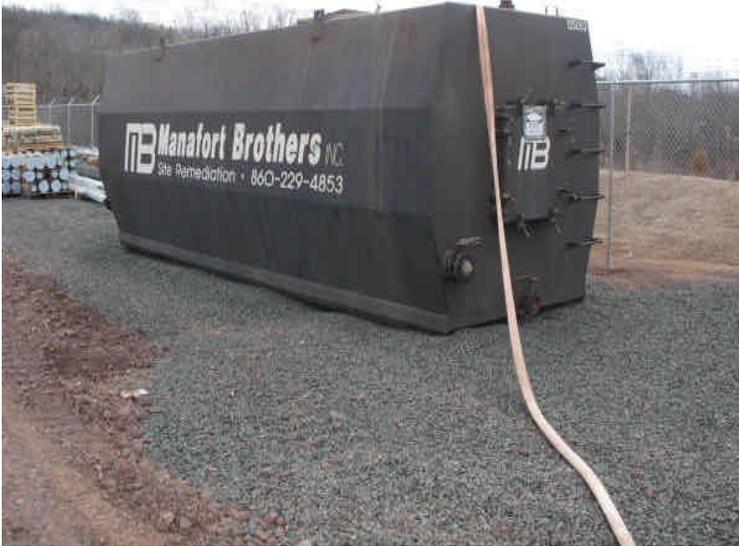
View of settling tank. Foundation pits were filled with rainwater or meltwater and were being dewatered appropriately to the tank.

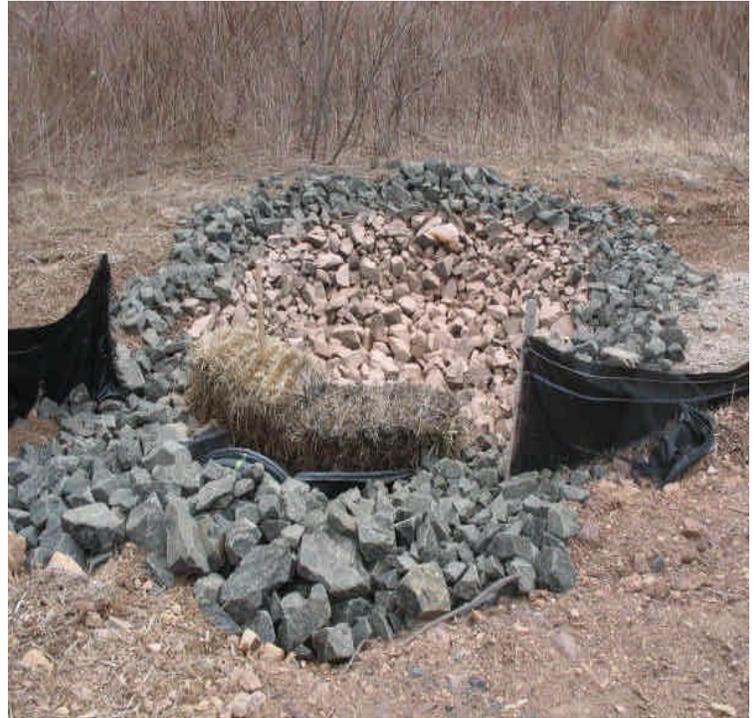
View of the culvert and sediment trap under the access road to the ROW. Sediment appears to be contained.

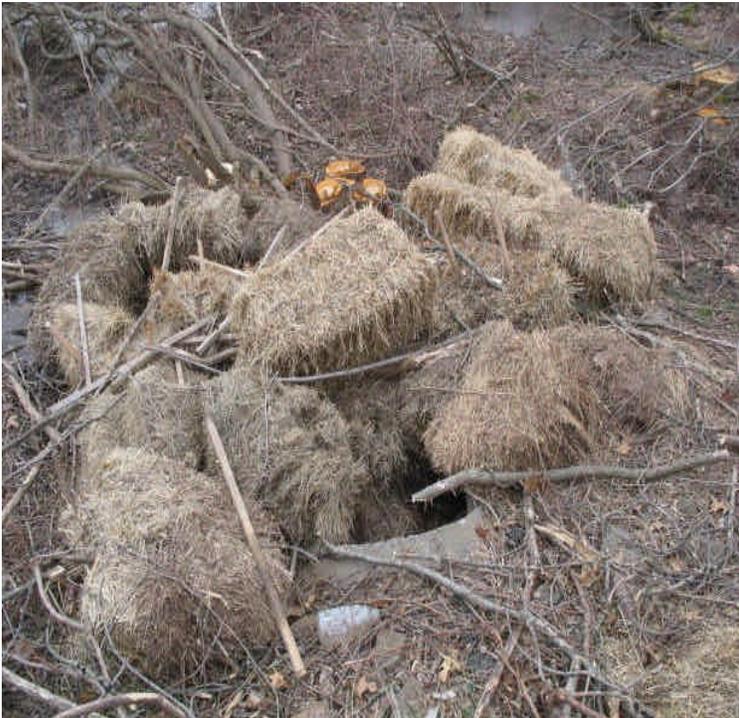
Storm drain outlet across Carpenter Lane has clear water flowing through the haybales. Tree clearing is complete in the wetlands as part of the Segment 2a work.

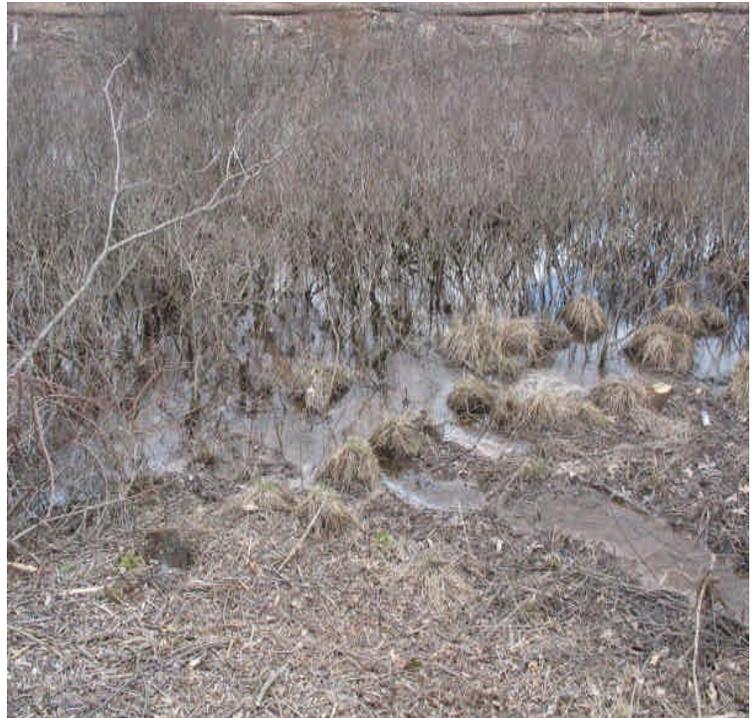
Clear water was observed leaving the haybales and entering the wetland. Evaluate whether the amount of sediment accumulation justifies the minor disturbance needed to remove it, once the water subsides.

<p>Inland Wetland and Watercourse encroachment and mitigation</p>	<p>Clear water was observed leaving the outlet across Carpenter Lane and entering wetlands. 4/10/07</p>	<p>Several areas in the wetland have sediment accumulation. Sediment should be removed from the outlet and adjacent areas when water levels recede 12/26/06- 4/10/07. It will be evaluated whether the accumulation justifies the</p>	<p>Continue to evaluate and add controls as needed.</p>
