Docket No. 272 – Development and Management Plan Inspection

Beseck Switching Station Inspection

Date: April 17, 2007

Location: Beseck Switching Station

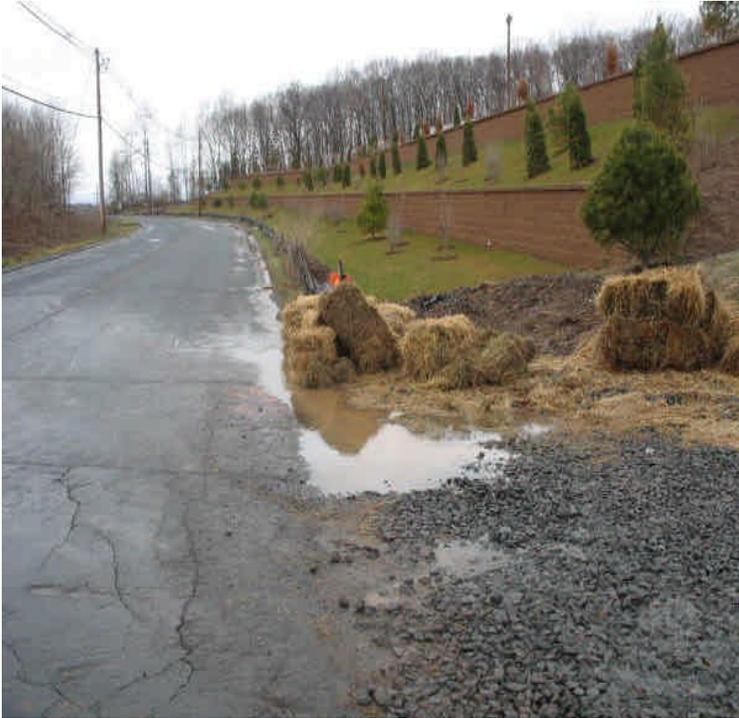
Site exit off Carpenter Lane is at final grade; haybales at the exit were replaced. However, the heavy rains overwhelmed the controls and turbid water was flowing off site and into a CB.

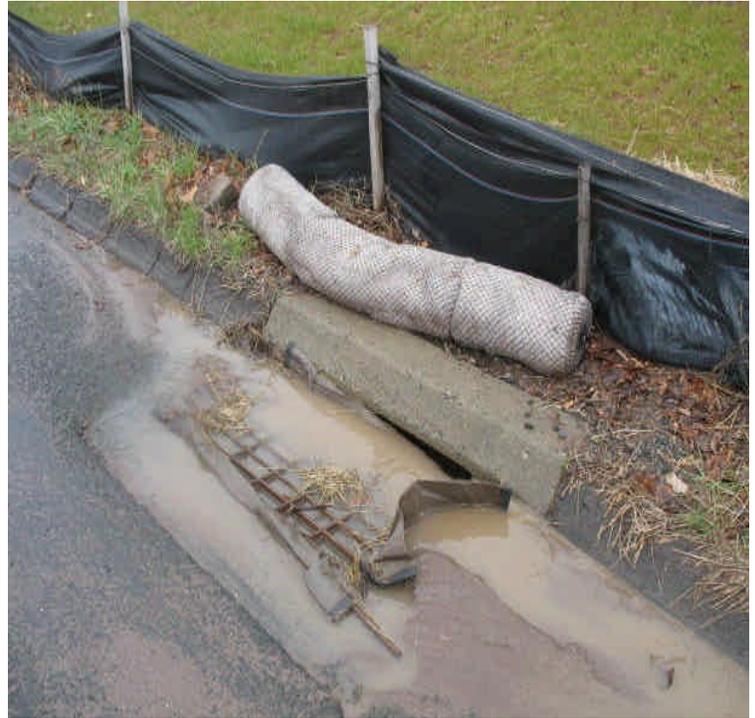
Turbid water entering a CB downgradient of the exit. The gutter buddy was removed because the high volume of water was ponding on Carpenter Ln., causing a safety issue.

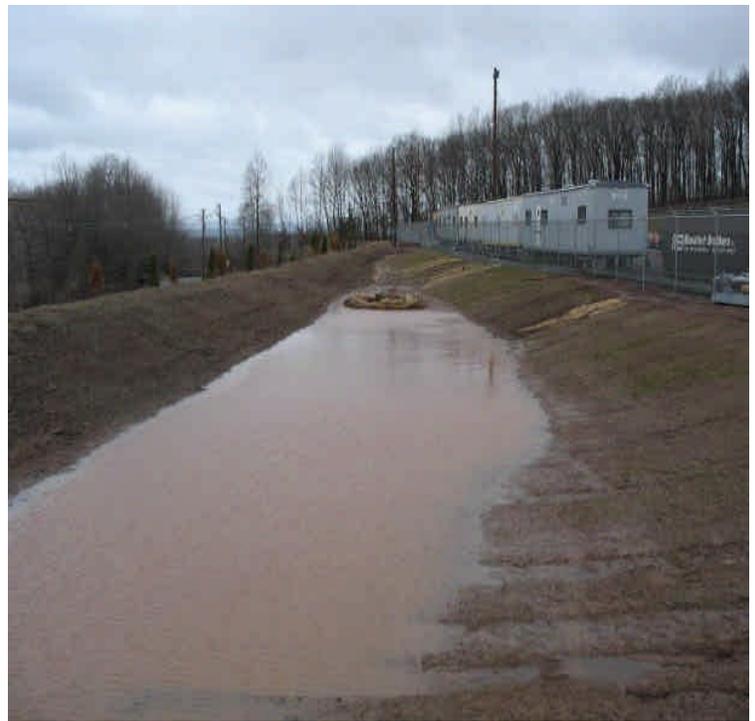
Haybales and controls remain in place at the inlet of the detention basin. Turbid run-off had overtopped the controls due to the heavy rain but contractors were working to pump water into settling tanks.

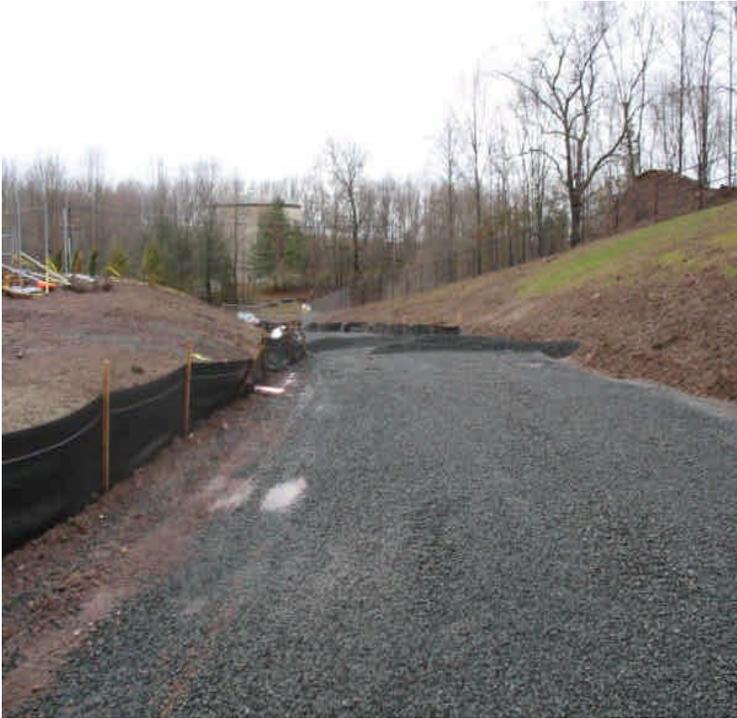
New stone and stone check dams were added to the site entrance which was closed in anticipation of the rain. Controls appear to be working effectively.

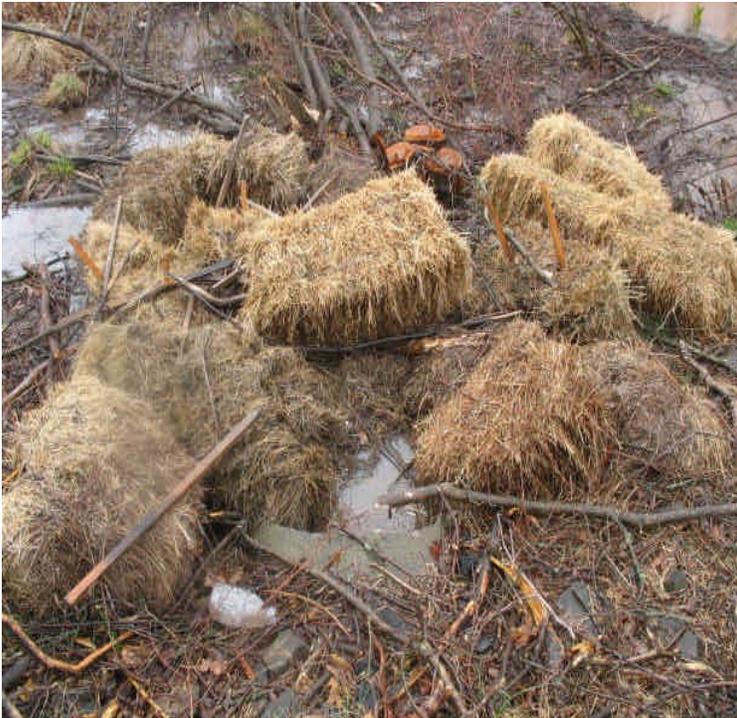
Storm drain outlet across Carpenter Lane had turbid water flowing through the haybales as the very heavy rains (over 3" in 24 hours) overwhelmed the controls on site.

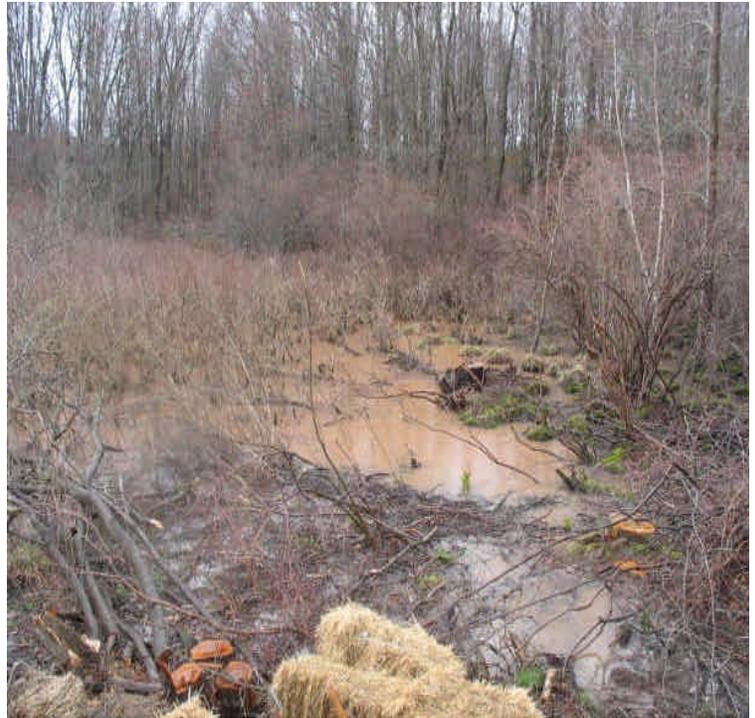
Turbid water was observed in the wetlands as a result of the heavy rains. Evaluate whether the amount of sediment accumulation justifies the minor disturbance needed to remove it, once the water subsides.
