**Docket No. 272 – Development and Management Plan Inspection**

**East Devon Substation Inspection**

**Date:** April 12, 2007

**Location:** East Devon Substation

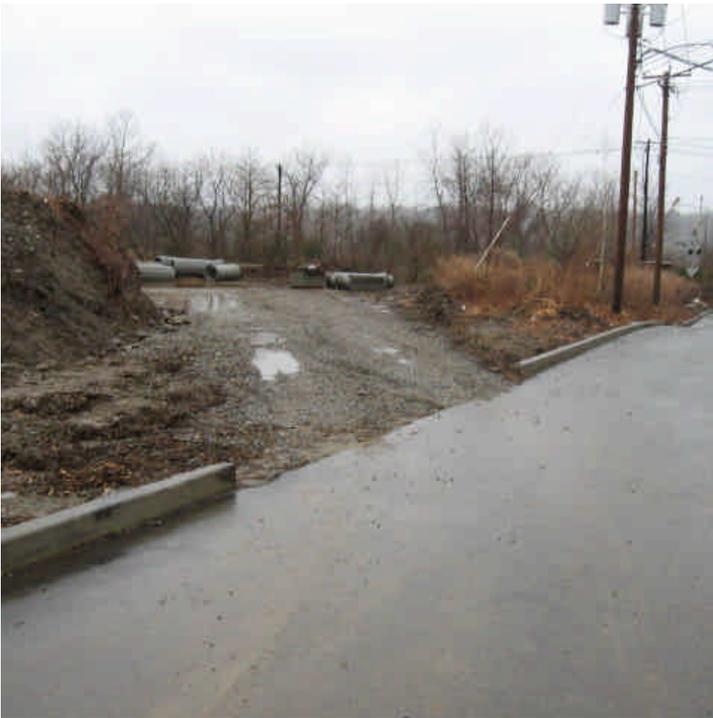
**Stone tracking pads are in place at the access points off Plains Road.**

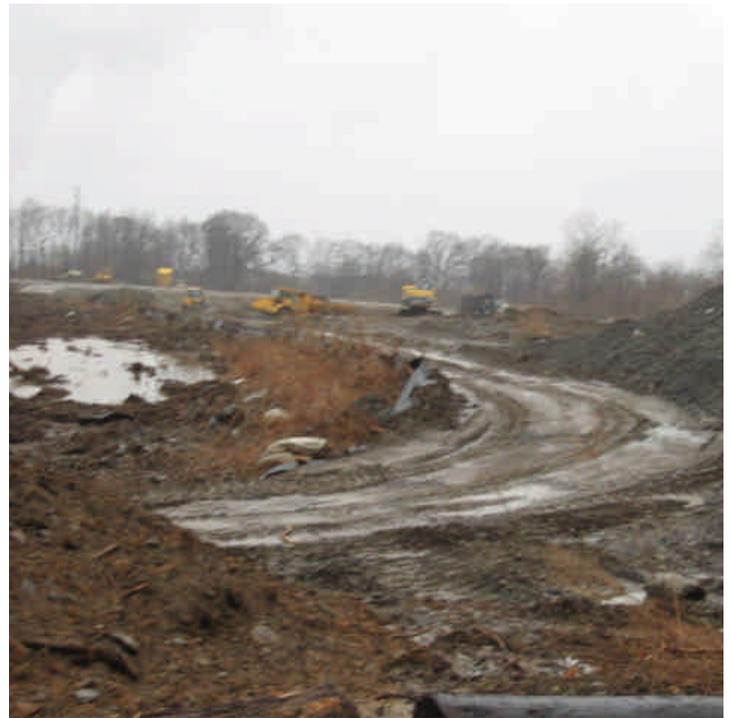
**Overall view of the active work this week. Grading and access road construction continues.**

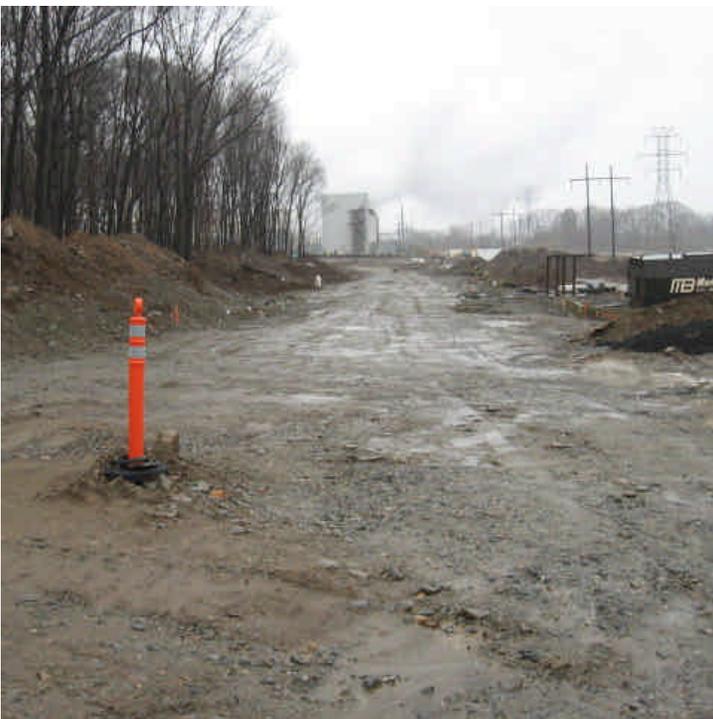
**View of the new location of Shelland Street.**

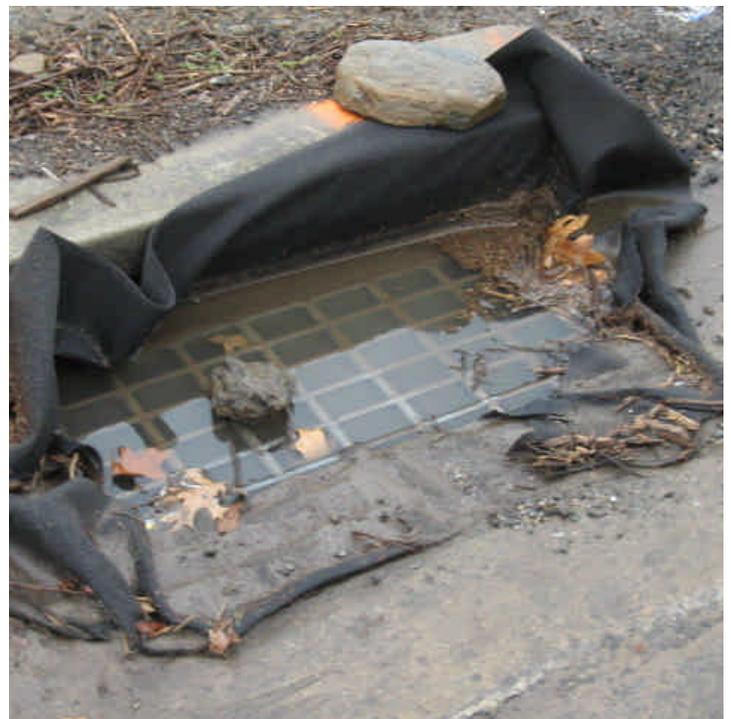
**Silt saks remain intact within the catch basins on Plains Road. The filter fabric was pulled over the curb here for inlet protection. Water was pooling before it filters into the inlet.**
