Docket No. 272 – Development and Management Plan Inspection

Scovill Rock Switching Station Inspection

Date: April 9, 2007

Location: Scovill Rock Switching Station

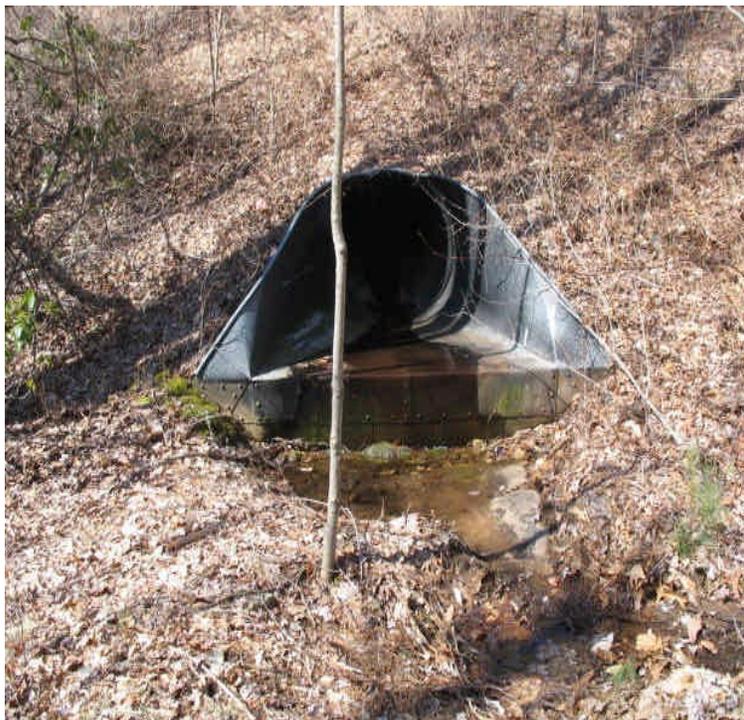
View of the culvert under the access drive. No sediment issues have been observed.

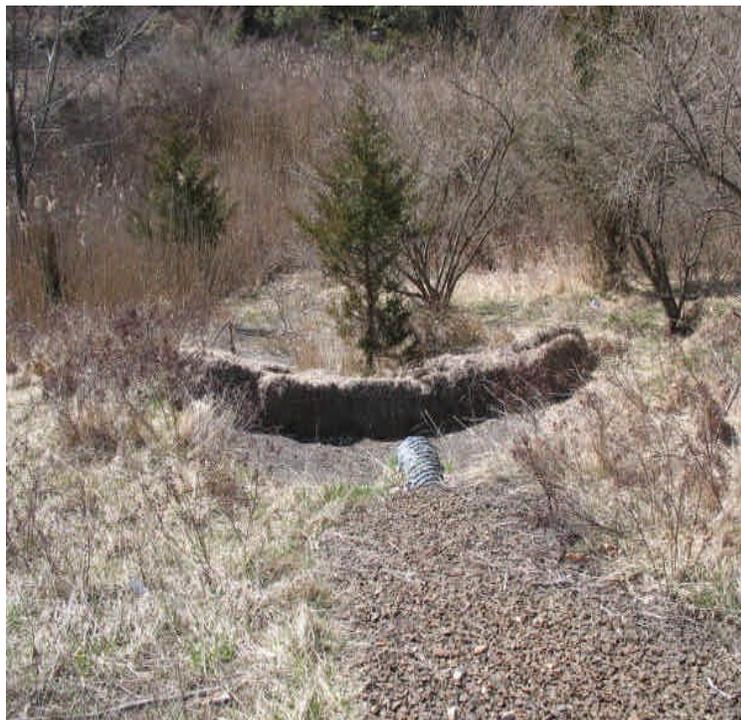
Final controls should be removed. Site is stable.

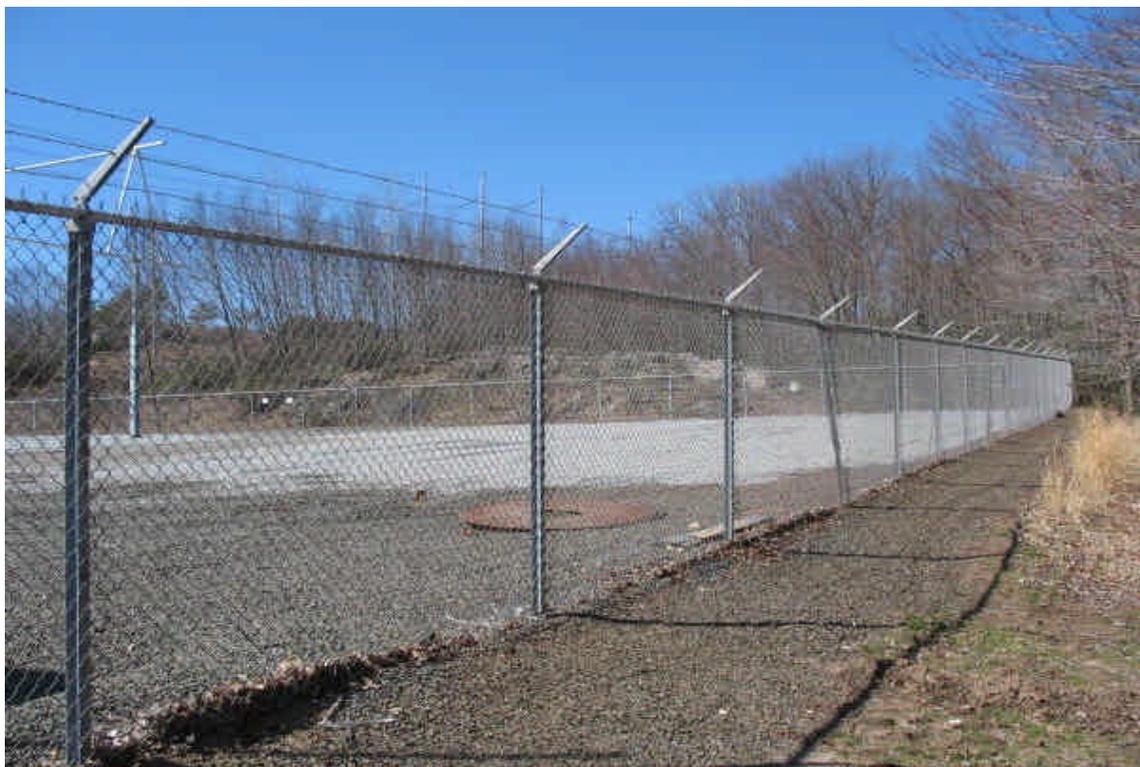
Soil stockpile has been removed and the area was regraded and lined with stone. 4/9/07	None. The area is stable. 4/9/07	Soil stockpile removed.

Soil stockpile was removed and the area was regraded and lined with stone. Work on site is complete and the area is stable.
