Docket No. 272 – Development and Management Plan Inspection

Segment 1a Inspection

Date: April 2, 2007

Location: Segment 1a – Scovill Rock Switching Station to Chestnut Junction, Oxbow Junction to Beseck Switching Station (excluding Royal Oak Bypass), and Black Pond Junction to Beseck Switching Station

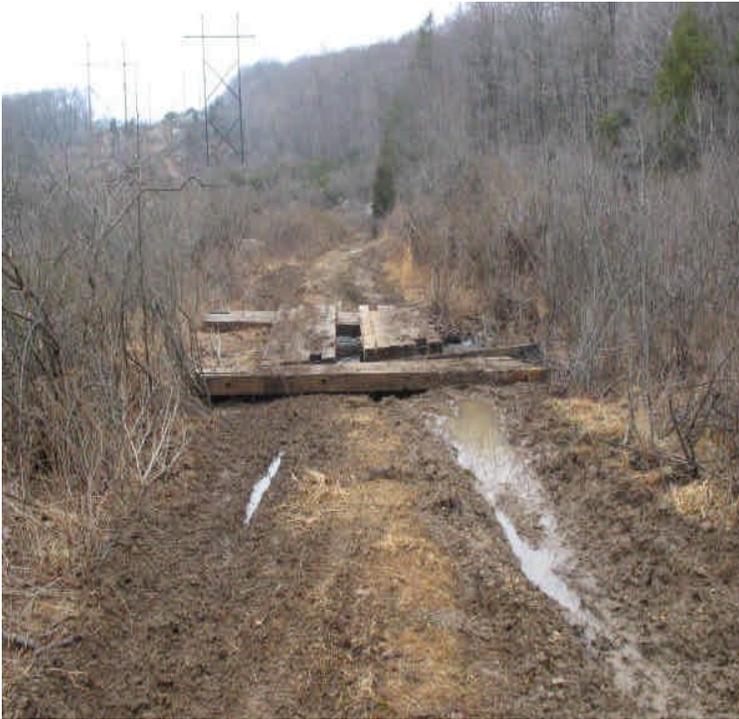
Timber mat crossing within the ROW west of Scovill Rock SS. This was installed for clearing crews access. Crews should work to stabilize soil after vehicles cause disturbance with tracking.

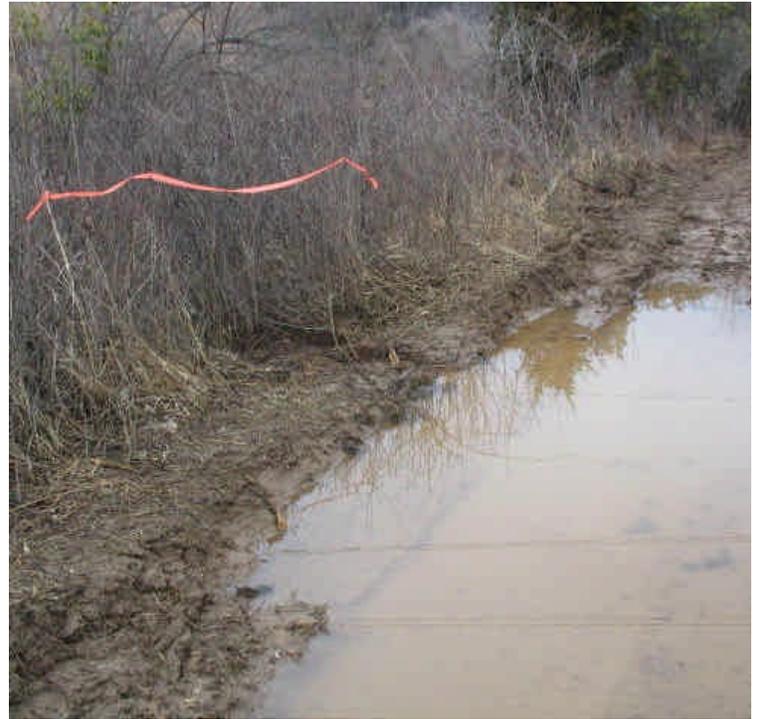
Water has ponded up along the access road in several locations west of Scovill Rock. Disturbance from vehicle tracking could result in turbid run-off. Consider installing controls in these areas.

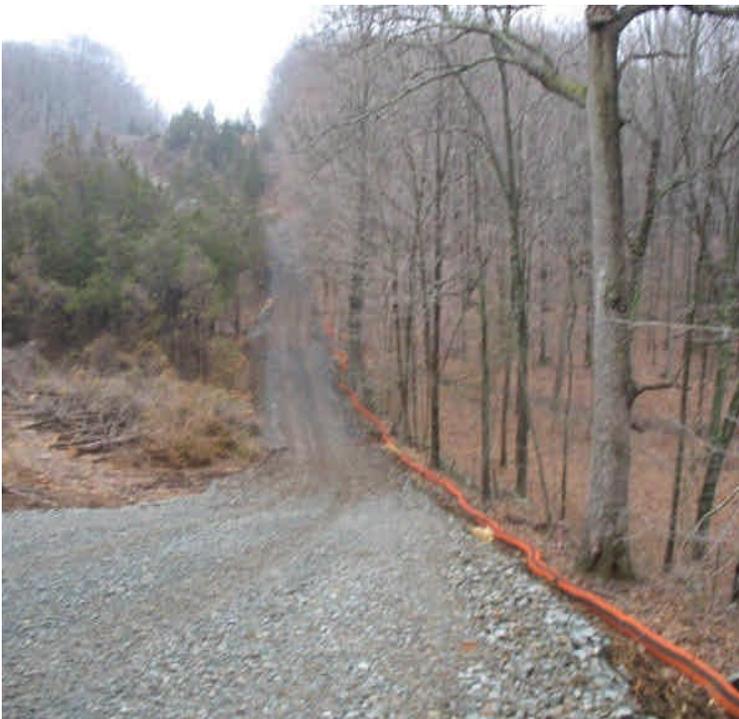
View of access road leading to the culvert area off Black Walnut Dr. A new stone access road was installed over the existing stone/soil access road to better control run-off.

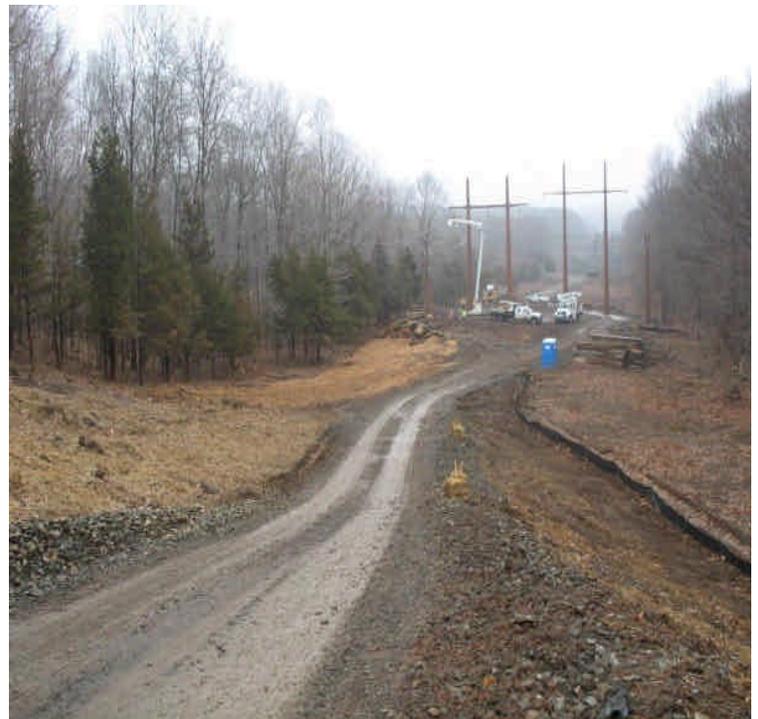
Line removal/installation off Black Walnut Dr. Additional mulch, haybales, and filter sockswere placed along the slope in an effort to reduce erosion.

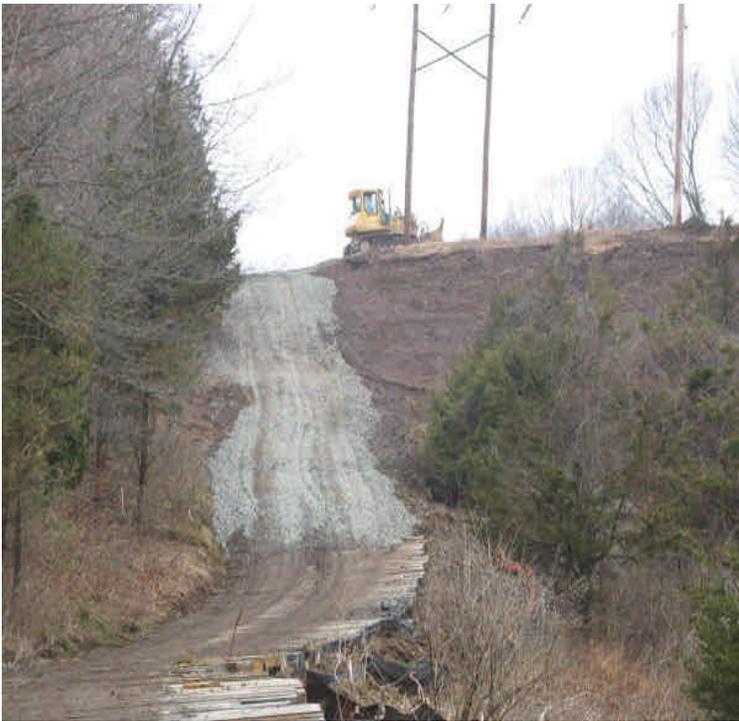
Timber mats located along a wetland off Arbutus St. New stone was being installed along the access road and at a new pad site.

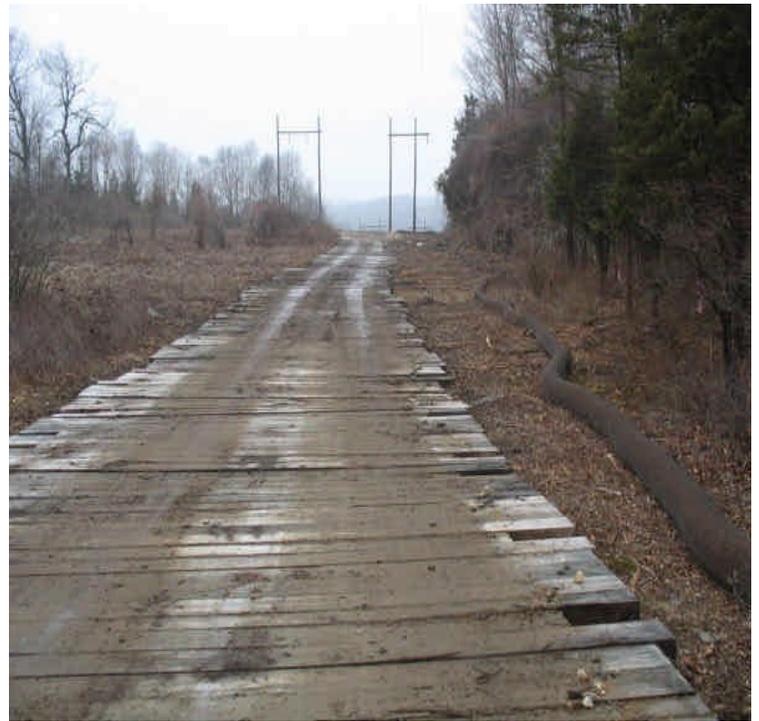
Filter socks were installed along the wetland crossing off Haddam Quarter Road. Clear water was flowing off-site.

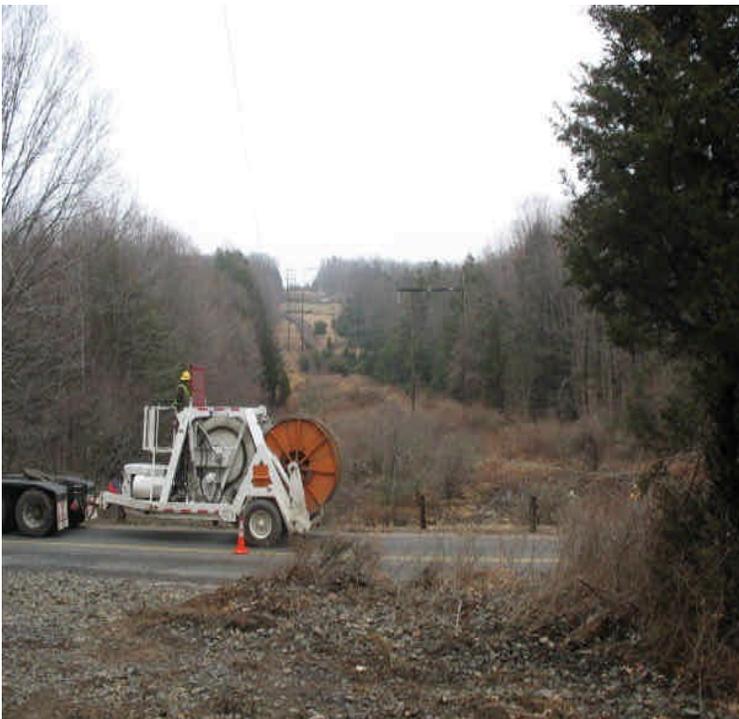
Line work off Johnson Ln. Controls were being maintained during removal.

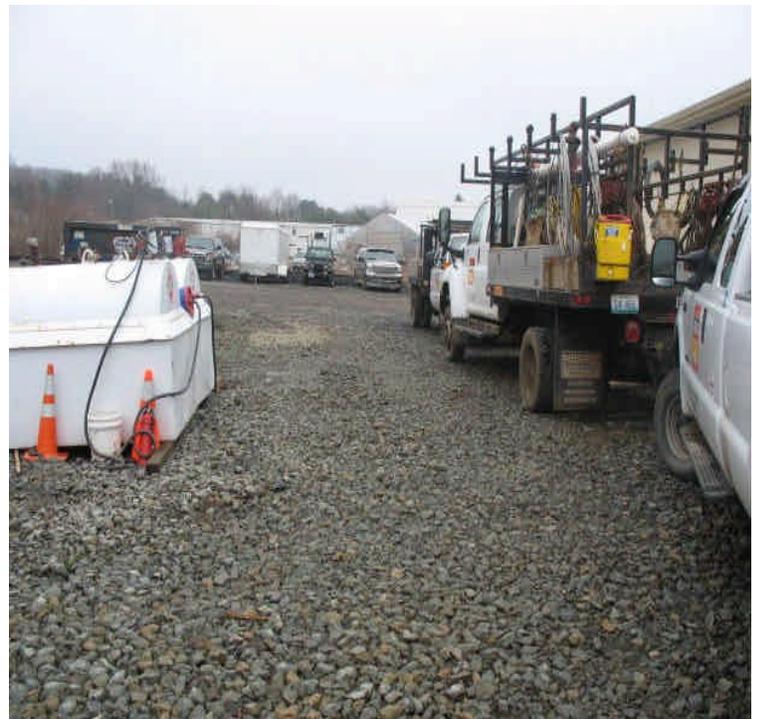
Both nozzles were contained at the fuel tanks within the contractor receiving yard. No spills were noted during this inspection.

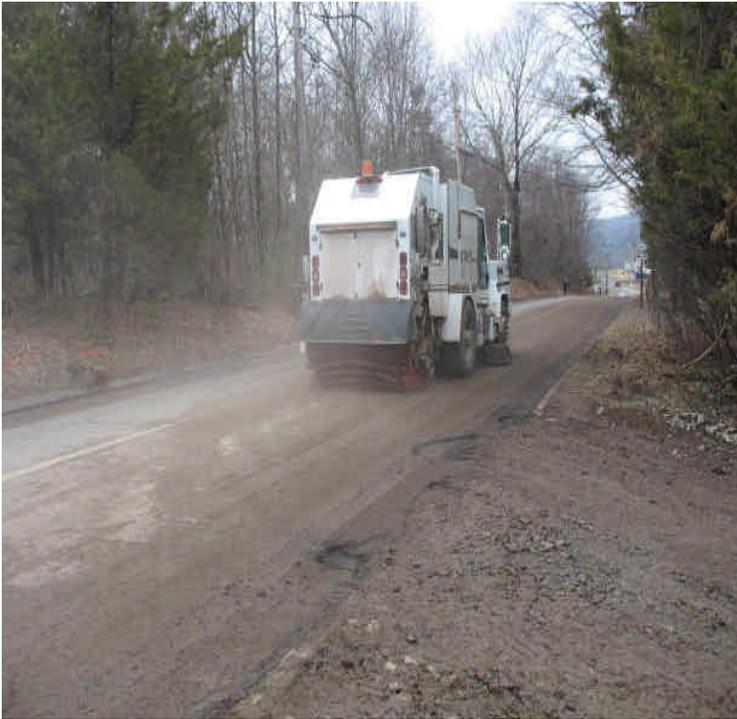
Powder Hill Road was being swept during the inspection. Roadway sweeping should continue on a regular basis at all active sites. The stone construction entrance should also be refreshed to reduce tracking

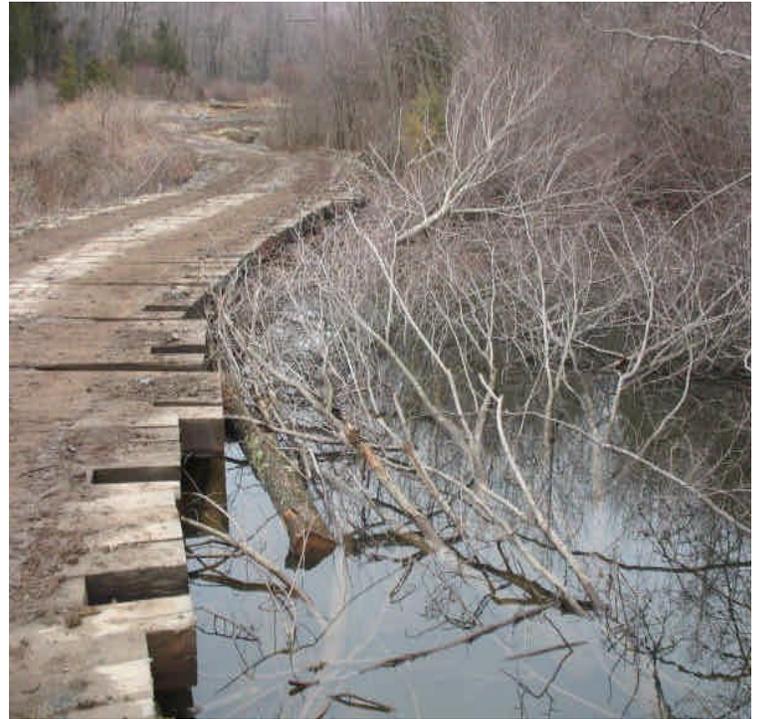
Wetland crossing off Powder Hill Road. Turbidity was not observed within the wetlands at this inspection.

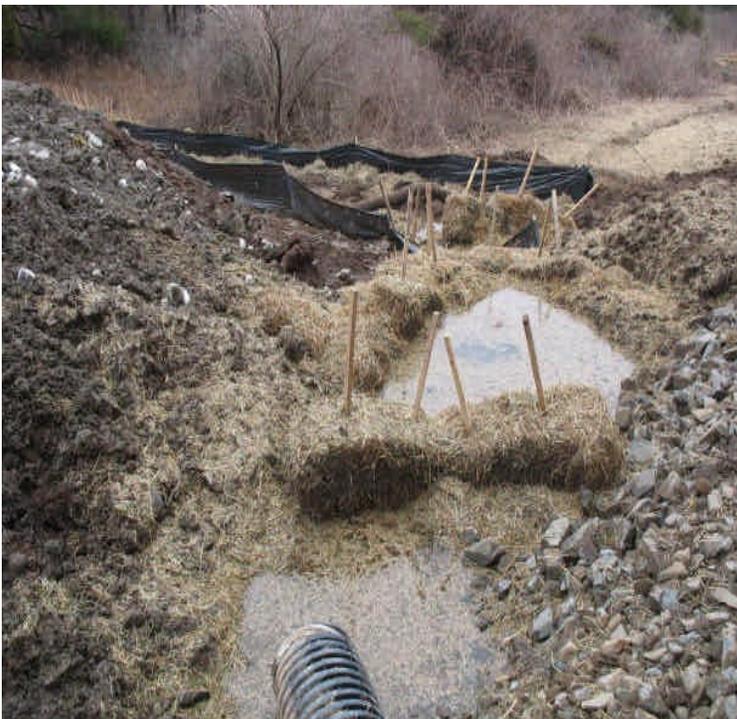
View of newly installed culvert, mulch and haybale controls in place off Powder Hill Rd. Sediment is filtered from the run-off before it flows off-site

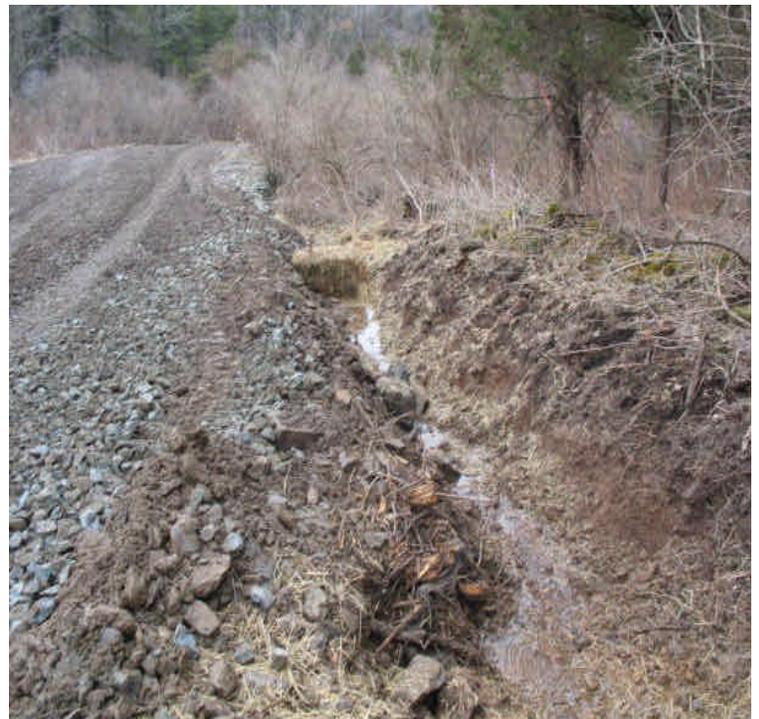
A new drainage swale with haybale check dams was installed along the access road off Powder Hill Rd. Run-off is diverted and filtered prior to leaving the site.

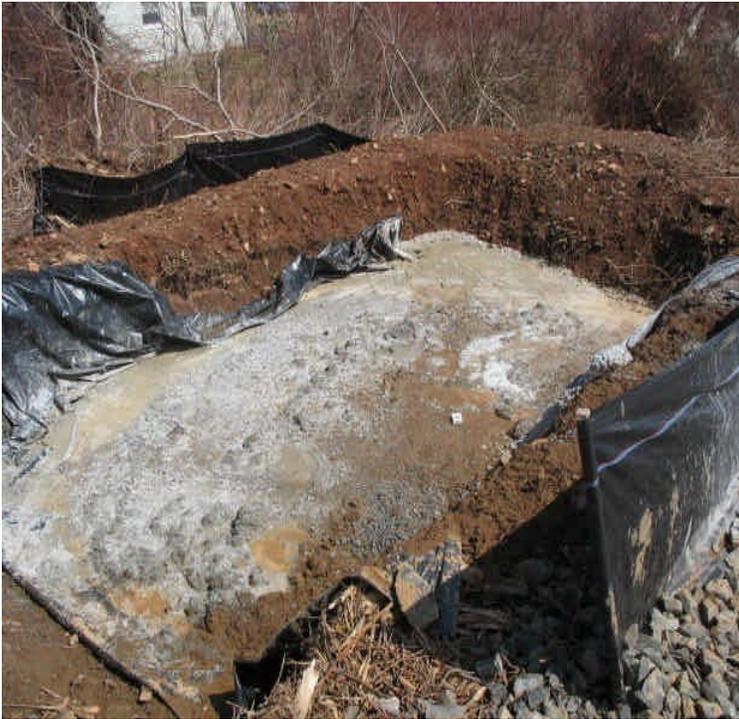
Concrete washout area in use off Valley View Drive. Material should be removed when work is complete.

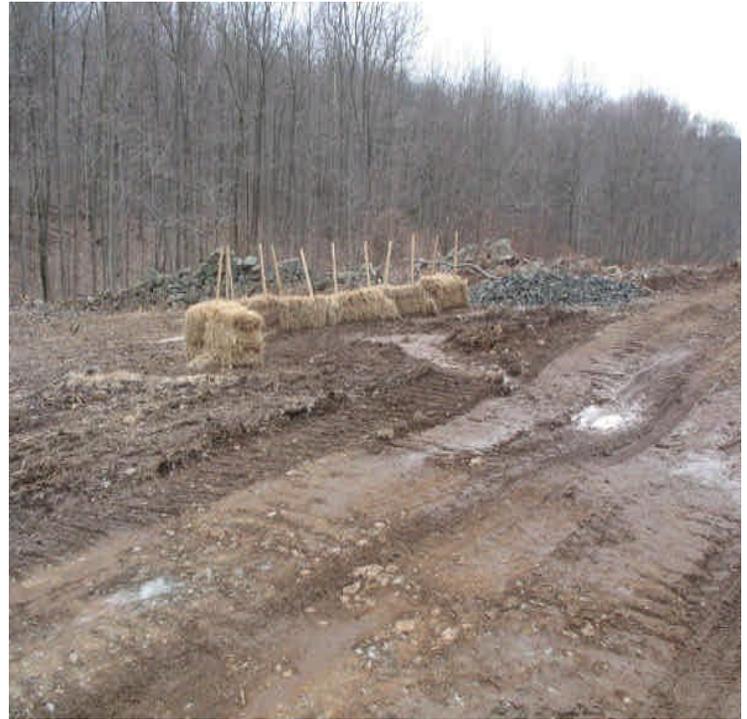
Access road north of Beseck SS has been regraded and stone was added as needed to stabilize the soils and reduce run-off. Haybale barriers are in place to slow and contain run-off.

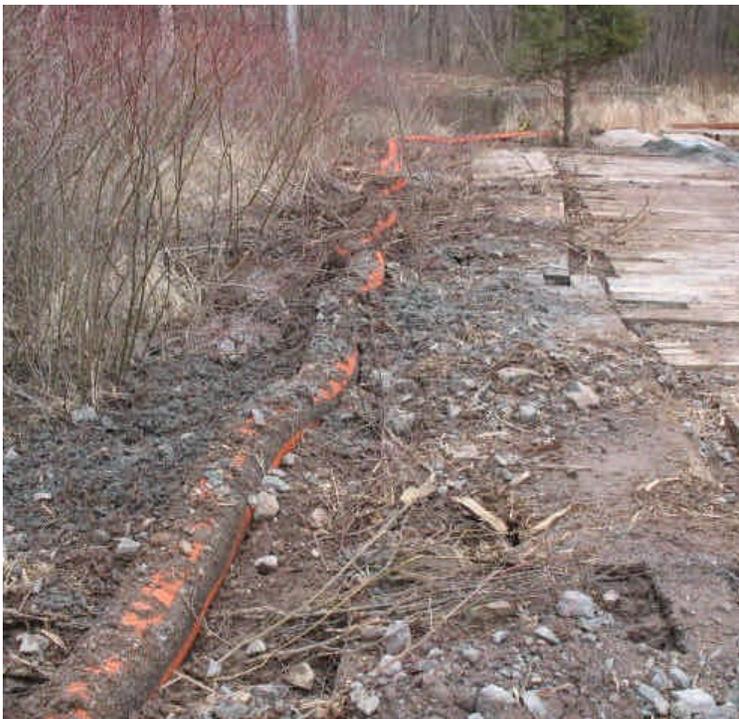
Valley View Drive	<p>Erosion controls remain along the edge of the access road. 4/2/07</p>	<p>Continue to monitor controls and roadway. 4/2/07</p>	<p>NA</p>
East of Beseck SS	<p>At the spot adjacent to the wetlands east of Beseck SS, fiber rolls (filter socks) remain adjacent to the timber</p>	<p>The sediment will have to be carefully removed by hand from the wetland's edge. 4/2/07</p>	<p>Needs attention.</p>

Sediment (likely from snow clearing in past weeks) was noted on and beyond the filter sock at the matted pad near Beseck SS. Sediment in the wetland needs to be carefully removed by hand.

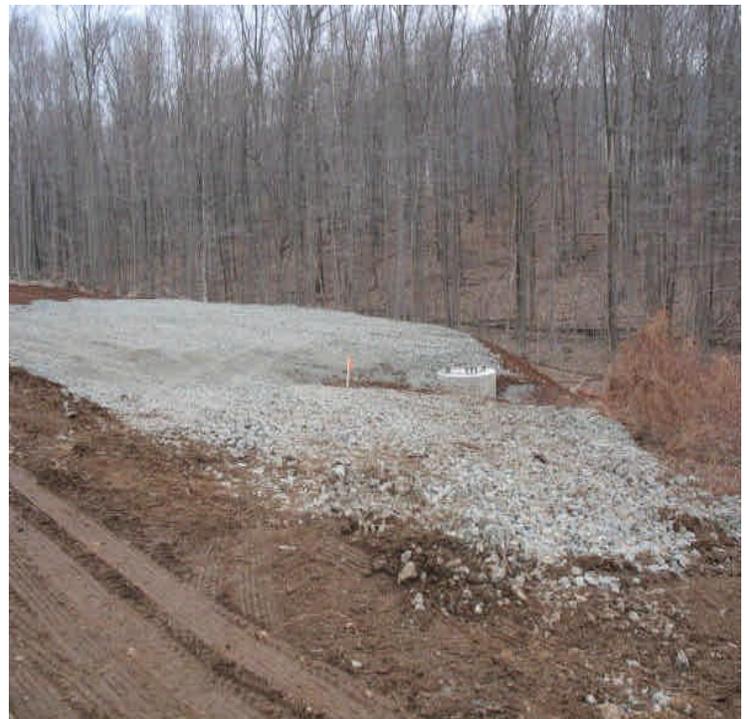
Stone was installed at pad sites for further stability during construction.

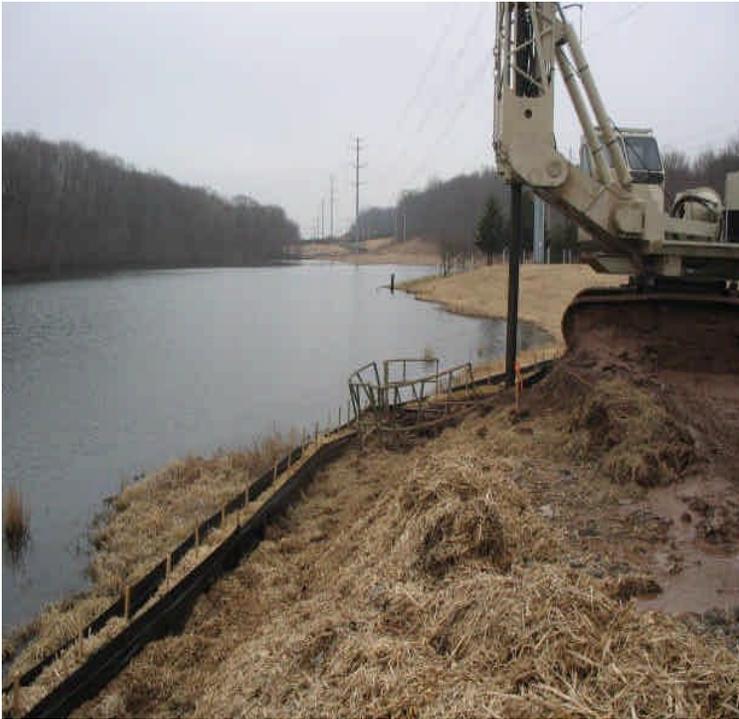
Black Pond Junction to Beseck SS Fleming Rd.	<p>Foundation work is occurring adjacent to the edge of the pond. Good controls are in place. 4/2/07</p>	<p>Continue to monitor the work along wetlands. Be cautious of the adjacent resource area during slurry production. 4/2/07</p>	<p>NA</p>
High Hill Rd. South to East Meriden Substation and north to Black Pond	<p>Pad site/work area is in place within a stream. The flow is being re-routed through a riprap channel and culvert. Erosion control mats are in place at the top of bank. 4/2/07</p> <p>The root system and stumps were retained along the stream and within the wetland even though larger trees were cleared. 4/2/07</p>	<p>Continue to stabilize soils and adjust controls as necessary to protect wetlands and filter turbid run-off. See erosion control section for more details. 4/2/07</p> <p>Continue to monitor and adjust controls as needed. 4/2/07</p>	<p>Clear water was flowing from the site.</p> <p>Low impact/careful clearing was noted in this area.</p>

Controls remain in place along the pond north of Beseck SS to E. Meriden SS off Fleming Rd. Foundation drilling underway. Slopes were mulched for temporary stabilization.

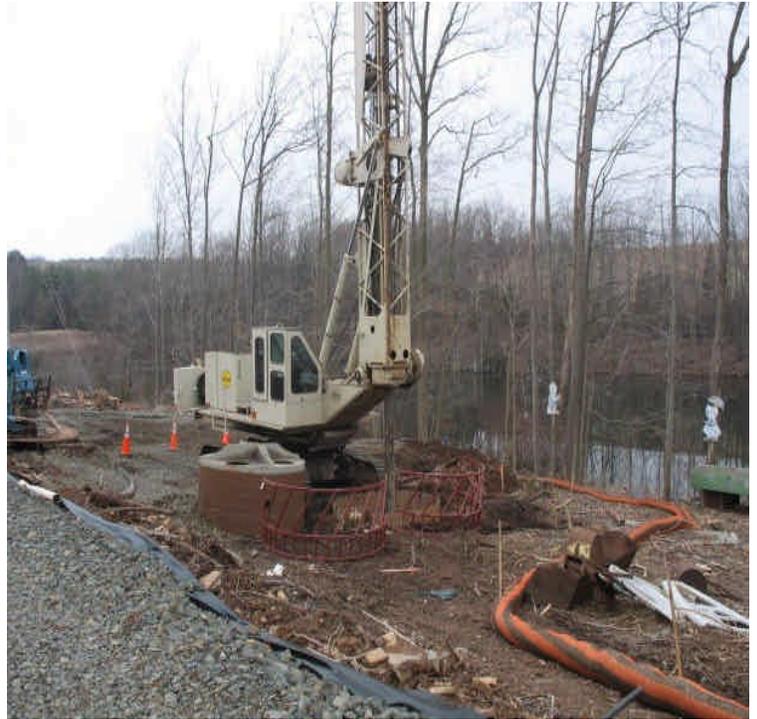
Foundation drilling just west of E. Meriden SS. A slurry pit has been established and will be used as needed. Filter socks are in place around the work. Continue to monitor controls carefully.

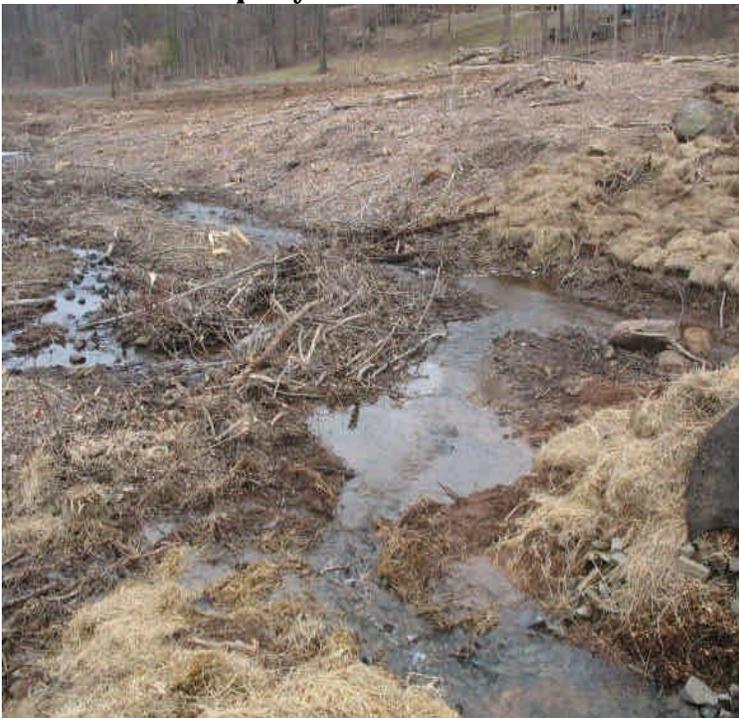
View of the stream flow through the culvert/riprap channel and stream under the timber mats in the ROW between E. Meriden SS to Black Pond. Controls were removed from the stream and flow is clear.

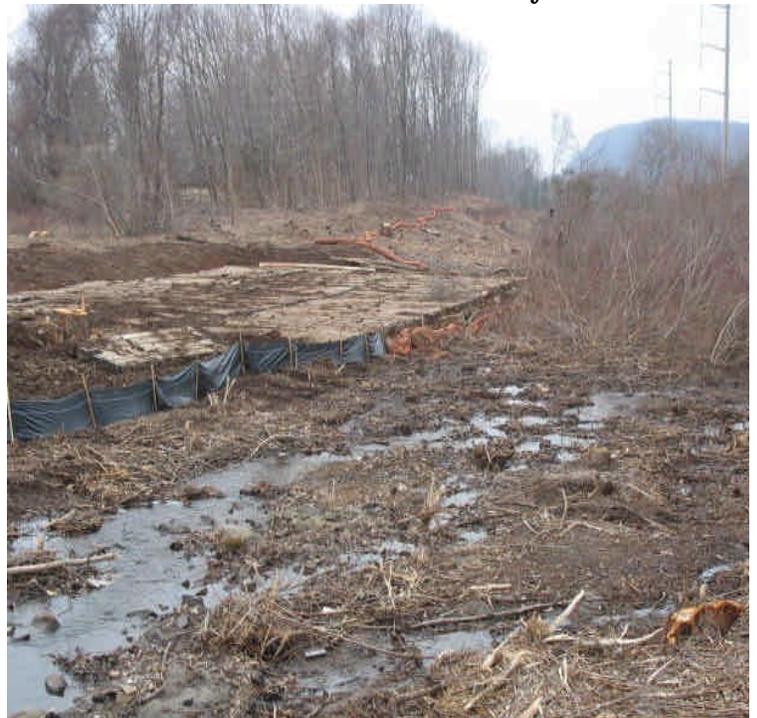
New pad area and controls installed above the stream south of High Hill Road. No run-off noted. Reduce tracking to the timber mat pad to the extent feasible.
