Docket No. 272 – Development and Management Plan Inspection

Segment 1a Inspection

Date: April 16, 2007

Location: Segment 1a – Scovill Rock Switching Station to Chestnut Junction, Oxbow Junction to Beseck Switching Station (excluding Royal Oak Bypass), and Black Pond Junction to Beseck Switching Station

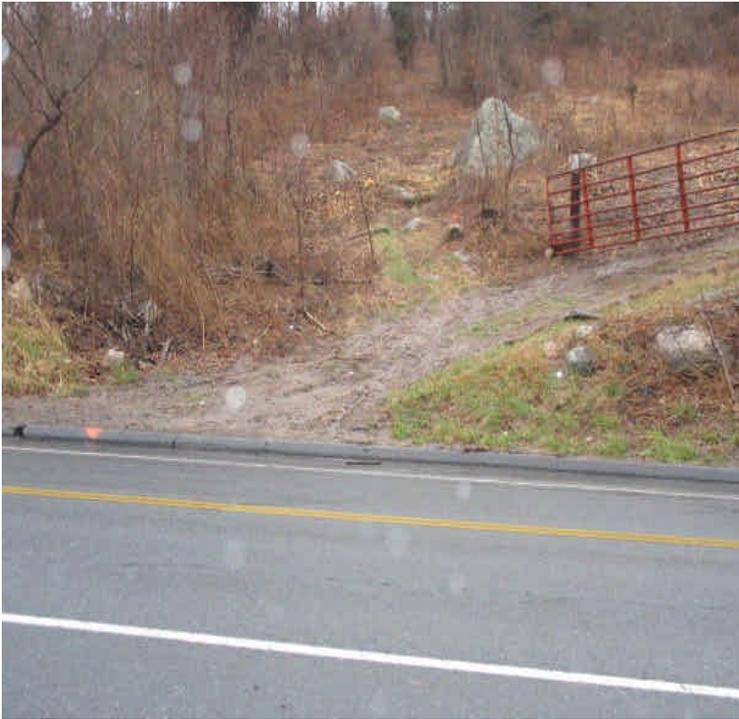
ROW access off Rte 9. No sediment tracking noted or turbid run-off noted.

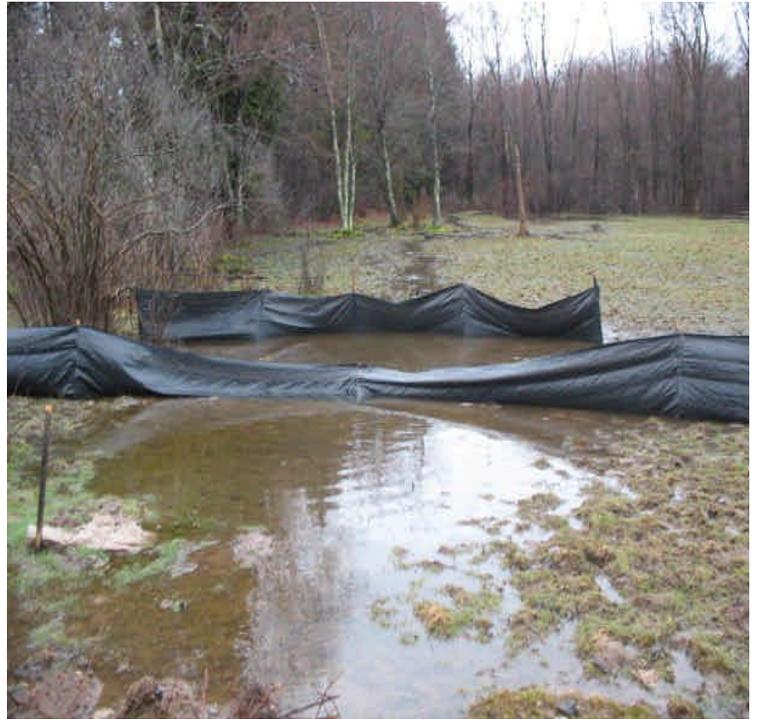
Wetland crossing off Little Ln. A large volume of water was leaving the site through the controls but the run-off was clear.

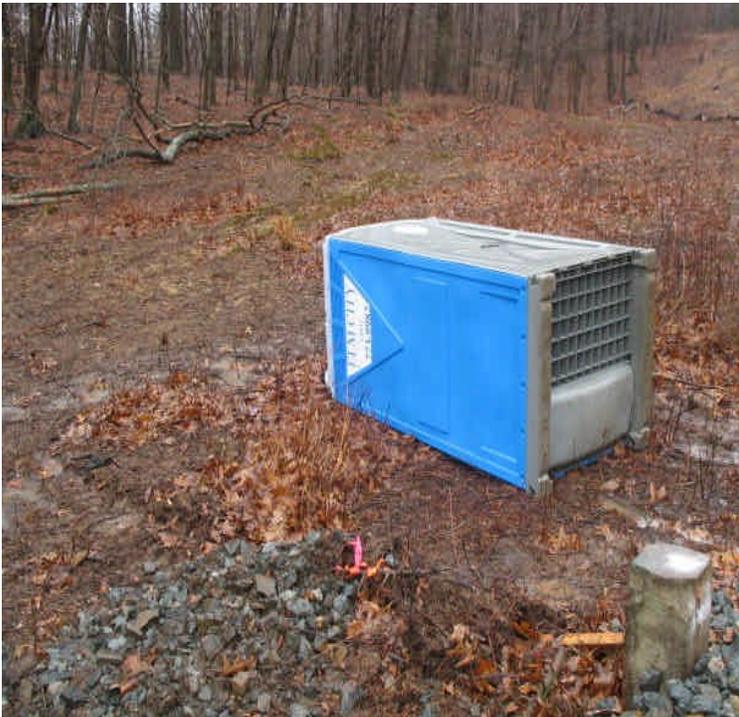
Portable sanitary facility has tipped in the ROW off Black Walnut Dr. Wetlands are not in the vicinity but the area needs to be cleaned up.

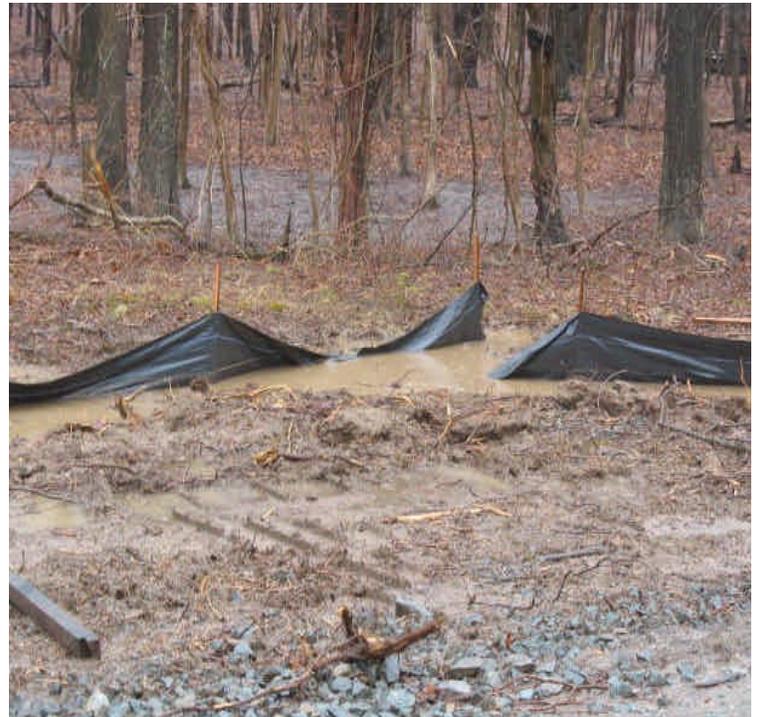
Section of silt fence in disrepair off Black Walnut Dr. Turbid water was flowing off site but wetlands are not in the vicinity.

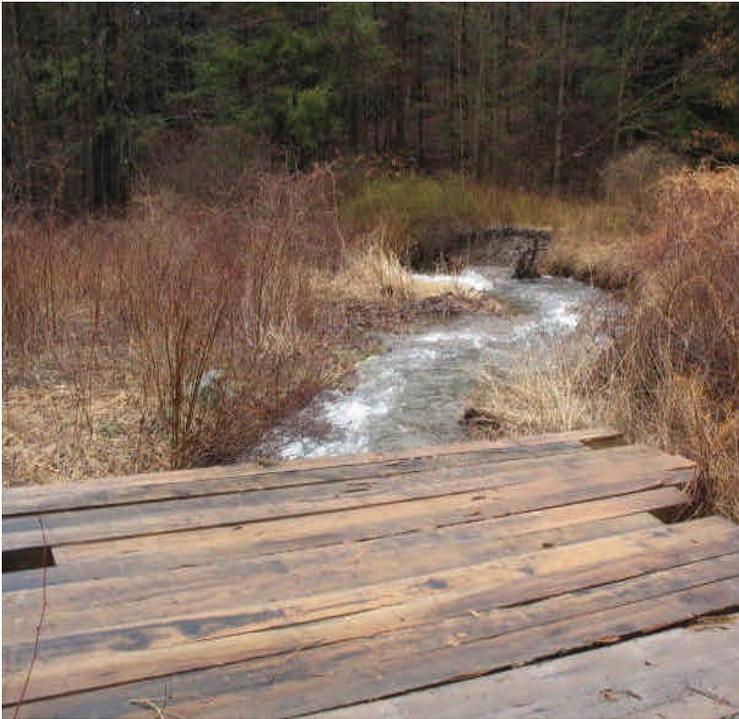
Wetland and stream crossing off Foot Hills Rd. Mats were installed and turbid run-off was not noted.

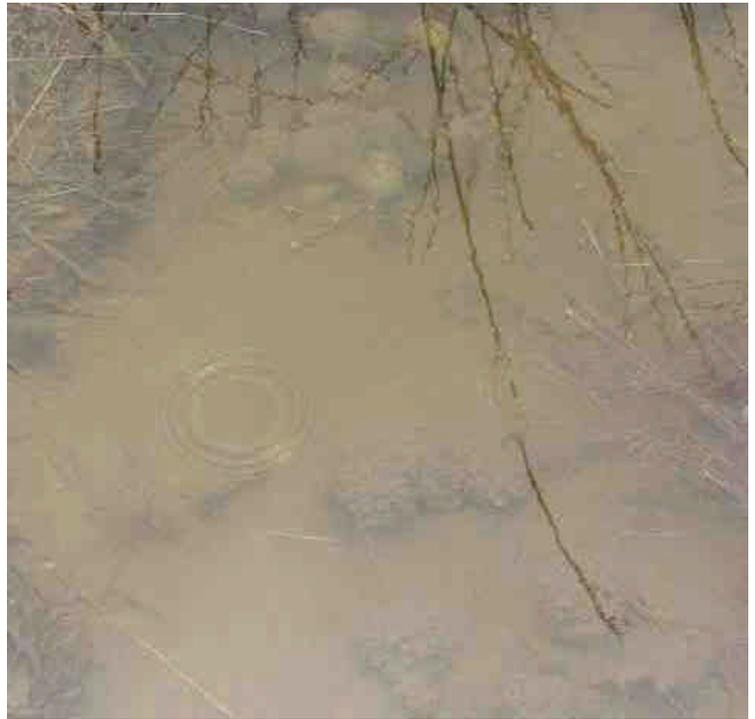
***Ambystoma* and wood frog egg masses were noted in the ponded water adjacent to a timber mat crossing off Johnson Ln. Slight turbidity was present with the heavy rain. Continue to prevent turbidity and sedimentation here to the extent possible.**

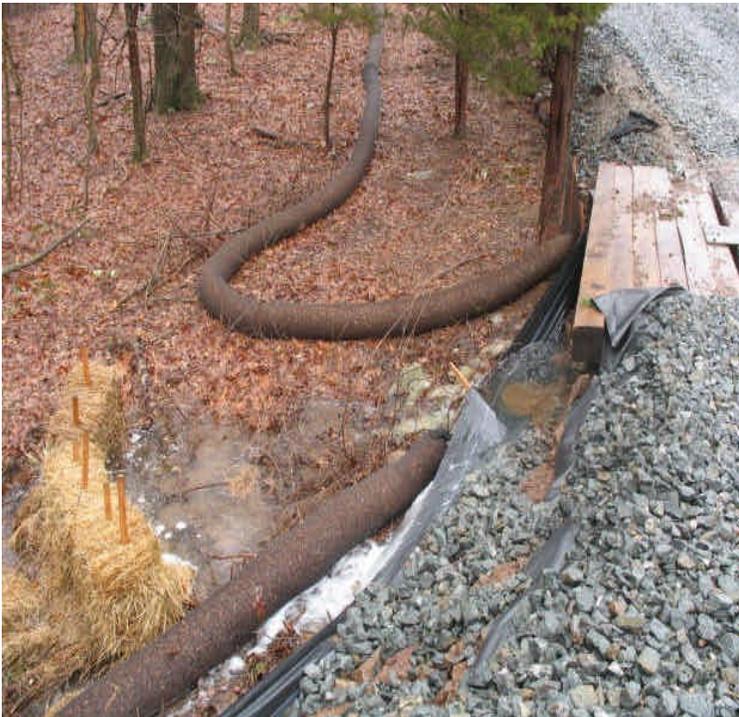
Timber mat wetland crossings have controls, including haybale check dams and filter socks installed downgradient off Johnson Lane

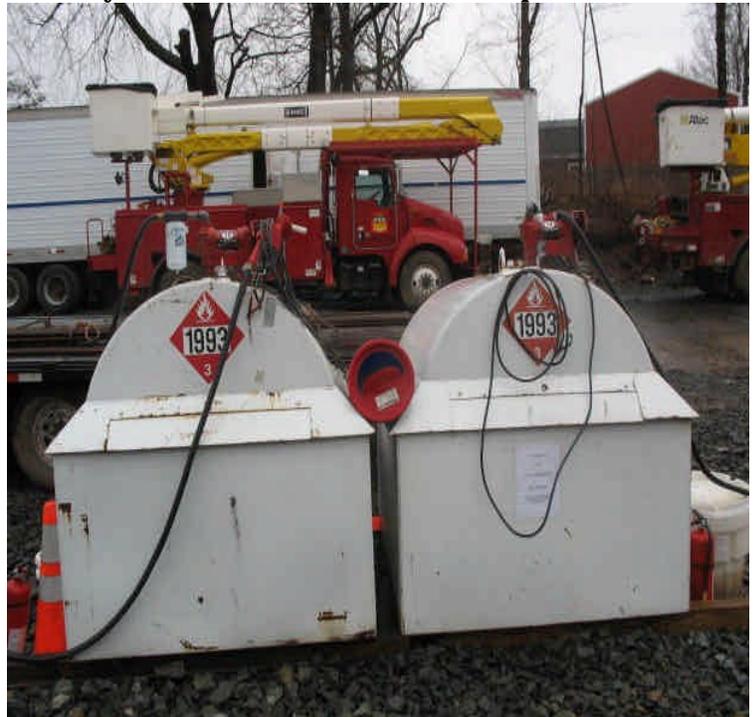
Both nozzles were hung on top of the fuel tanks within the contractor receiving yard. One minor spill/drip was noted during this inspection.

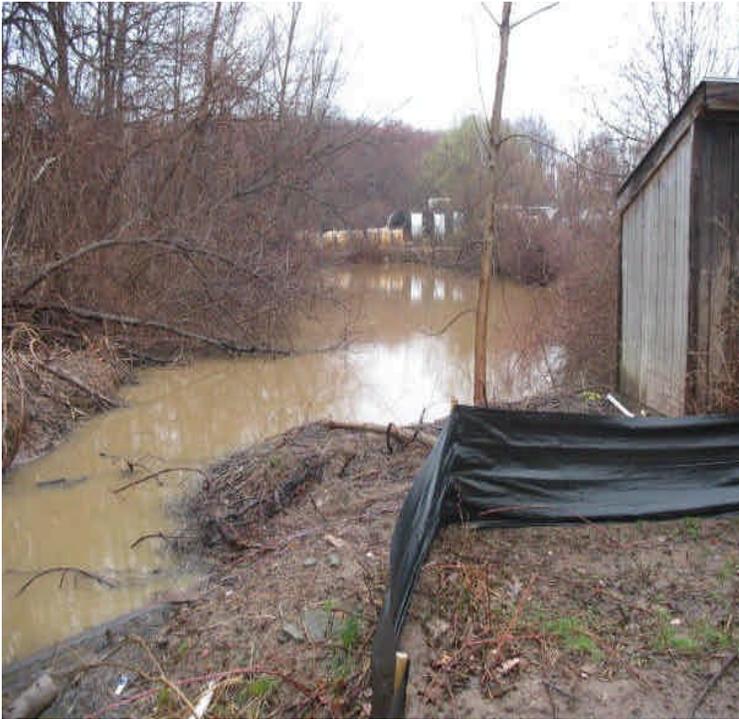
Pond at the contractor receiving yard is increasingly turbid in the heavy rain. A direct source from the contractor yard has not been identified as controls remain in place. This is likely a result of non-project related adjacent land use.

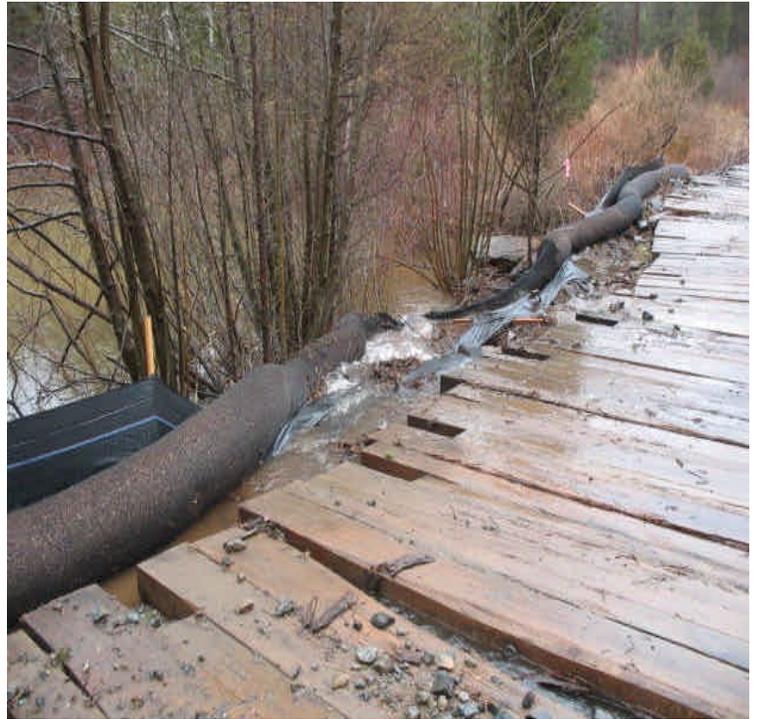
Wetland crossing off Powder Hill Road. Turbidity was observed within the wetlands at this inspection. Several controls were damaged from this week's significant storm.

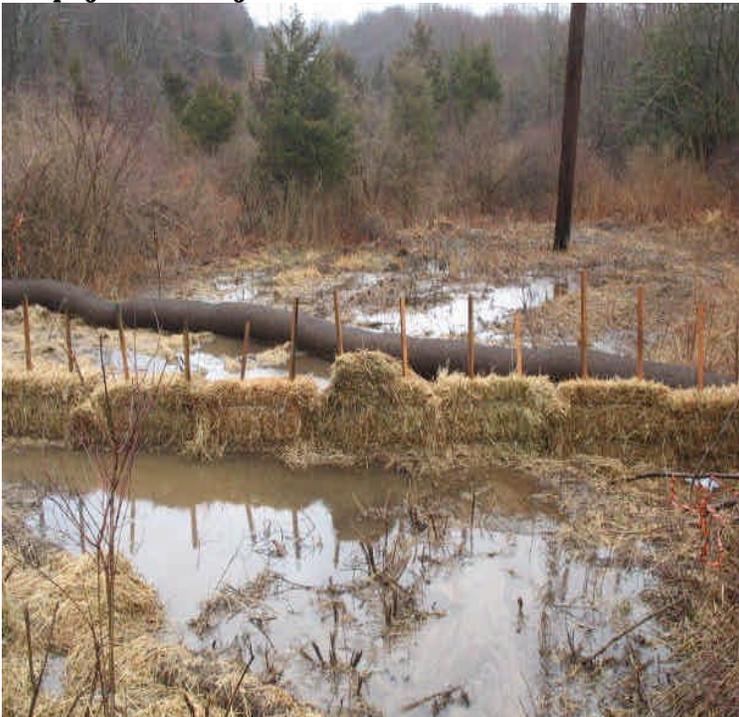
View of newly installed haybales and fiber rolls at the base of the slope off Powder Hill Rd. Sediment is filtered from the run-off before it flows off-site in this area.

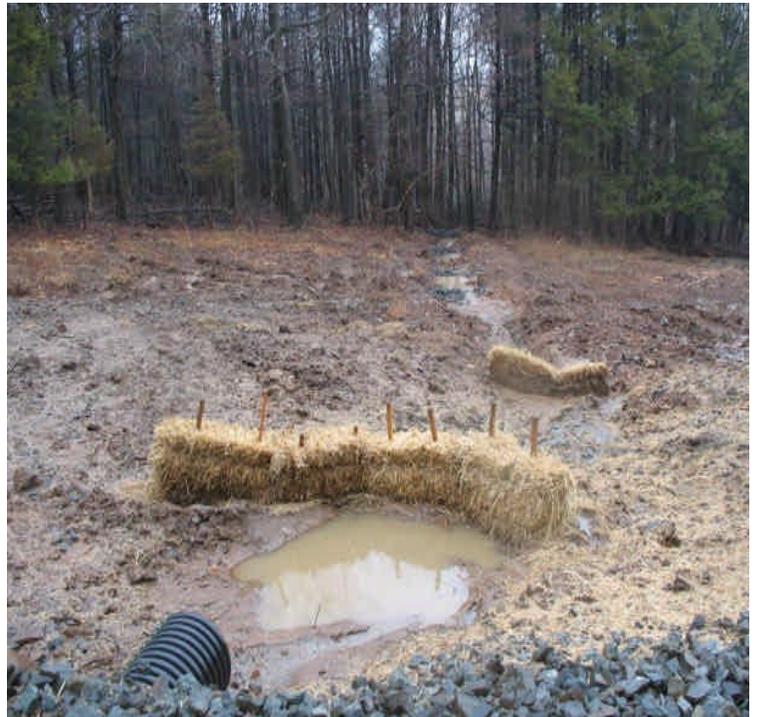
View of a drainage swale with haybale/stone check dams installed along the access road off Powder Hill Rd. Run-off is diverted and attempts are made to filter prior to it leaving the site.

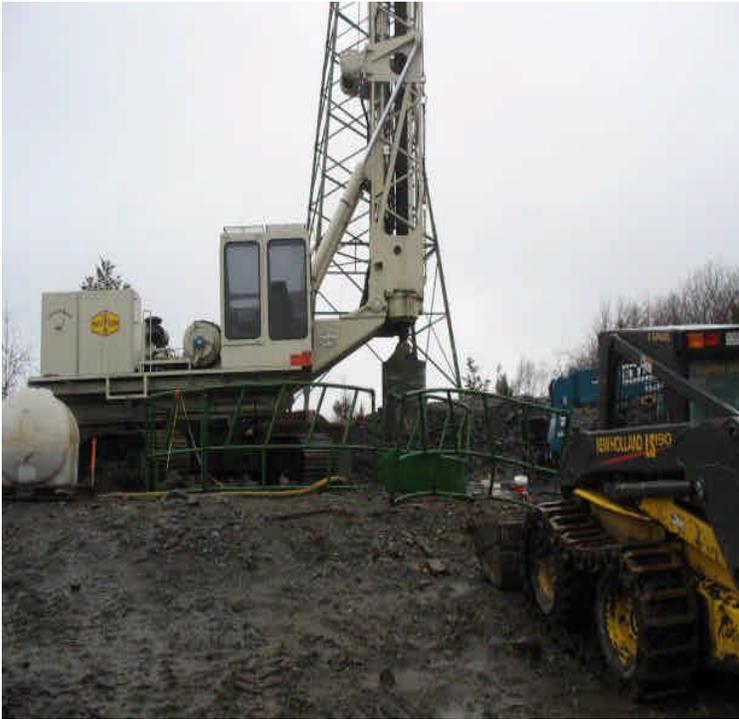
Foundations were being drilled off Powder Hill Rd.

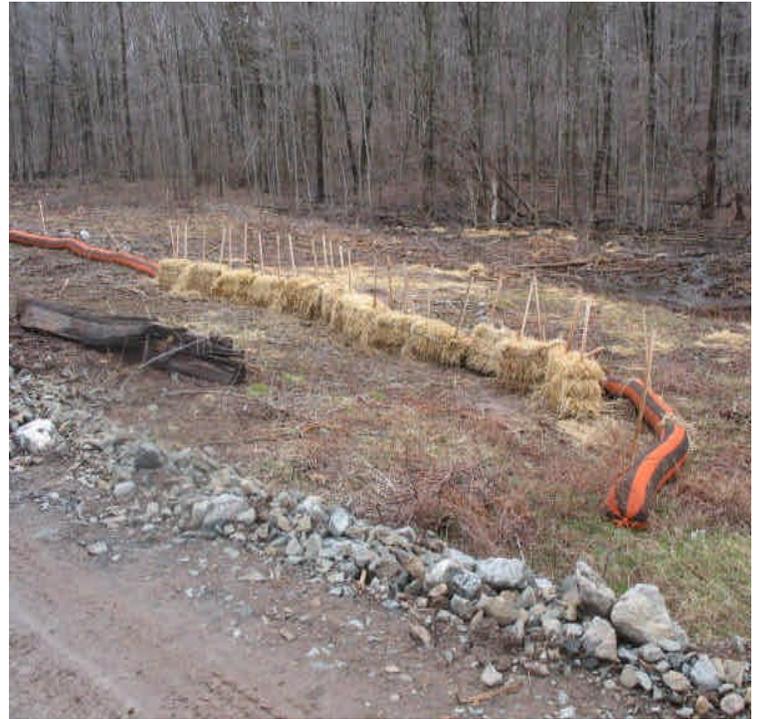
Access road north of Beseck SS is well controlled with stone in place to stabilize the soils and reduce run-off. Haybale and filter sock barriers are in place for additional control.

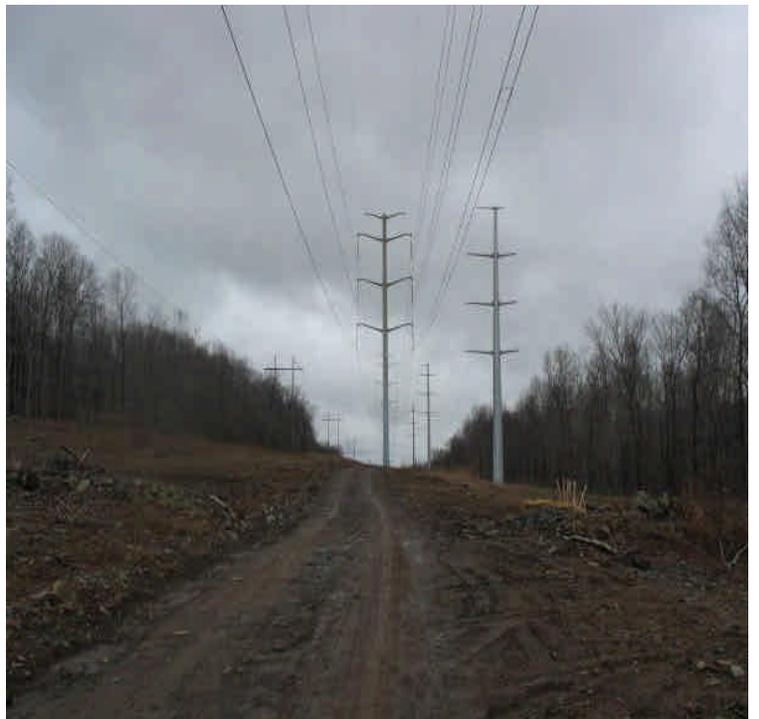
New poles were constructed moving north of the Beseck SS.

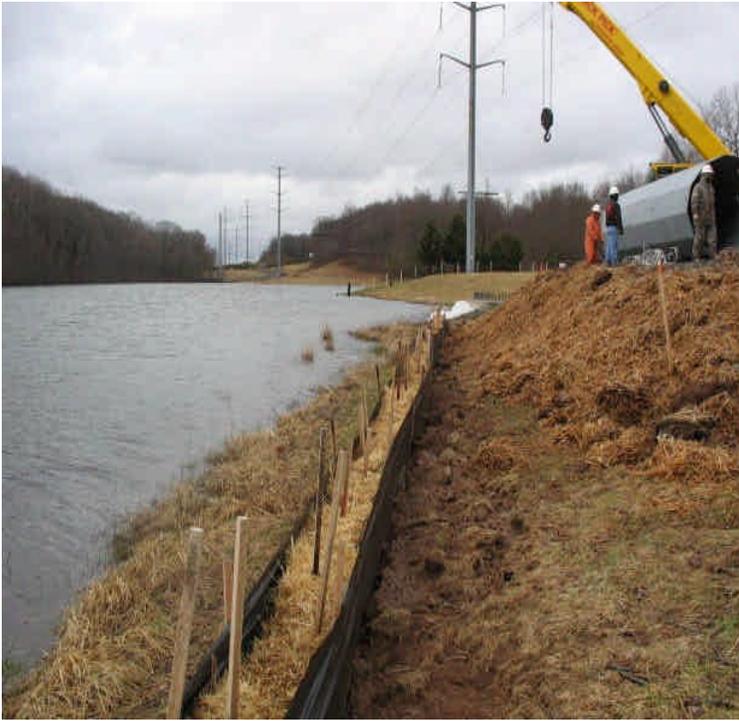
Controls remain in place along the pond north of Beseck SS to E. Meriden SS off Fleming Rd. Controls appear to have contained all soils at this time. Slopes were mulched for temporary stabilization.

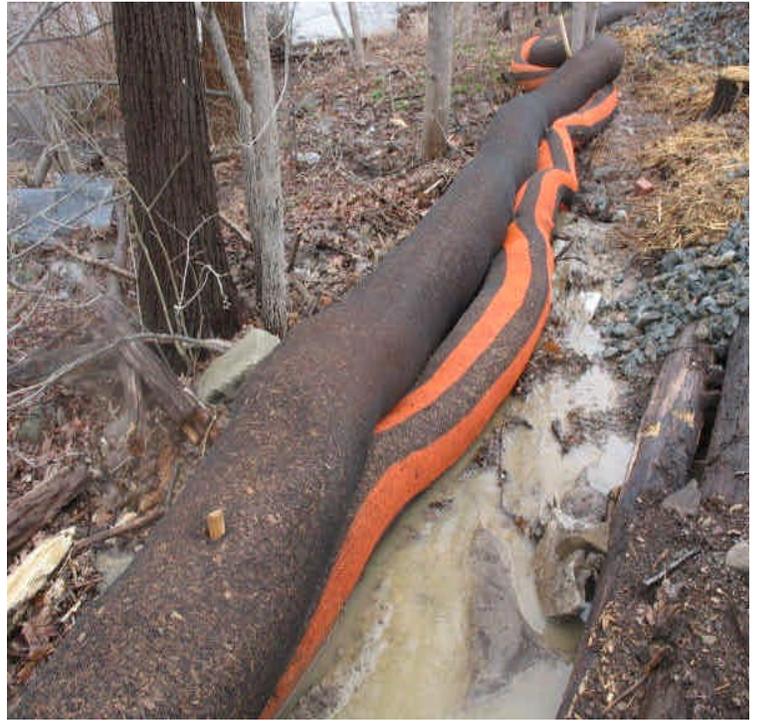
Controls just north of E. Meriden SS are being undermined by turbid run-off which is reaching the pond. These controls need to be re-established and toed into the soil, or replaced with more effective controls.

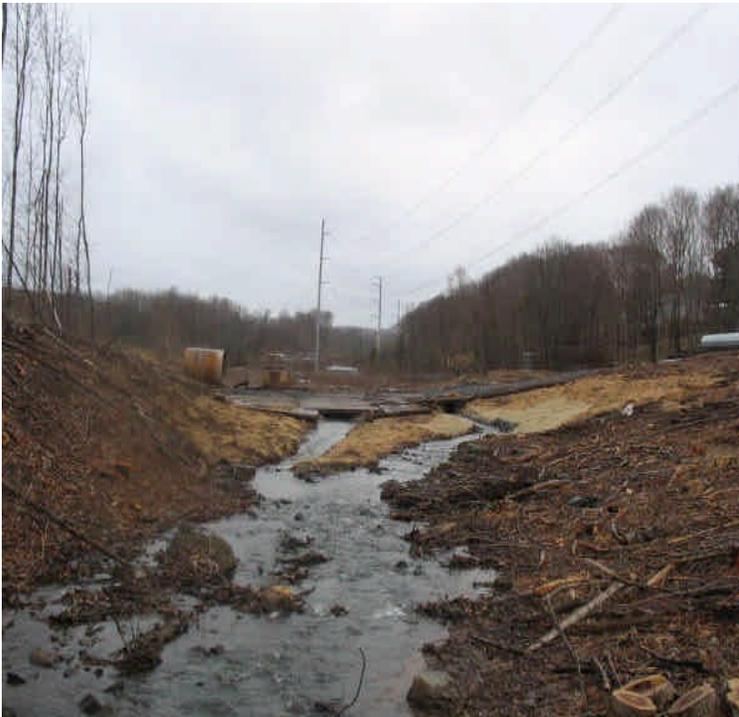
View of the channel banks and adjacent soil temporarily stabilized. in the ROW between E. Meriden SS to Black Pond. Timber mats are in place for workspace and access.

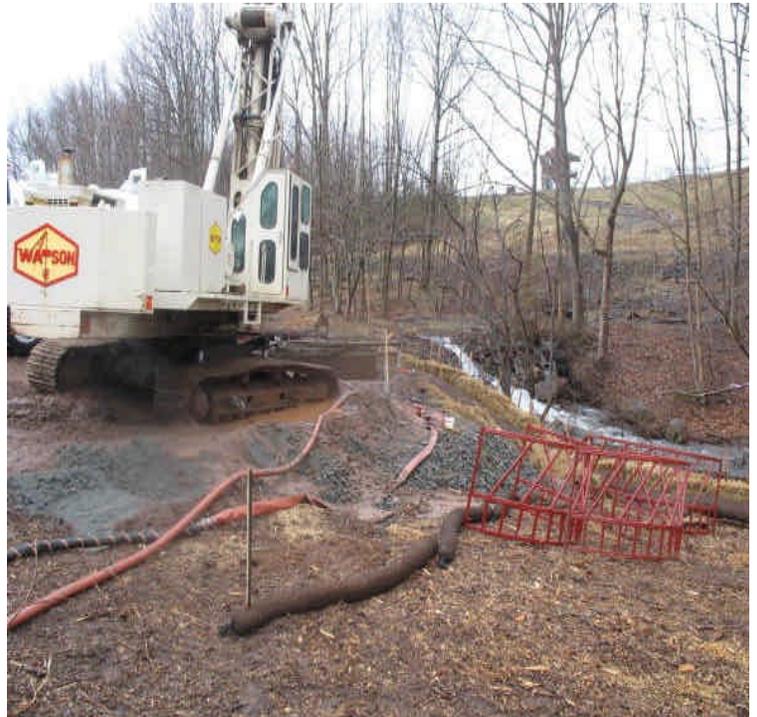
Foundation being installed south of High Hill Rd adjacent to a stream. No sediment was noted entering the stream from the pad. A pump truck and settling tank were being used for slurry control.
