Docket No. 272 – Development and Management Plan Inspection

Segment 1a Inspection

Date: April 23, 2007

Location: Segment 1a – Scovill Rock Switching Station to Chestnut Junction, Oxbow Junction to Beseck Switching Station (excluding Royal Oak Bypass), and Black Pond Junction to Beseck Switching Station

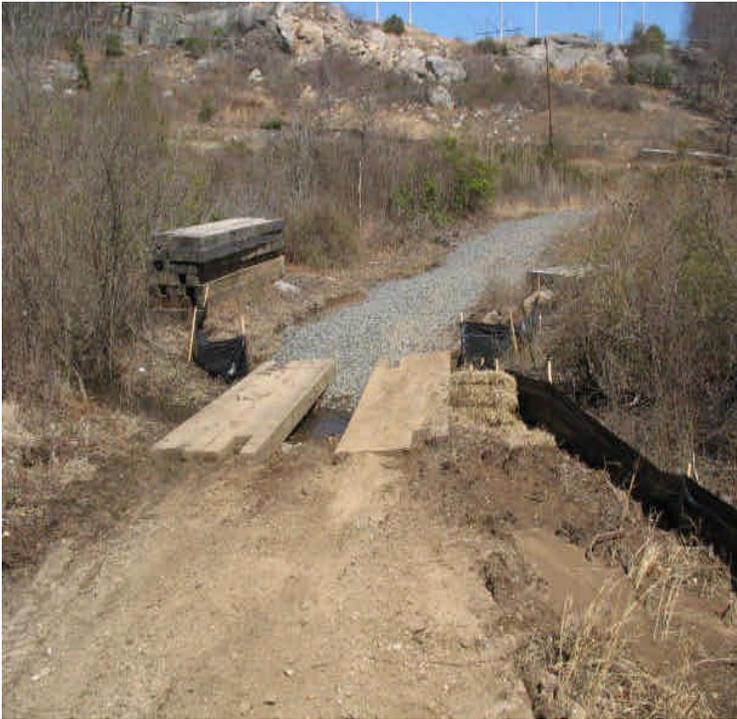
View of the access road and a timber mat stream crossing off Freeman Road. Controls are in place, however, avoid filling stone directly to the bank of the stream.

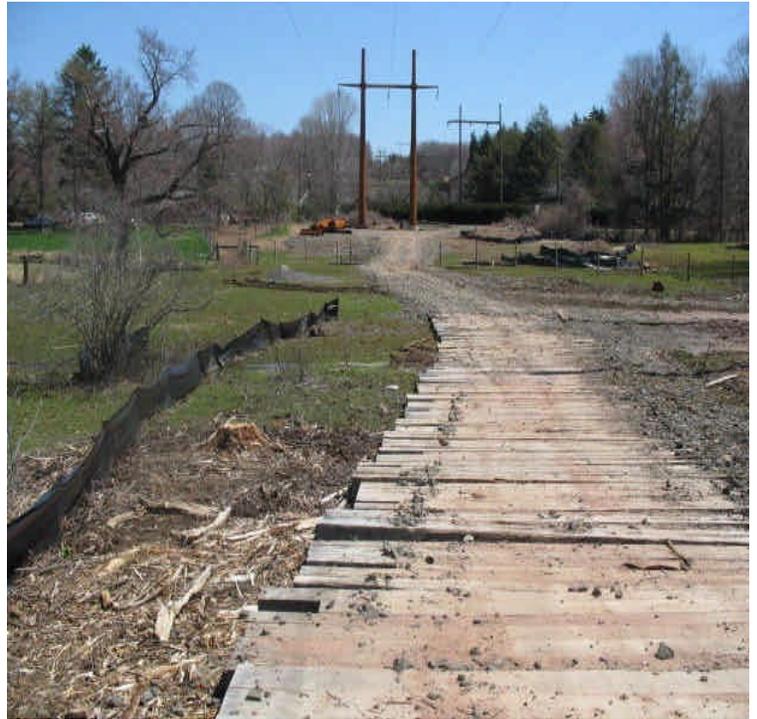
Wetland crossing with timber mats off Little Ln. Clear run-off was observed leaving the site.

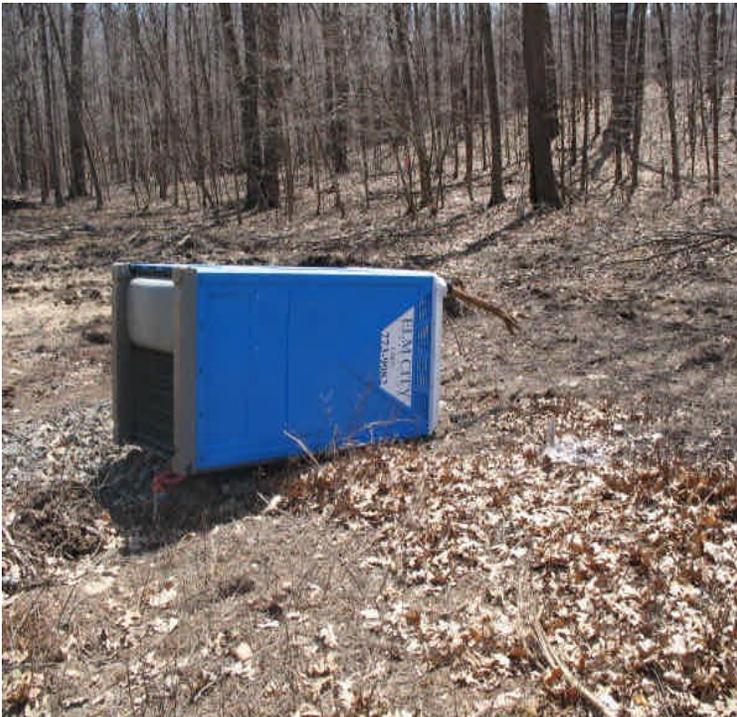
Portable sanitary facility remains on its side in the ROW off Black Walnut Dr. Wetlands are not in the vicinity but the area needs to be cleaned up.

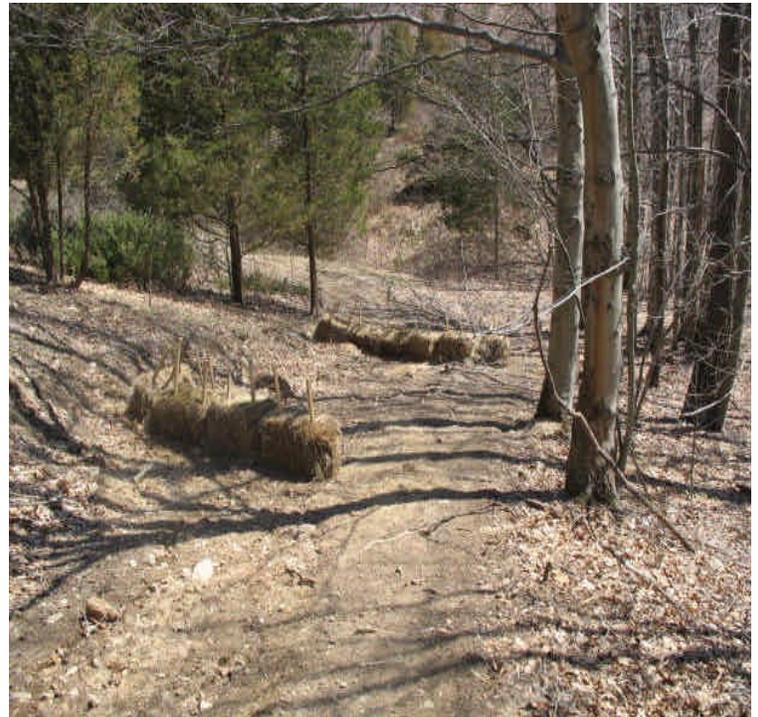
Haybales check dams in the access road off Black Walnut Dr. upgradient from Ball Brook.

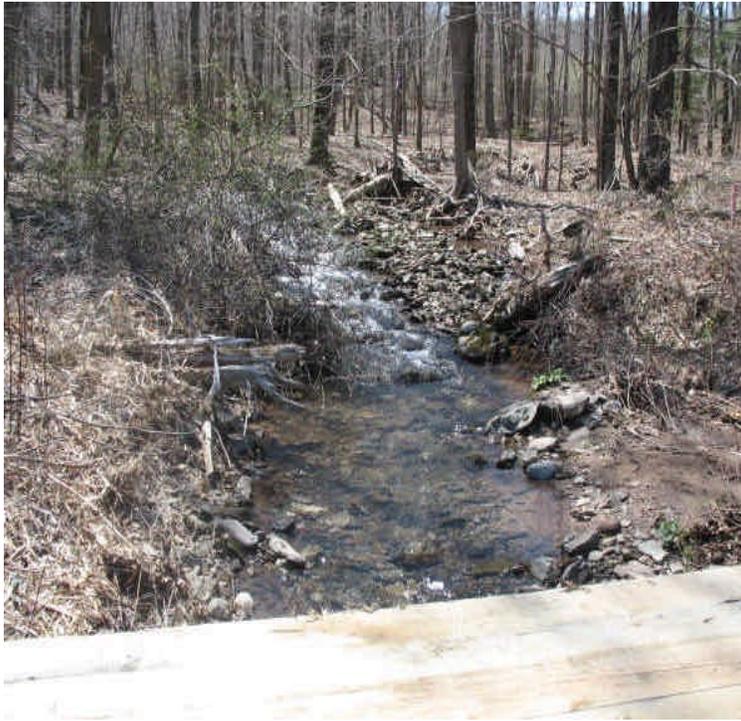
Wetland and stream crossing off Foot Hills Rd. Mats were in place and turbid run-off was not noted.

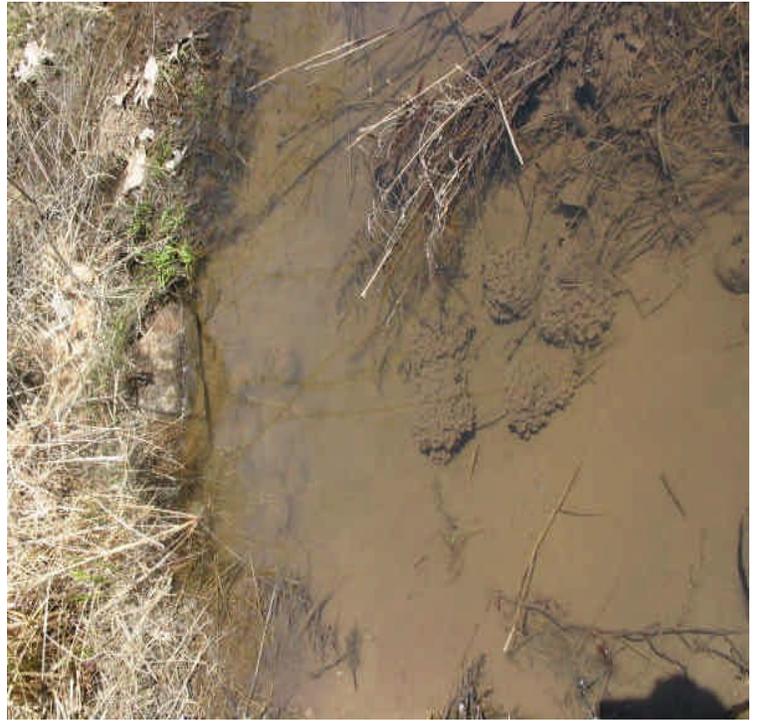
Ambystoma and wood frog egg masses were noted in the ponded water adjacent to a timber mat crossing off Johnson Ln. Slight sedimentation resulted from recent heavy rain. Continue to prevent turbidity and sedimentation here to the extent possible.

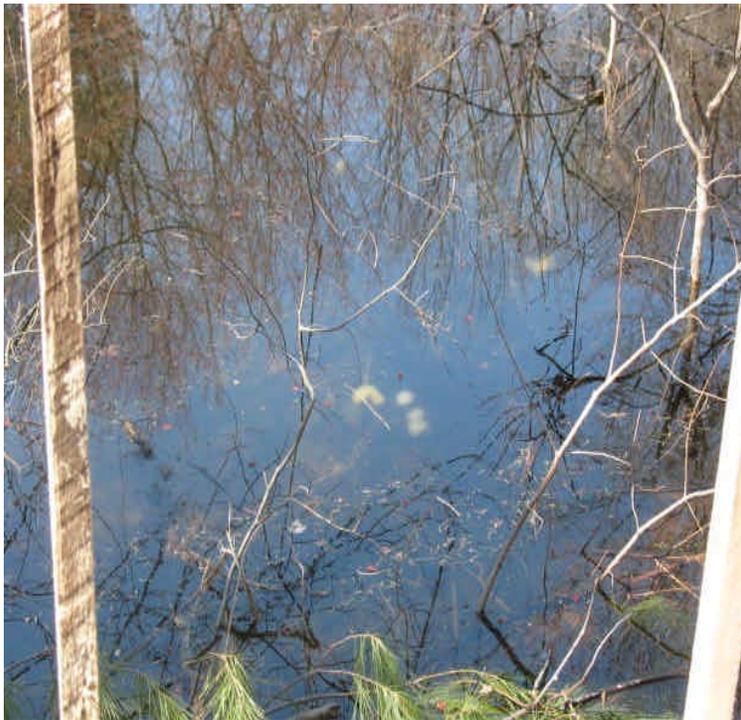
Ambystoma egg masses noted within the pond off Haddam Quarter Rd. Continue to prevent turbidity and sedimentation here to the extent possible.

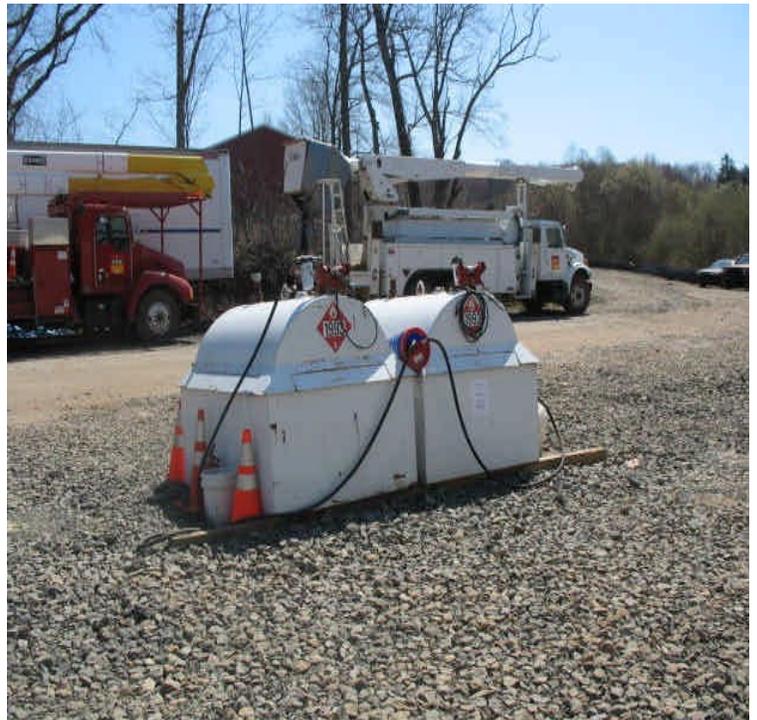
Both nozzles were contained in a 5-gallon bucket within the contractor receiving yard.

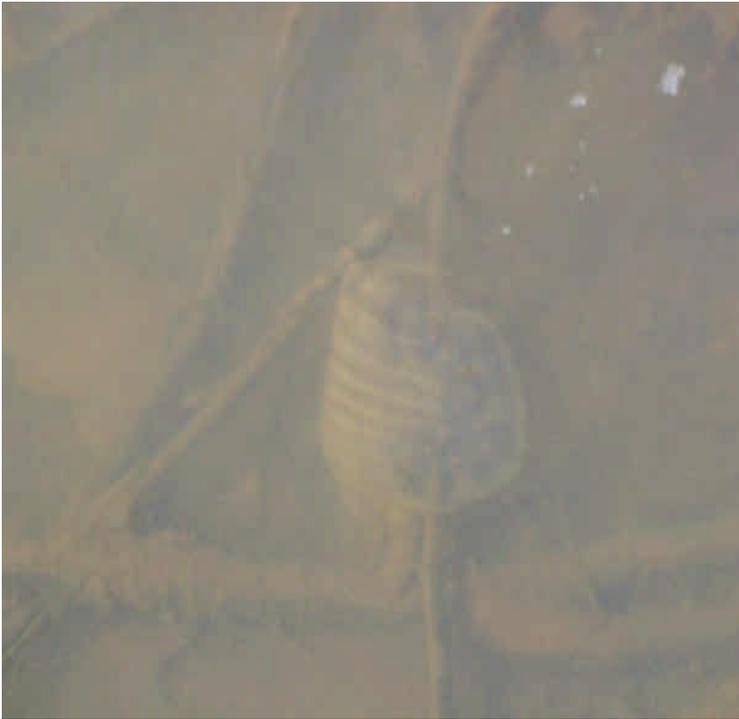
Pond adjacent to the contractor receiving yard also provides good amphibian breeding habitat based on the presence of egg masses, tadpoles and frogs.

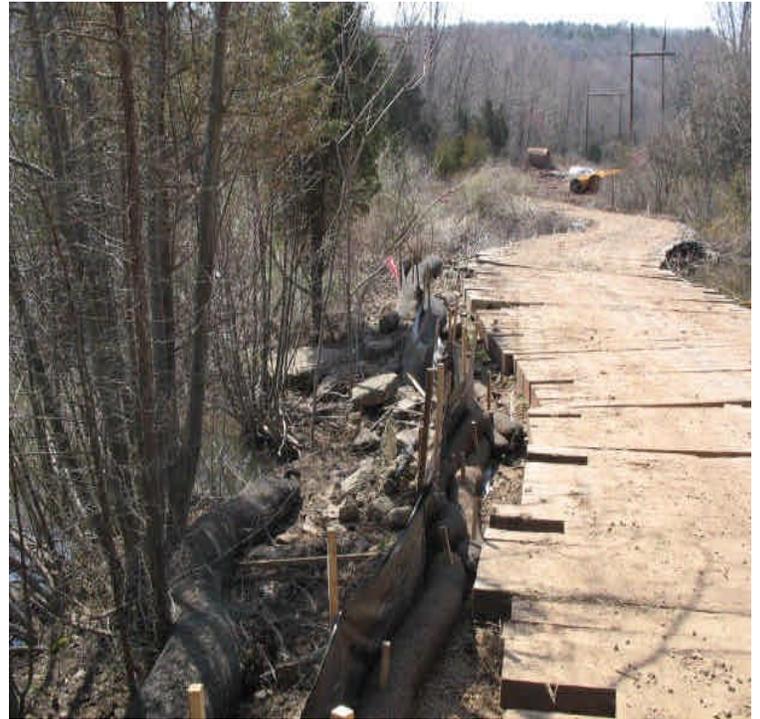
Wetland crossing off Powder Hill Road. Damaged controls have been repaired after the heavy rains last week.

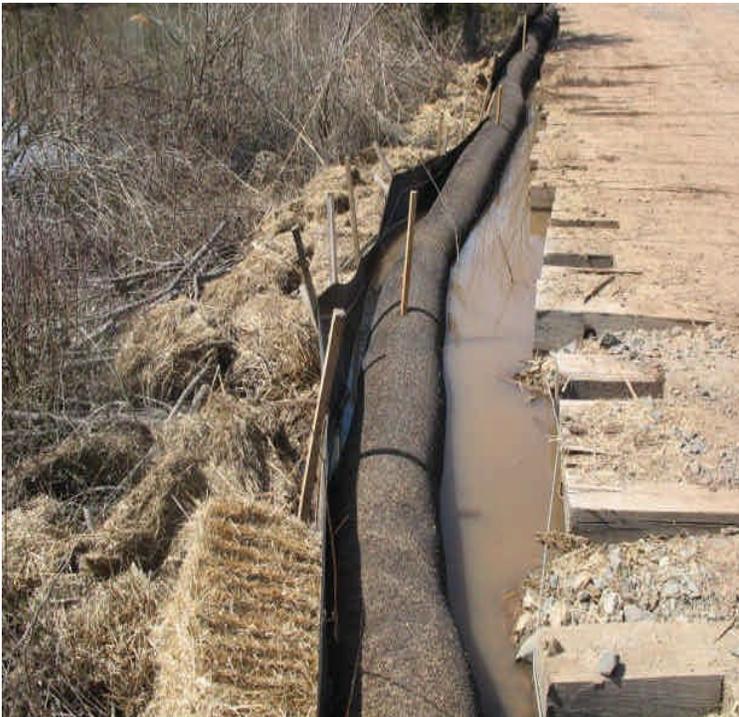
View of newly installed haybales and fiber rolls at the edge of the timber mat crossing off Powder Hill Rd. Sediment is filtered from the contained run-off before it flows off-site.

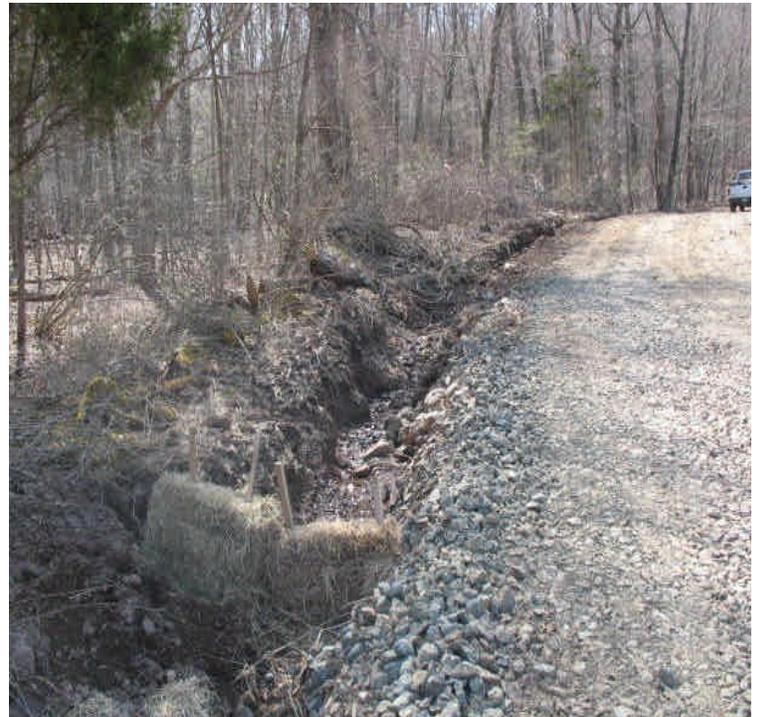
View of a drainage swale with haybale/stone check dams in place along the access road here. Run-off is diverted and attempts are made to filter it prior to leaving the site.

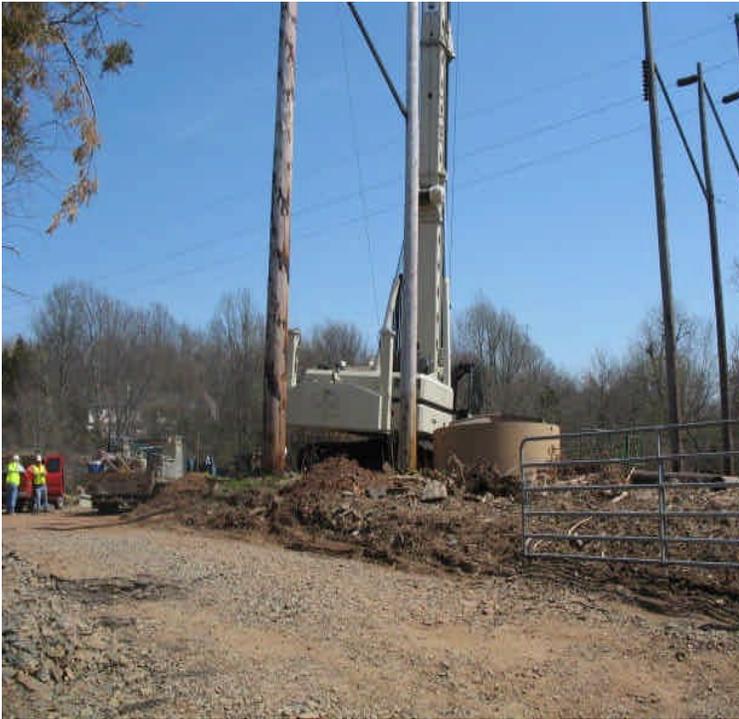
Foundations were being drilled east of Powder Hill Rd.

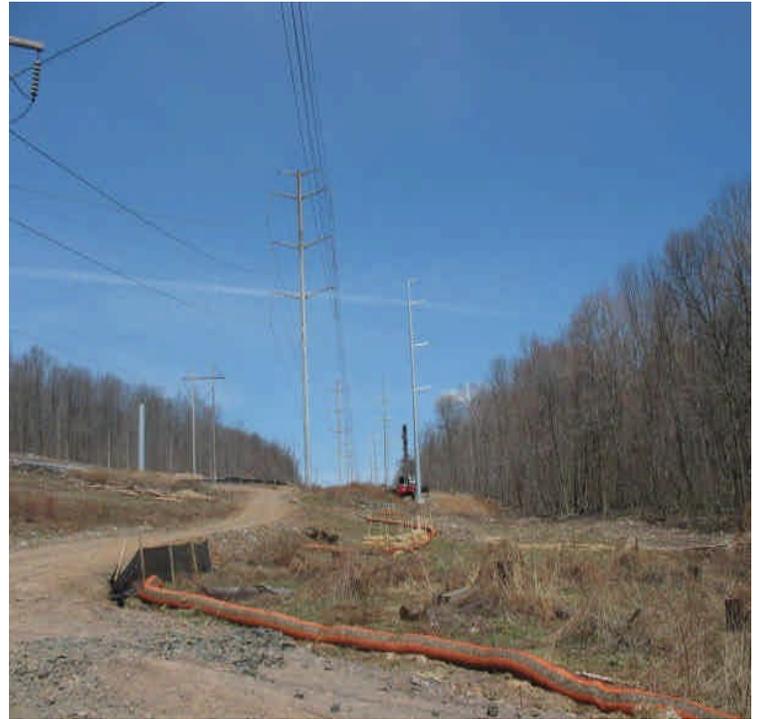
Access road north of Beseck SS is well controlled with stone in place to stabilize the soils and reduce run-off. Haybale and filter sock barriers are in place for additional control.

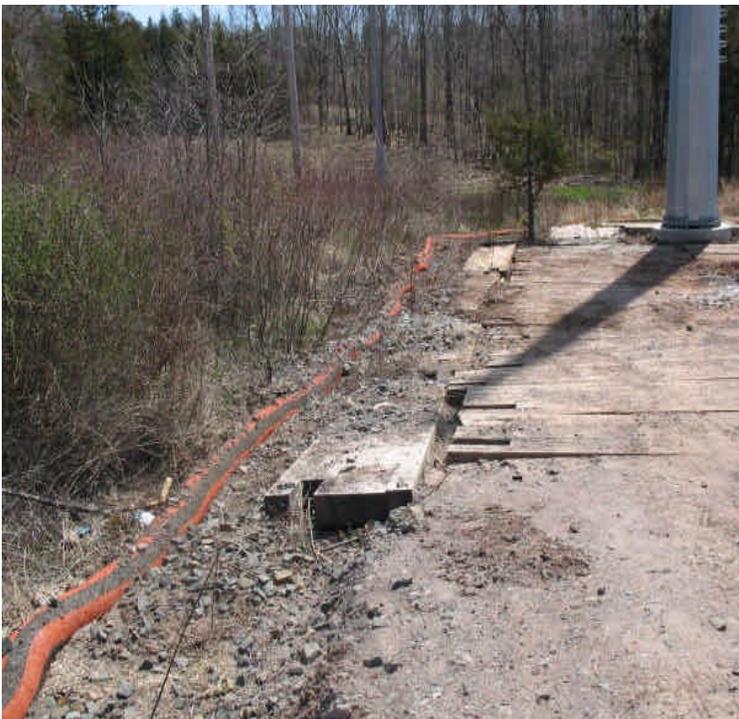
Sediment (likely from snow clearing) was noted on and beyond the filter sock at the matted pad near Beseck SS. Sediment in the wetland needs to be carefully removed by hand.

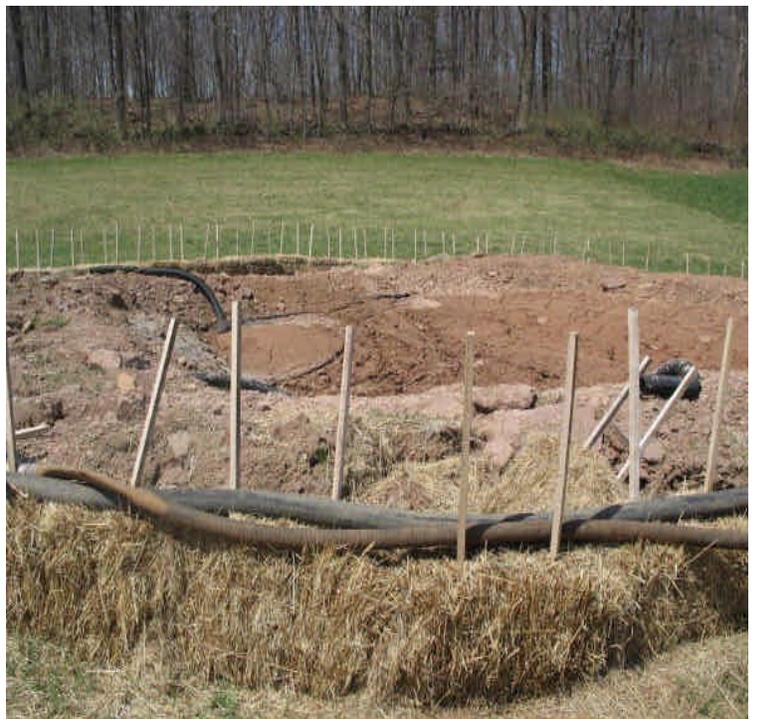
View of a slurry/dewatering containment area just north of Beseck SS.

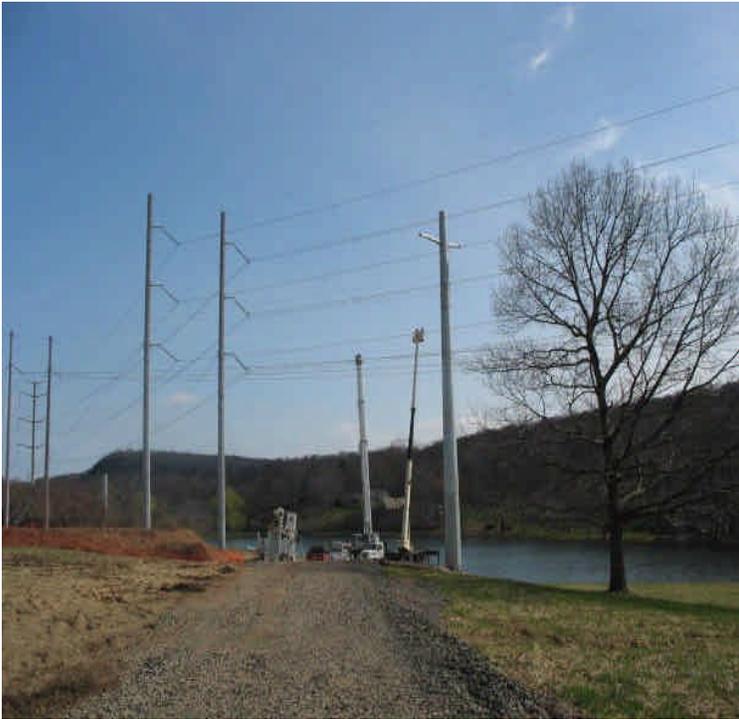
Controls remain in place along the pond north of Beseck SS to E. Meriden SS off Fleming Rd. Pole installation underway adjacent to the pond. Slopes were mulched for temporary stabilization.

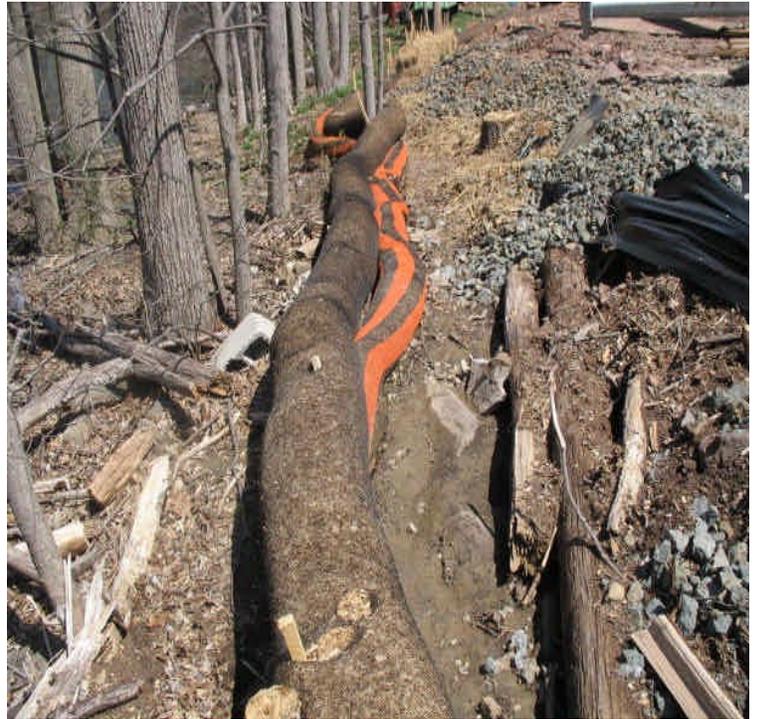
Controls just north of E. Meriden SS had been undermined by turbid run-off during the heavy rains last week. Haybales were installed at some areas for additional control. Filter socks should be toed-in.

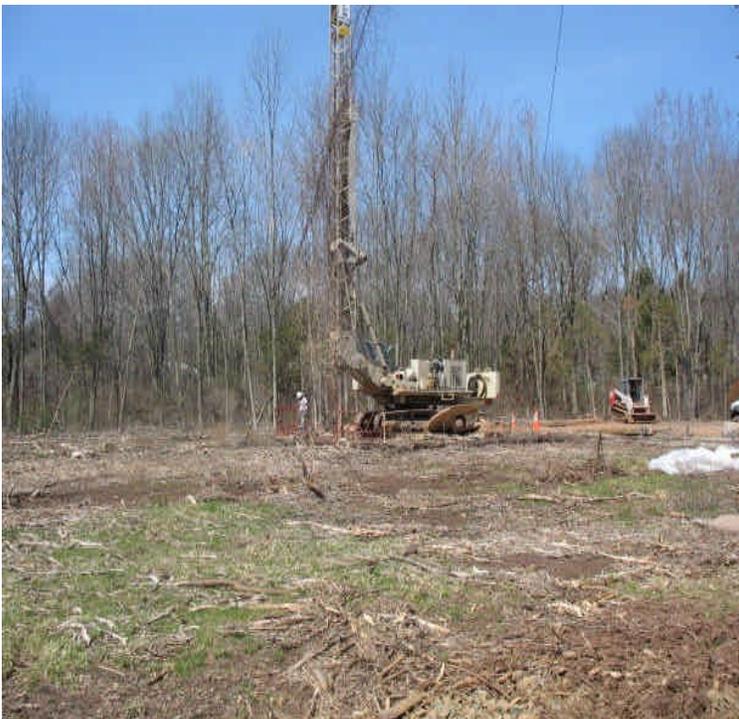
Permitted foundation drilling was occurring within the wetlands just south of High Hill Rd. No sediment issues were noted.

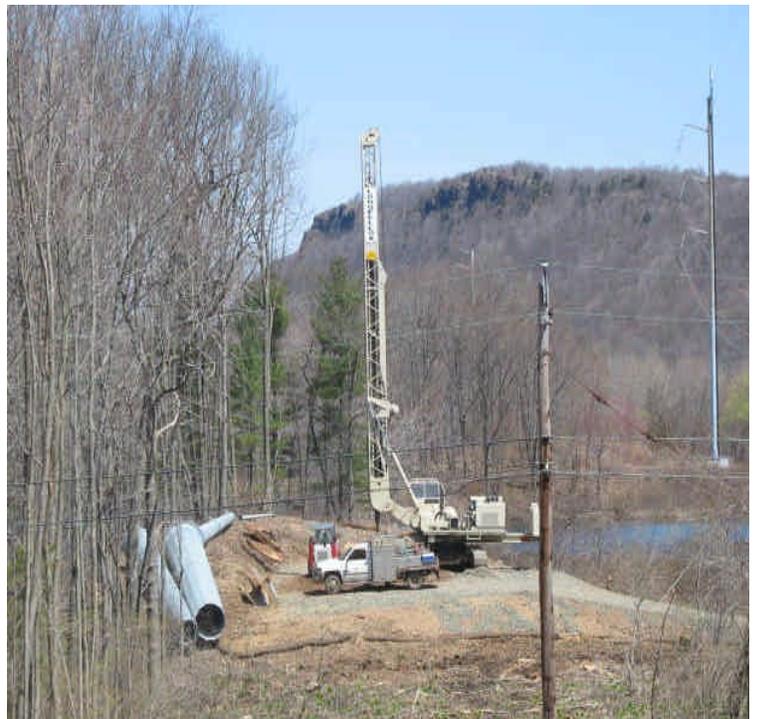
Foundation drilling north of High Hill Rd. adjacent to Black Pond. No sediment issues were noted at the pond.
