Docket No. 272 – Development and Management Plan Inspection

Segment 1b (Royal Oaks Bypass) Inspection

Date: April 9, 2007

Location: Segment 1b (Royal Oaks Bypass)

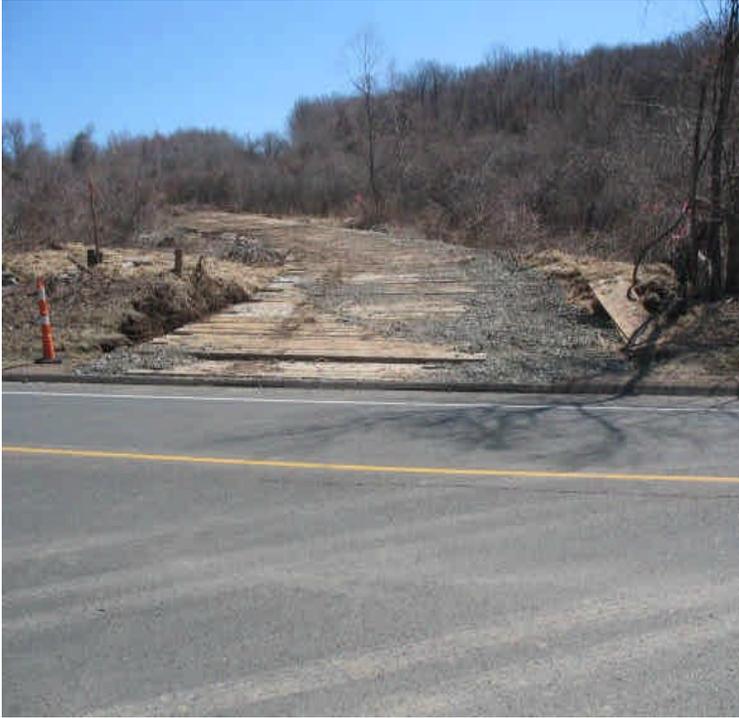
View from the contractor yard, looking across Rte. 17 at the access to the 1b ROW. The access is matted and sediment tracking was not an issue on the roadway.

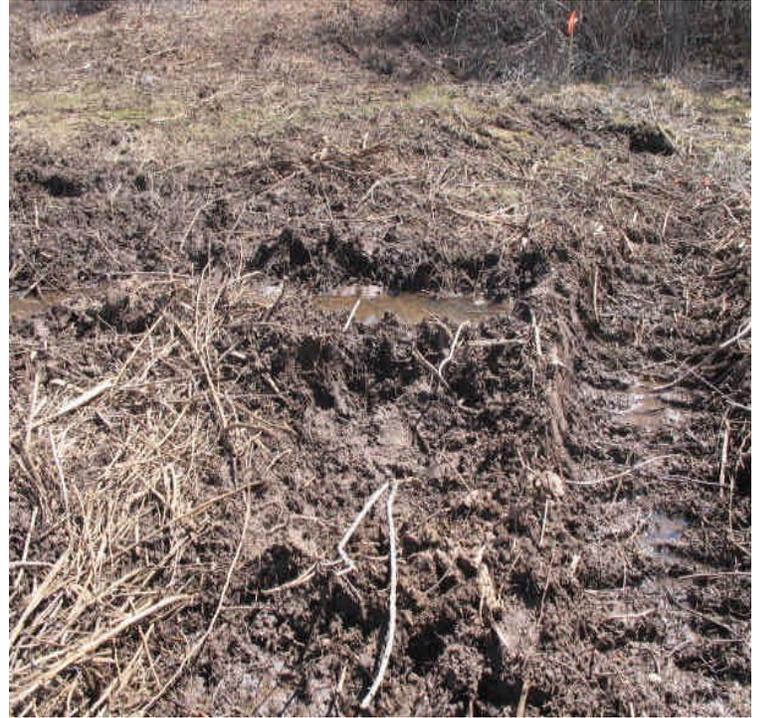
Areas of Inspection	Observation	Recommended Action	Corrected Action
	<p>within the ROW but roots stabilize the soil. 4/9/07</p> <p>Ruts from equipment access were noted in the wetland near Rte 17. Mats were not in place in this location to support the equipment. 4/2-4/9/07</p> <p>Timber mats are in place for equipment storage off Rte. 17. Haybales and stone sediment traps were used to filter water flowing from the timber mats. 4/9/07</p>	<p>install controls where applicable. 4/9/07</p> <p>Add controls at the wetland crossings and extend timber mats into the area to prevent impacts from the equipment. 4/2-4/9/07</p> <p>Continue to monitor and stabilize adjacent areas to avoid sediment tracking and accumulation on the mats. 4/9/07</p>	<p>Needs attention.</p> <p>Stone sediment traps and haybales were in place proactively to filter run-off.</p>
<p>Inland Wetland and Watercourse encroachment and mitigation</p>	<p>Cutting, skidding, and equipment movement within the ROW has occurred, compacting soils and causing ruts and disturbance in some areas. 4/2-4/9/07</p> <p>Using multiple access points from Rt 17 and Black Walnut Dr. allowed equipment to stay out of the pond within the ROW. Controls were not in place here but roots help stabilize the soil. 4/9/07</p>	<p>Continue to monitor wetlands and add controls as needed when soil is first disturbed. Install/extend mats into the wetlands for vehicle access. 4/2-4/9/07</p> <p>Install controls where necessary. Continue to retain as much vegetation as possible in and adjacent to wetlands. 4/9/07</p>	<p>Needs attention.</p> <p>NA at this time. Continue to evaluate.</p>

Ruts were observed from equipment through wetlands near Rte 17. Mats should be installed to support vehicles before they access saturated/wetland areas.

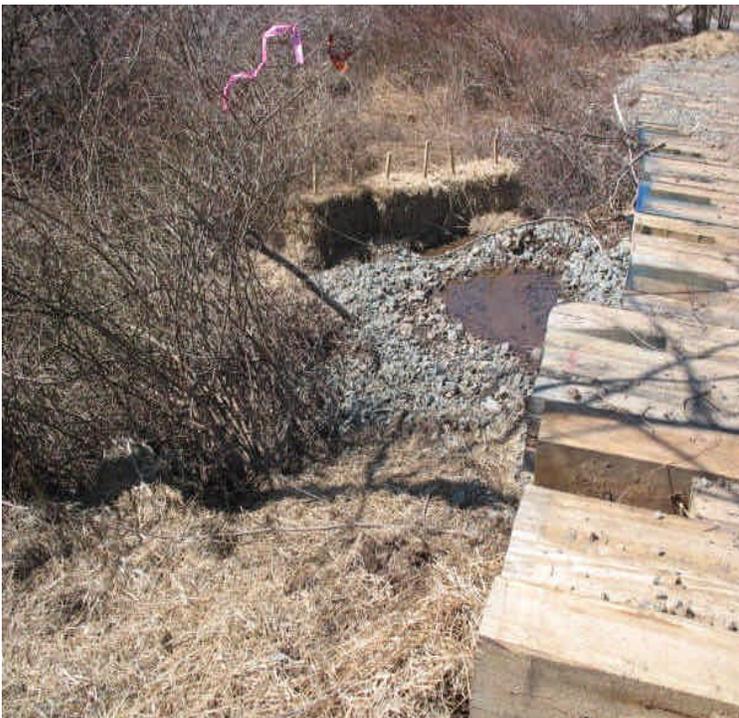
Haybale controls with a stone sediment trap was installed to filter run-off at the edge of the timber mat access off Rte 17.

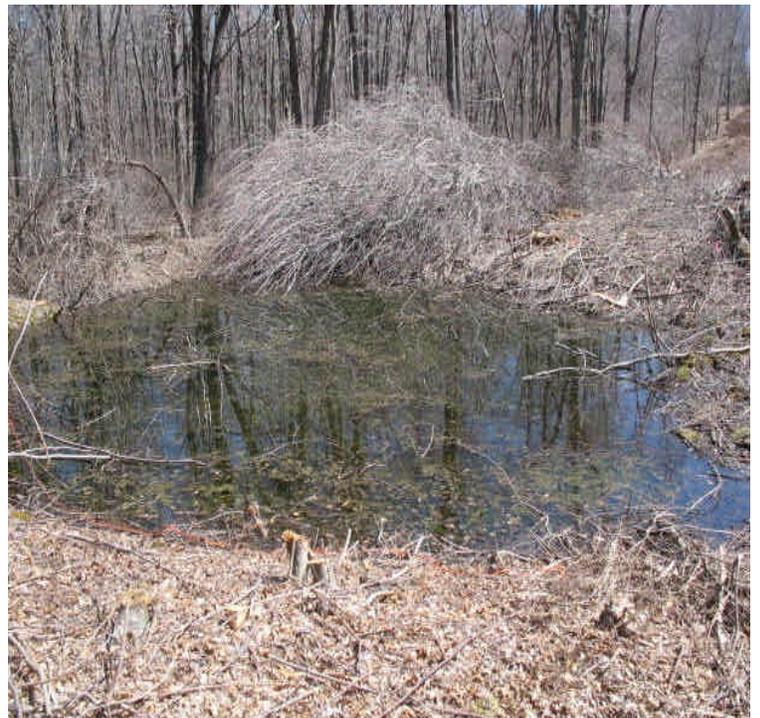
View of the ponded area within the ROW. This was protected from direct impacts by using multiple access points into the ROW.
