**Docket No. 272 – Development and Management Plan Inspection**

**The Connecticut Light and Power Company Certificate of Environmental Compatibility and Public Need for the construction of a new 345-kV electric transmission line and associated facilities between Scovill Rock Switching Station in Middletown and Norwalk Substation in Norwalk, Connecticut, including reconstruction of portions of existing 115-kV and 345-kV electric transmission line, the construction of Beseck Switching Station in Wallingford, East Devon Substation in Milford, (and Singer Substation in Bridgeport), modifications at Scovill Rock Switching Station and Norwalk Substation, and the reconfiguration of certain interconnections.**

**Segment 1b (Royal Oaks Bypass) Inspection**

**Date:** April 30, 2007

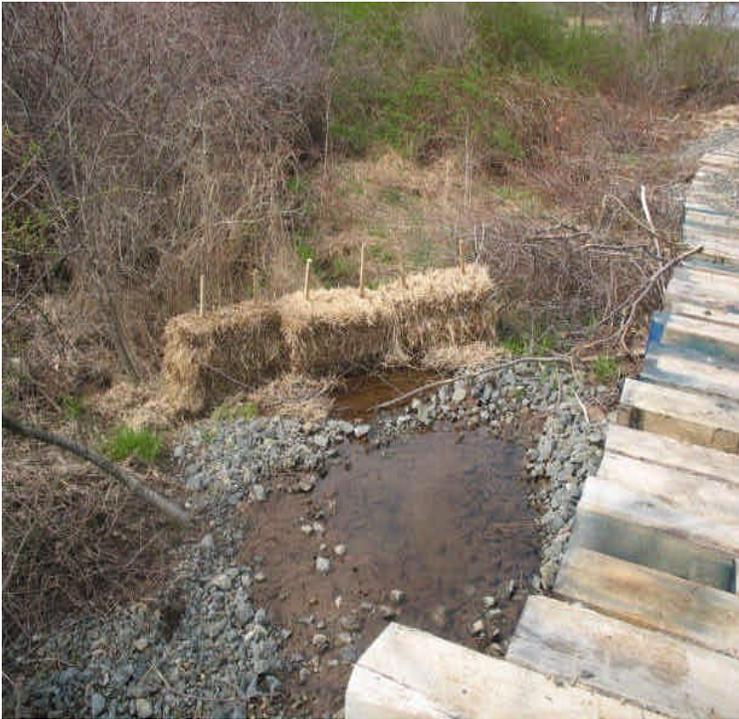
**Stormwater controls remain adjacent to the timber mat crossing off Rte 17. Clear water was flowing off site.**

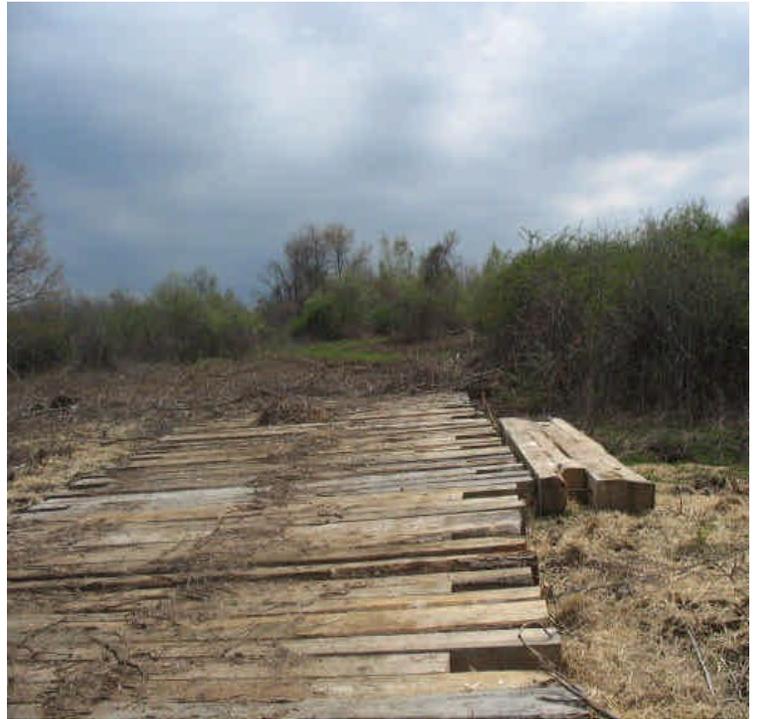
**Hay mulch remains along the edge of mats and wetlands near Rte 17 to temporarily stabilize the exposed soil.**

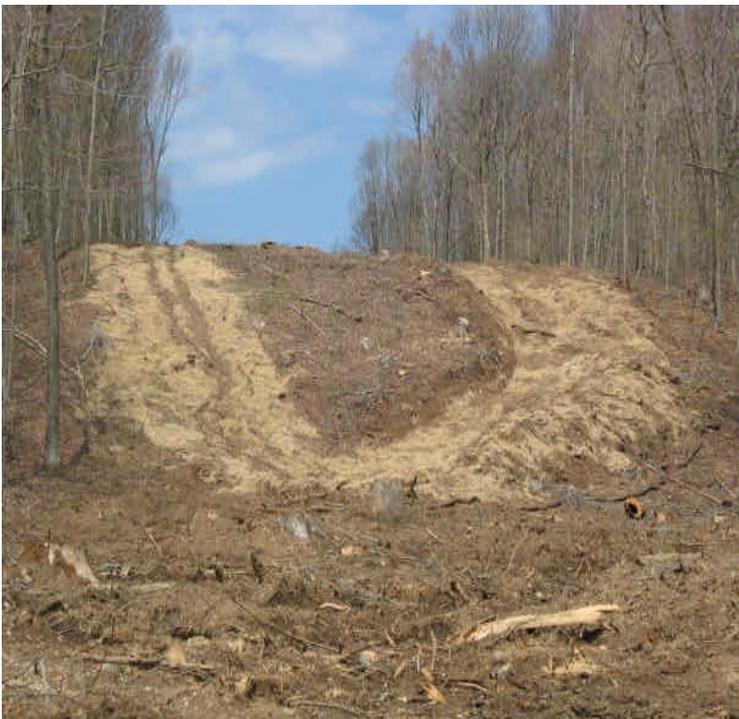
<b>Erosion and sediment controls</b>	<p>Clearing is complete; Mulch remains along a steep slope and much of the root system remains in place to stabilize the soil. Some washouts/gullies were noted on the steep slope as a result of heavy rains (noted 4/16). 4/30/07</p>	<p>As clearing construction and soil disturbance progress, add controls where needed. Regrade and seed steep slopes for further stabilization when feasible. 4/16-4/30/07</p>	<p>Needs to be monitored.</p>

**Minor washouts/gullies were noted on the steep slope due to heavy rains several weeks ago. Mulch was in place prior to the rain.**

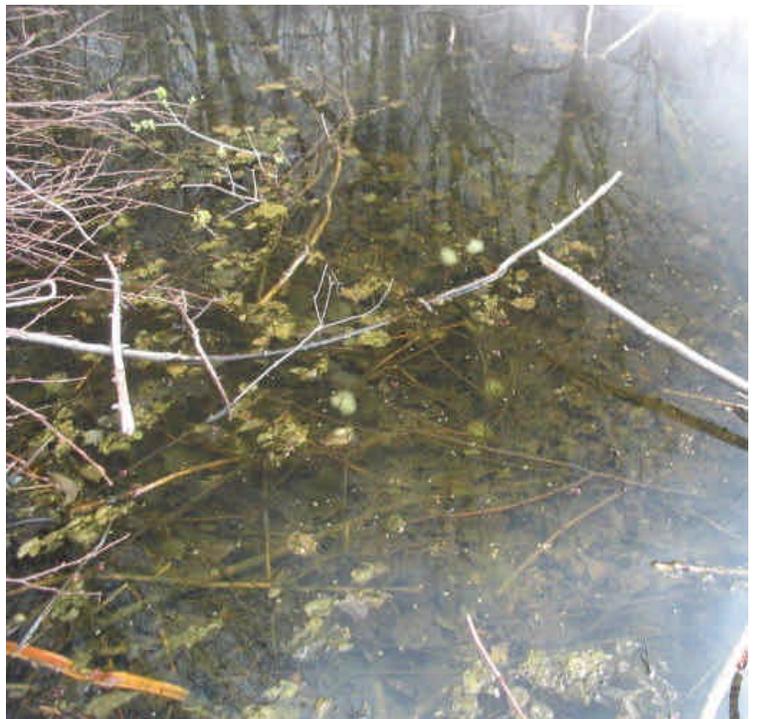
**View of several egg masses in the ponded area within the ROW. This pond was protected from direct impacts by using multiple access points into the ROW.**
