Docket No. 272 – Development and Management Plan Inspection

Segment 3 Underground Line

Date: April 3, 2007

Location: East Devon Substation to the Housatonic River Crossing

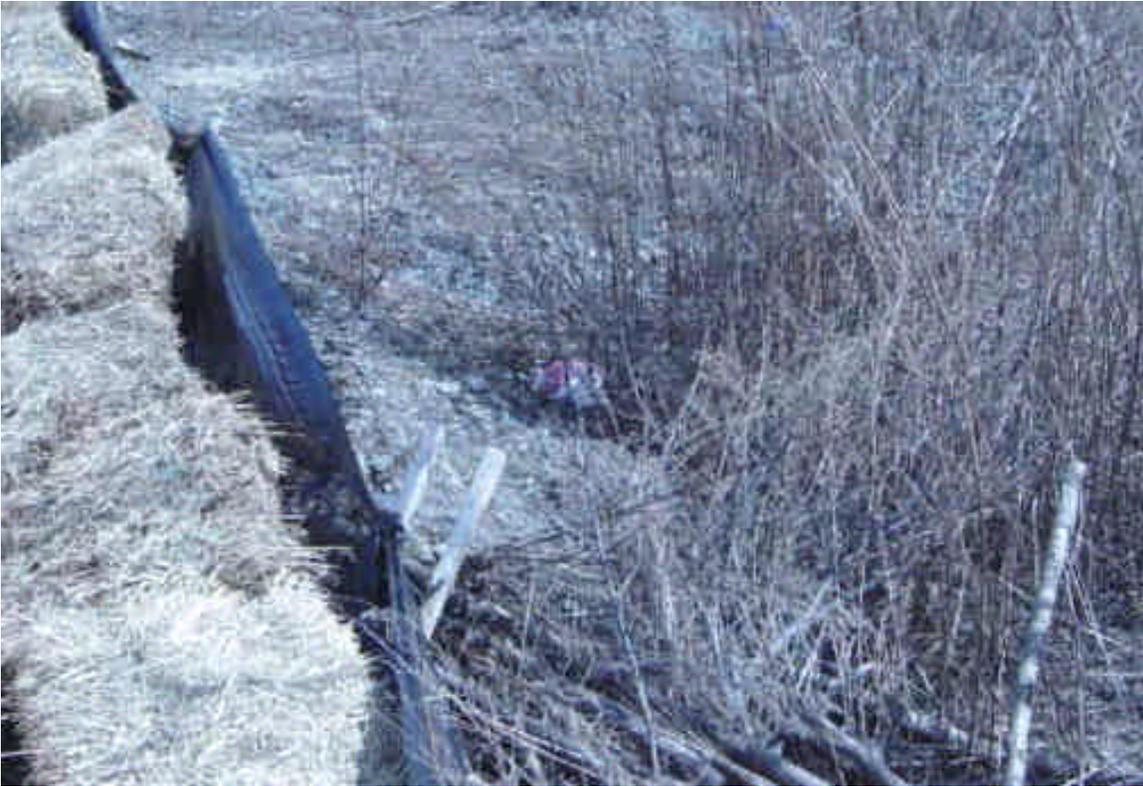
<p>Staging, Storage, and Parking Areas</p>	<p>A contractor lay-down yard is located in Milford off of Shelland St. Jersey barriers are set up as bins to hold fill materials. Additional stone is in place throughout the yard to reduce mud and subsequent tracking. 4/3/07</p> <p>The stone that was noted on the wrong side of the perimeter controls near the south side of the Shelland St. contractor yard (3/15) still remains. It appears to be the result of snow plowing over the fence. 3/27-4/3/07</p>	<p>Continue to monitor the perimeter of the yard to ensure sediment and materials are contained. 4/3/07</p> <p>Remove the gravel carefully by hand when feasible and restore the area if needed. 4/3/07</p>	<p>NA</p> <p>Needs attention when feasible.</p>

Photo of the stone pile located beyond the perimeter erosion controls at the Milford lay-down yard as a result of the snow clearing a few weeks ago. The stone should be carefully shoveled up and removed when feasible. Restore the area if needed.

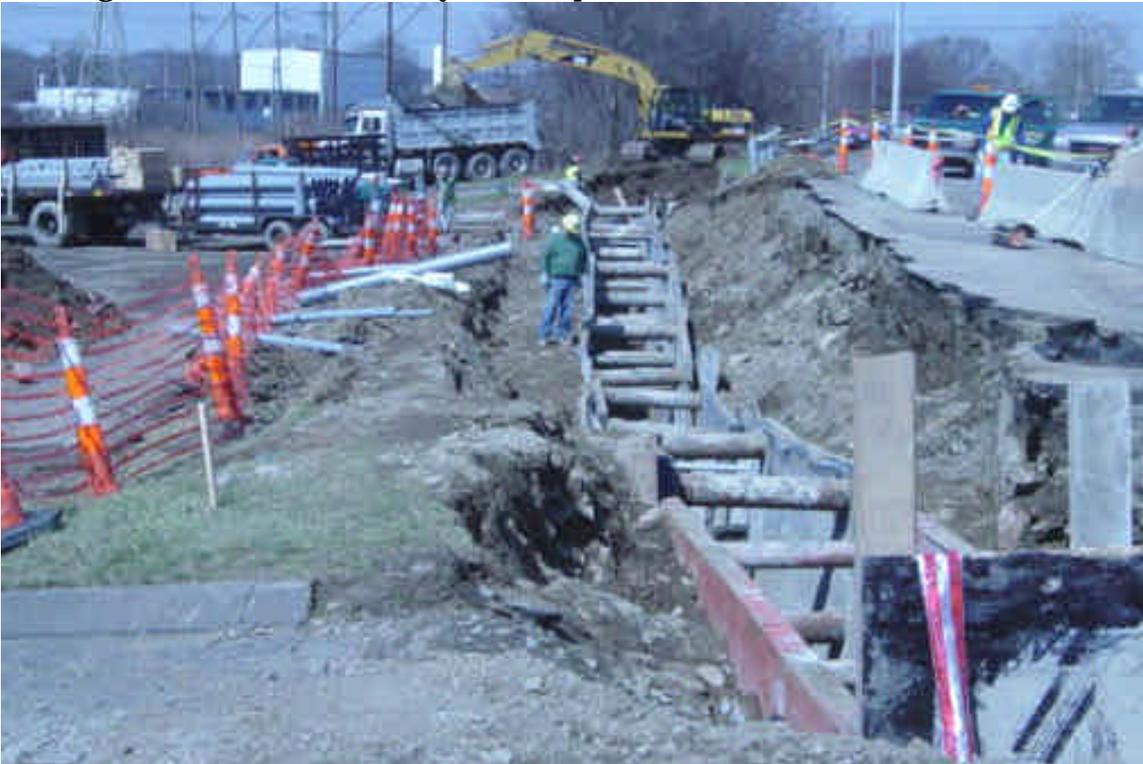
View of trenching activities between sta. #1073 to 1076.
