**Docket No. 272 – Development and Management Plan Inspection**

**Segment 3 Underground Line**

**Date:** April 25, 2007

**Location:** East Devon Substation to the Housatonic River Crossing

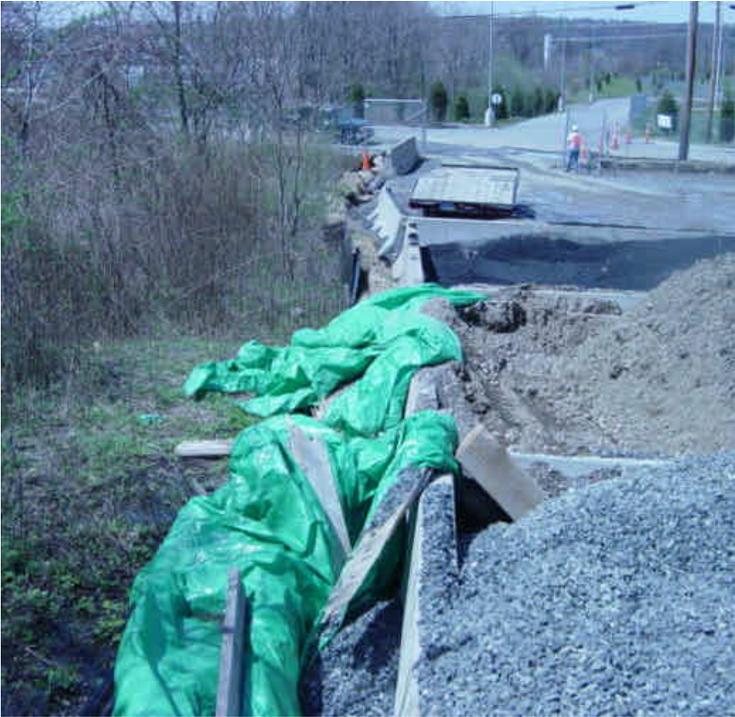
**Both photos show the Milford contractor yard. Left: The material in the storage bins have overtopped the containment area and the perimeter controls to the yard. Materials need to be pulled back into the yard. Right: Sediment has accumulated on the opposite side of the silt fence and is migrating into the catch basin. Controls are in place in the catch basin but accumulated sediment should be removed.**

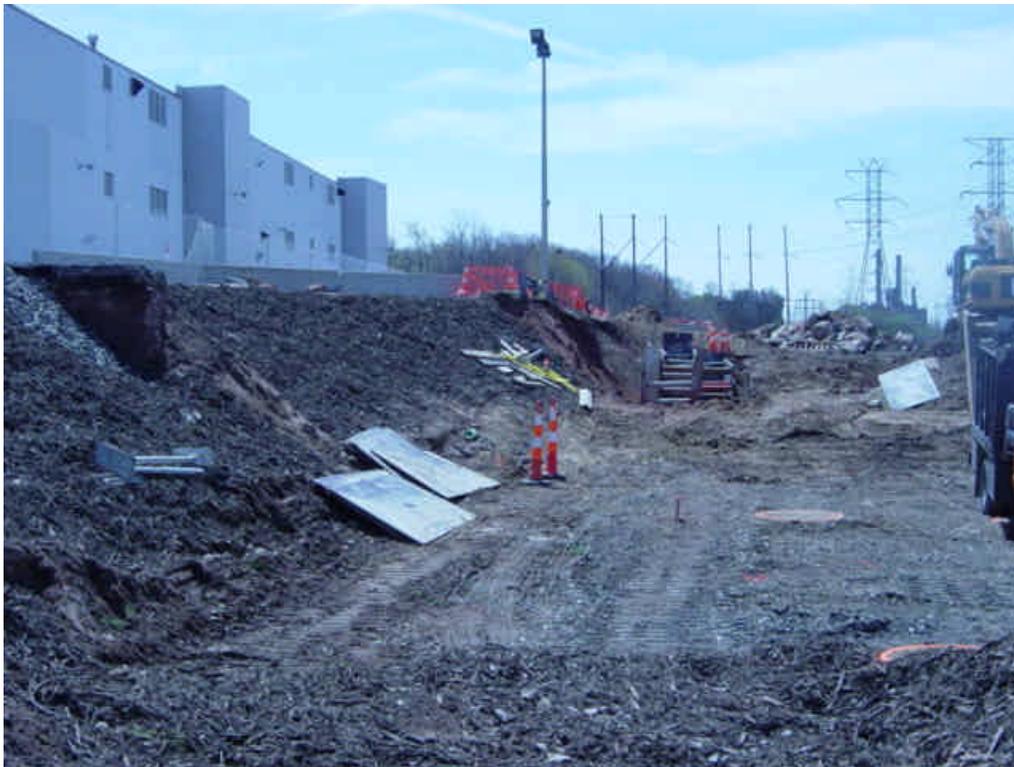
**View of construction activities near sta. #1080. The slope has been temporarily stabilized with bark mulch.**
