Docket No. 272 – Development and Management Plan Inspection

Segment 4a Underground Line

Date: April 13, 2007

Location: Singer Substation to Fairfield/Westport Town Line

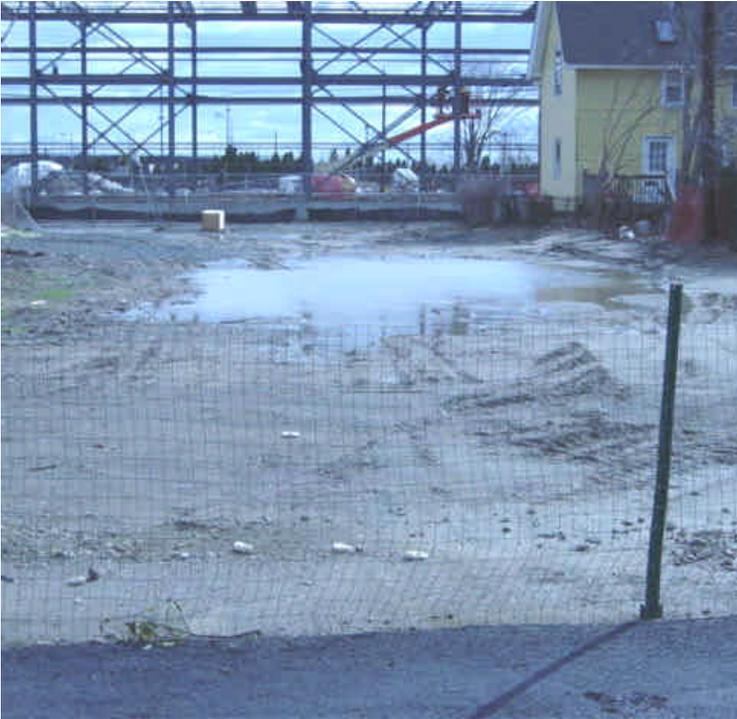
Areas of Inspection	Observation	Recommended Action	Corrected Action
	<p>near sta. #462 in accordance with the D&M Plan. 4/13/07</p> <p>The trench formerly located between Broad and Main St. has been backfilled with a hard pack material. The area appears to be stable. 4/13/07</p>	<p>restored as necessary upon completion of work in this area. 4/13/07</p> <p>Permanently restore area when feasible. 4/13/07</p>	NA at this time.
Dewatering	Dewatering activities were not observed during this week's inspection. 4/13/07	Continue to appropriately contain or filter 4/13/07	NA
Blasting	No blasting has been proposed. 4/13/07	None 4/13/07	NA
Spills and Material Storage	<p>Spill cleanup materials/kits were observed in the storage yards. 4/13/07</p> <p>A concrete washout was observed in an uncontained location, immediately adjacent to the railroad on Railroad Ave. between Rt. 1 and Bostwick Ave. 3/15-4/3/07 The concrete washout has been removed. 4/13/07</p>	<p>Ensure that spill kits are also present with each vehicle during active construction 4/13/07</p> <p>Continue to washout concrete only in an approved, contained location. 4/13/07</p>	<p>NA</p> <p>The material has been removed.</p>

Photo of former location of trenching activities between sta. #810 to #812. A hard pack material was used to aid in stabilizing the area. Final restoration measures are recommended when appropriate.

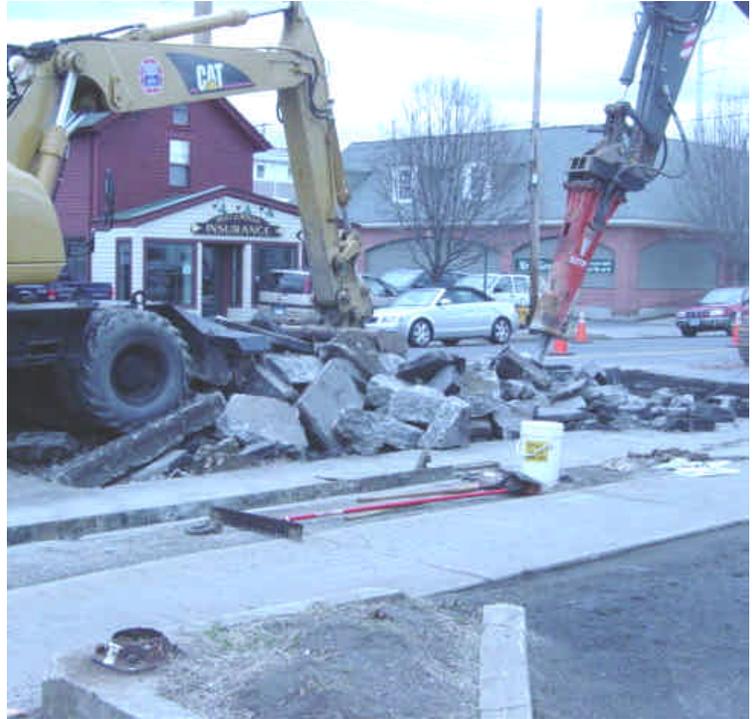
Preparation work being conducted for vault #32 construction activities.

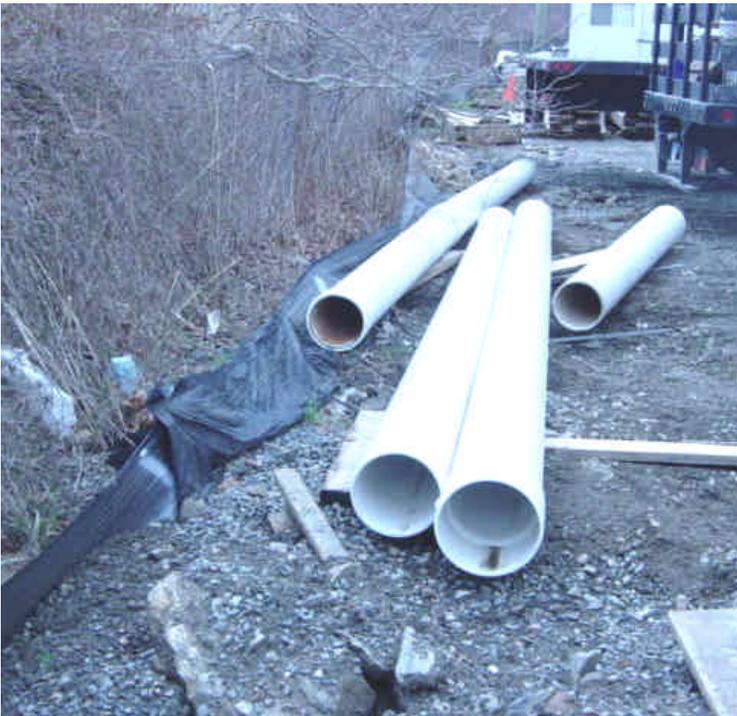
Materials within the King's Highway lay-down yard were piled against the controls, compromising them. The fence should be re-established. Continue to store materials in a way that does not strain the controls.

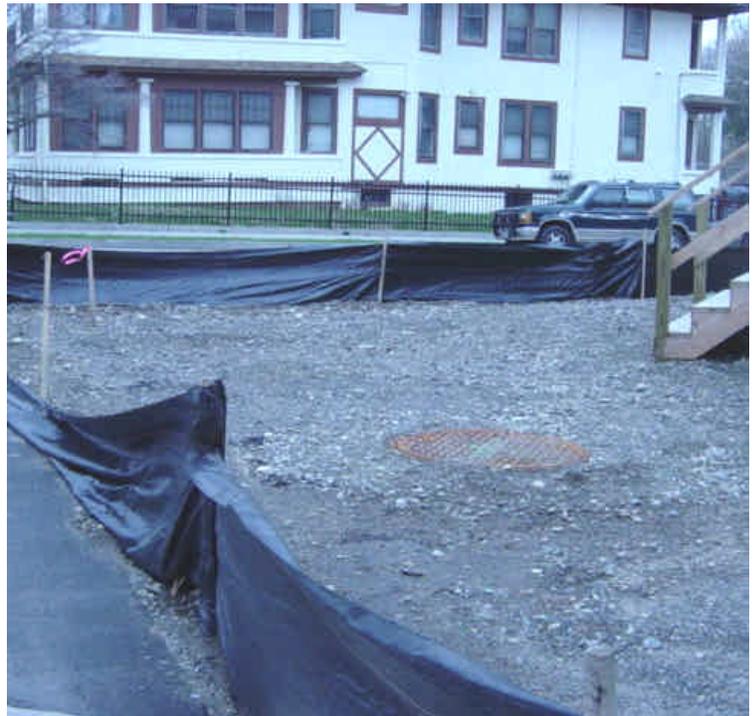
Fairfield	Slurry from saw cutting activities has the potential to enter catch basins. 4/13/07 Work at vault #41 is largely complete. Silt fence installed around the remaining exposed soils had been repaired, but still needs attention in one location. 4/13/07	Prevent slurry from entering catch basins and sensitive areas, by quickly attending to it as it is generated during cutting. 4/13/07 Repair/maintain controls and continue to stabilize soil as feasible. 4/13/07	NA Silt fence was repaired but one spot still needs attention when feasible.
Bridgeport	A soil stockpile along Pequot Ave. is partially covered with plastic and has adjacent silt fence. It remains stable. 4/13/07 Non-project related sediment tracking was noted on Railroad Ave. near its intersection with	Continue to monitor and maintain controls. 4/13/07 Noted for the record since sediment does not appear to be related to the project. 4/13/07	NA NA

Silt fence was re-established at vault #41, but has slumped in one location. Repair when feasible.
