Docket No. 272 – Development and Management Plan Inspection

Segment 4b Underground Line

Date: April 19, 2007

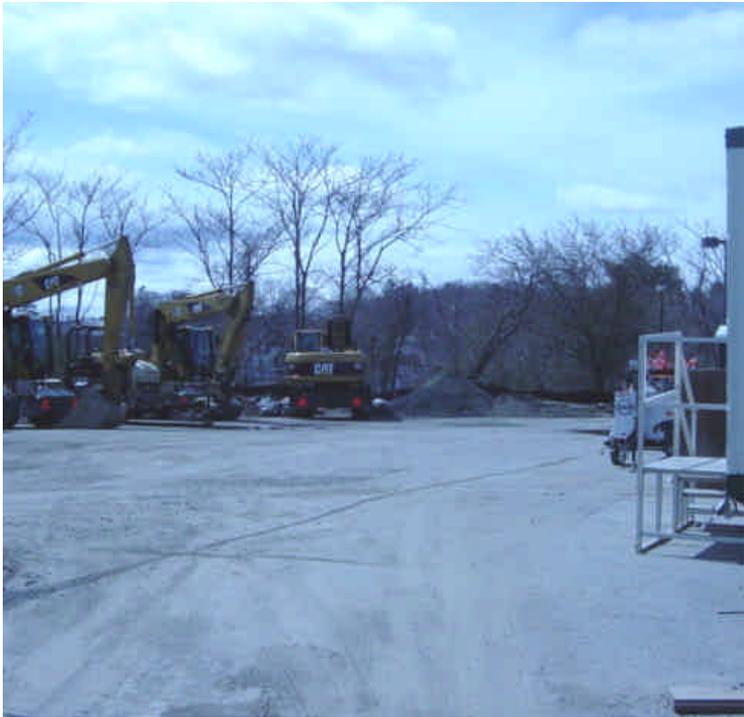
Both photos show the Imperial Ave. lay-down yard.

Left: General overview of yard. Right: Fluid filled equipment is being stored without containment. While leaks or spills were not observed at this time, consider storing such equipment on a liner or similar containment as a proactive measure.

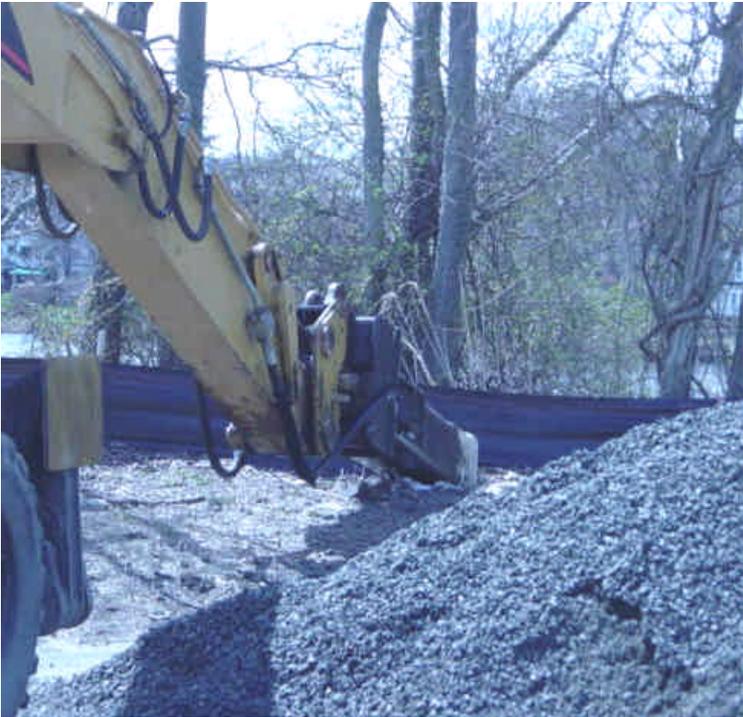
Areas of Inspection	Observation	Recommended Action	Corrected Action
yard	an issue at this time, fluid filled equipment was being stored in the yard without containment. 4/19/07	filled equipment on a liner or similar so that any spills are proactively contained. 4/19/07	
Sherwood Island lay-down yard	The fluid filled equipment previously observed being stored on a grassed area was no longer noted in the yard. 4/19/07	Consider storing fluid filled equipment on a liner or similar so that any spills are proactively contained. 4/19/07	The equipment is no longer in the yard
Additional Observations	None 4/19/07	None 4/19/07	NA

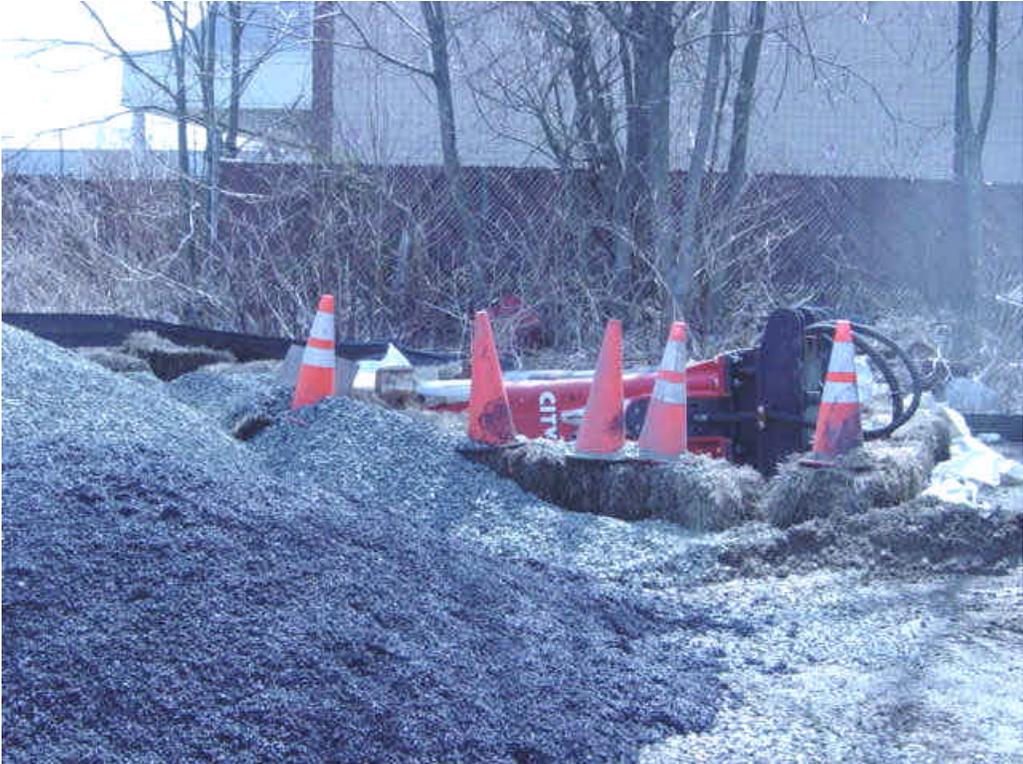
Fluid filled equipment is being adequately and proactively contained within the King's Highway lay-down yard.
