Docket No. 272 – Development and Management Plan Inspection

Segment 4b Underground Line

Date: April 25, 2007

Location: Fairfield/Westport Town Line to Westport Avenue in Norwalk

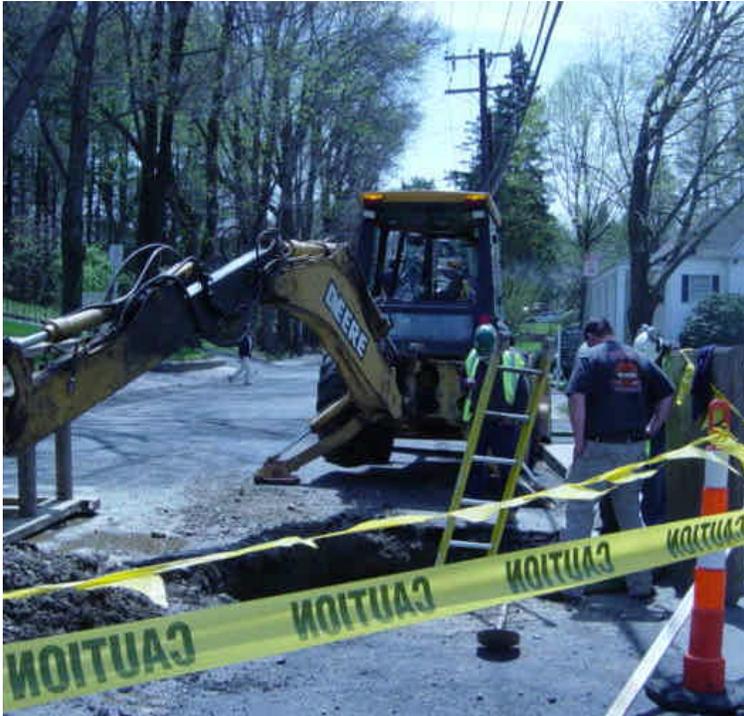
Sewer relocation activities on Imperial Ave. No issues were noted.

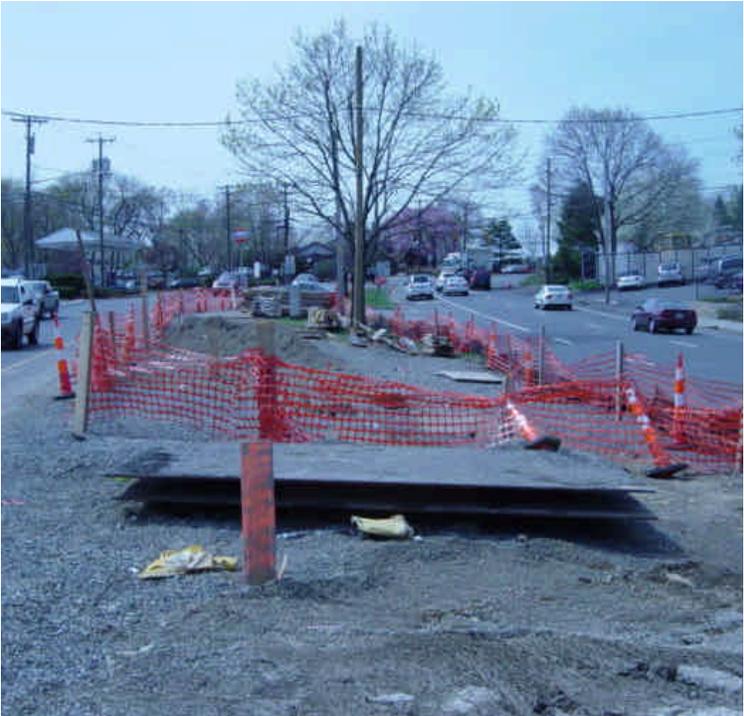
Trenching activities at sta. #313-318.

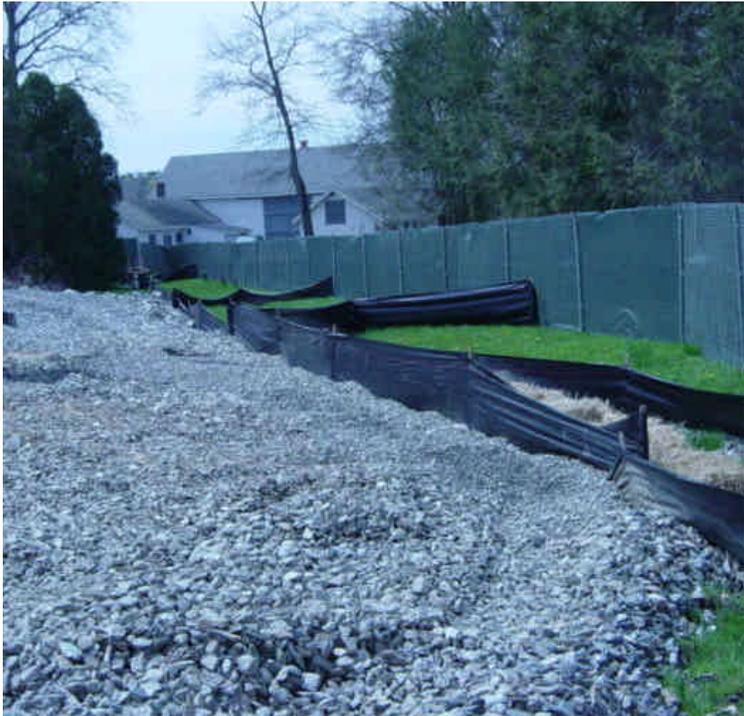
Both photos show the Sherwood Island lay-down yard. Left: The check dams and barriers that control the storm drain outlet have been fully re-established. Right: Equipment was removing access road stone that overtopped erosion controls.
