Docket No. 272 – Development and Management Plan Inspection

Beseck Switching Station Inspection

Date: August 2, 2007

Location: Beseck Switching Station

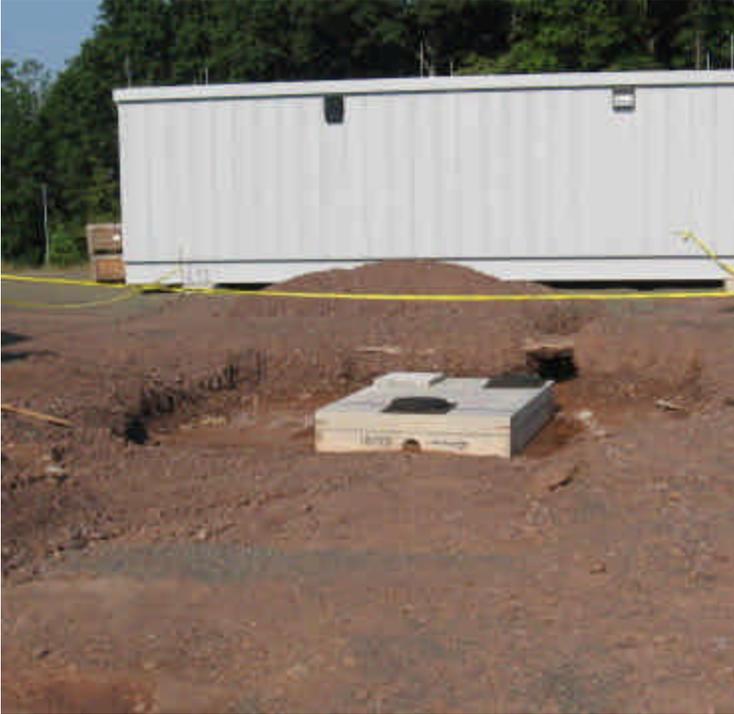
The septic system is now being installed on site.

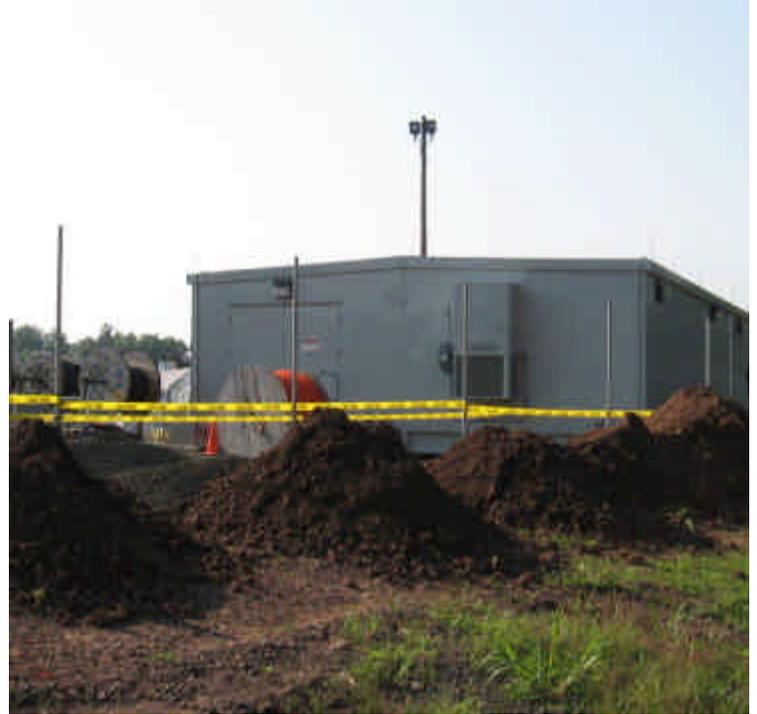
Installation of a perimeter fence is underway. Small soil stockpiles have been generated.

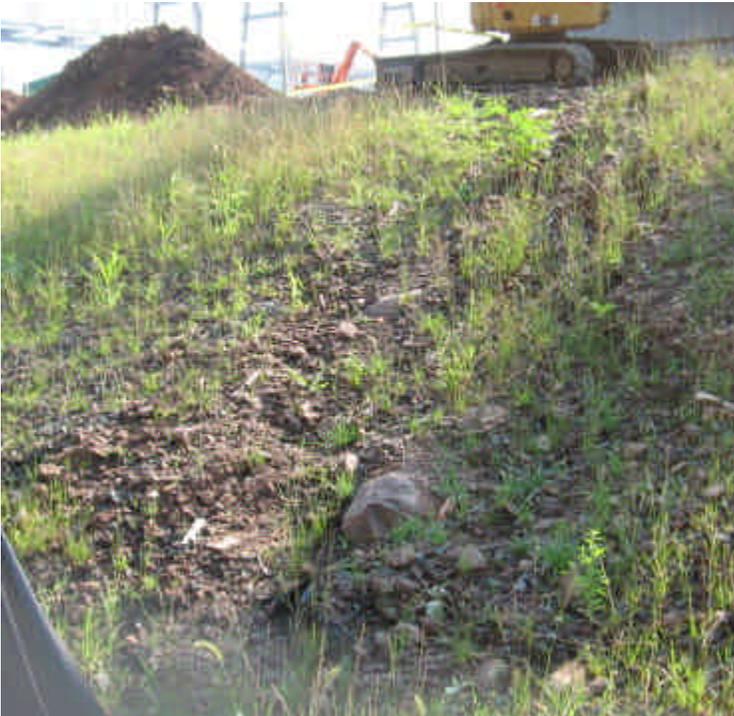
Overall vegetative growth on site is good. However, minor washouts need attention/stabilization.

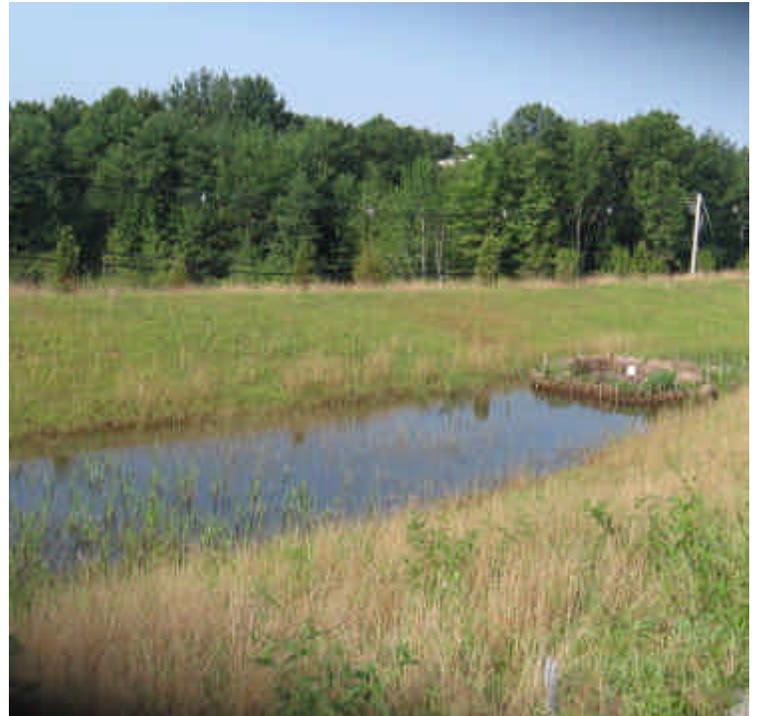
The detention basin appears to be working properly. Controls remain at the outlet and the slopes are well vegetated.

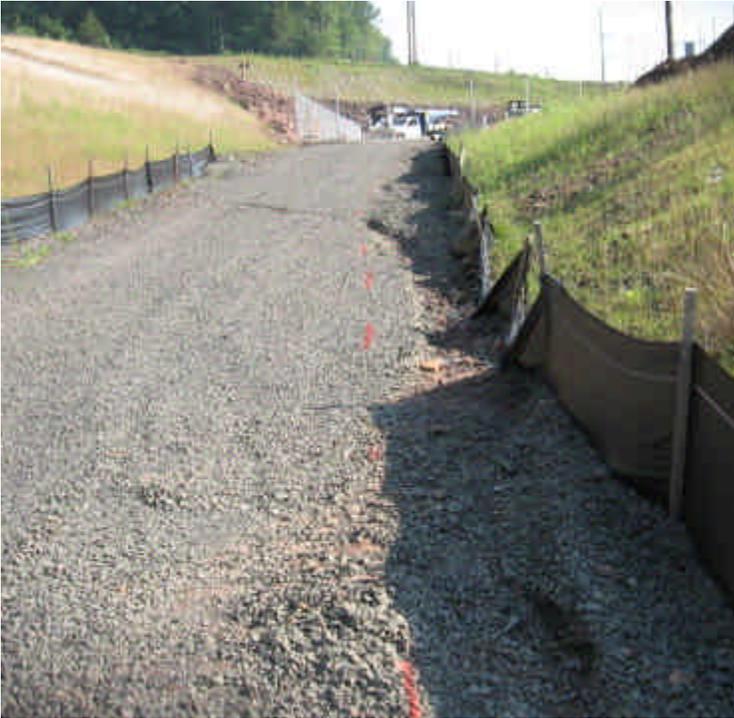
Small washouts noted along the western access road need attention/stabilization.

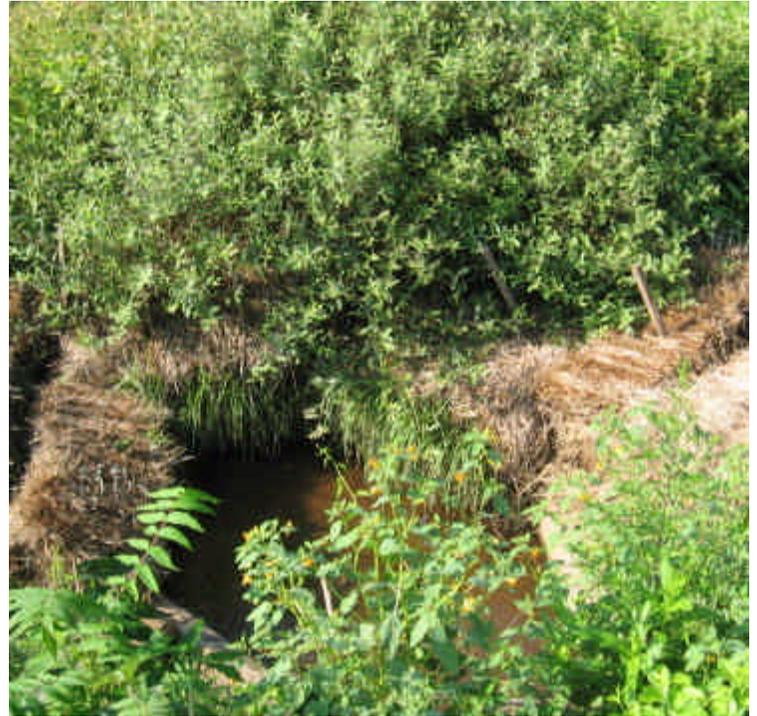
Sediment is settling at the haybale controls, placed at the culvert outlet south of Carpenter Lane. Sediment has migrated past the controls and into the wetland.

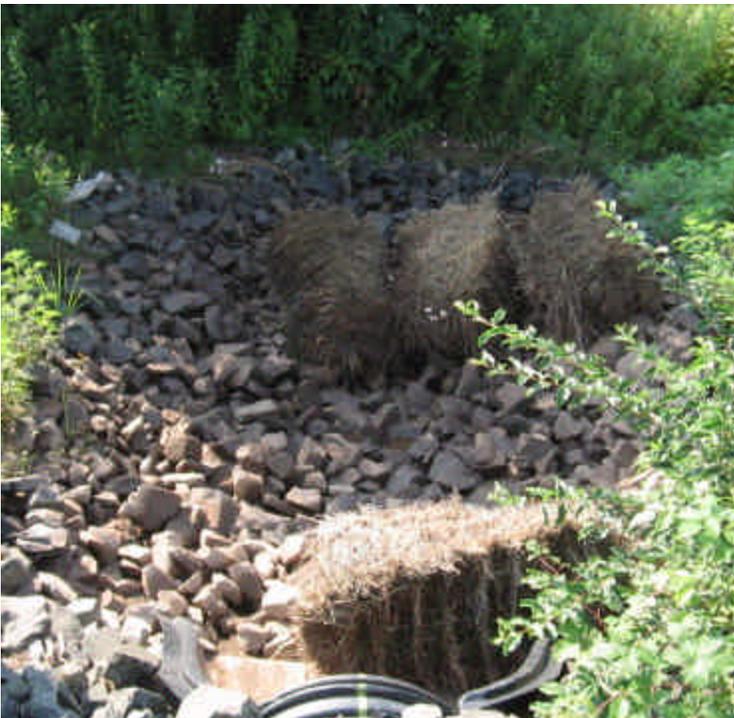
A view of the controls in place at the sediment trap along the eastern access road.

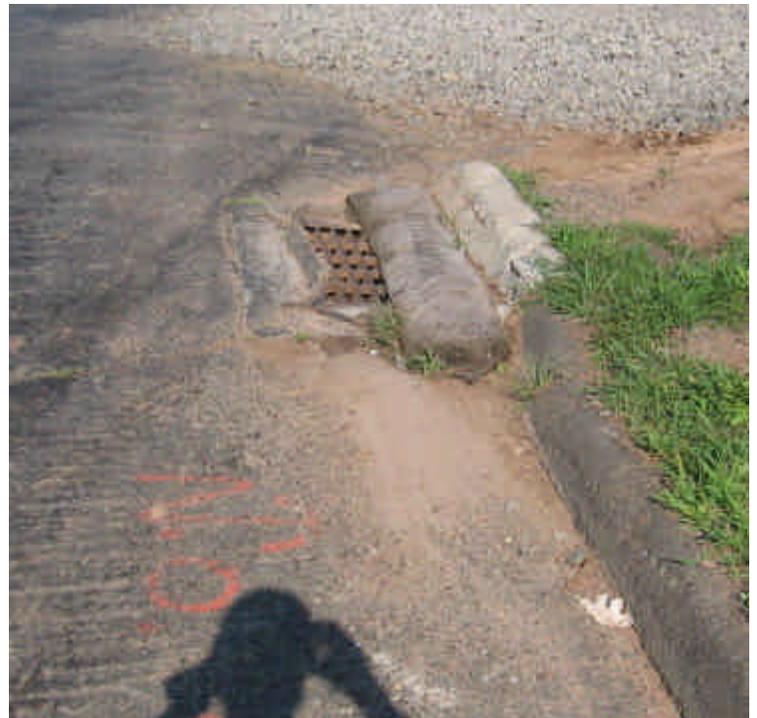
Some sediment accumulation remains at the catch basin controls in the gutters along Carpenter Lane. Sweep as needed.
