Docket No. 272 – Development and Management Plan Inspection

East Devon Substation Inspection

Date: August 24, 2007

Location: East Devon Substation

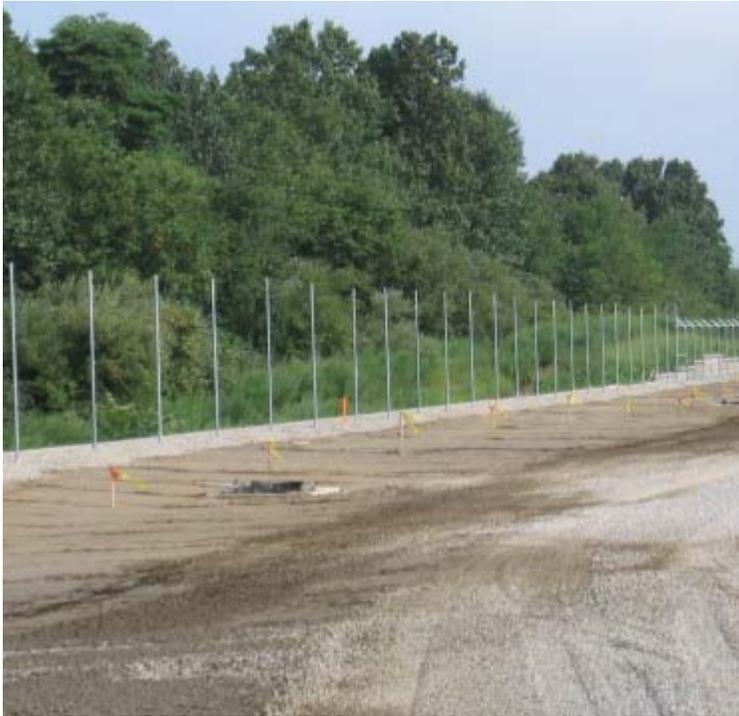
Perimeter fence installation continues. The yellow flags shown above identify the location of the recently installed underground power line.

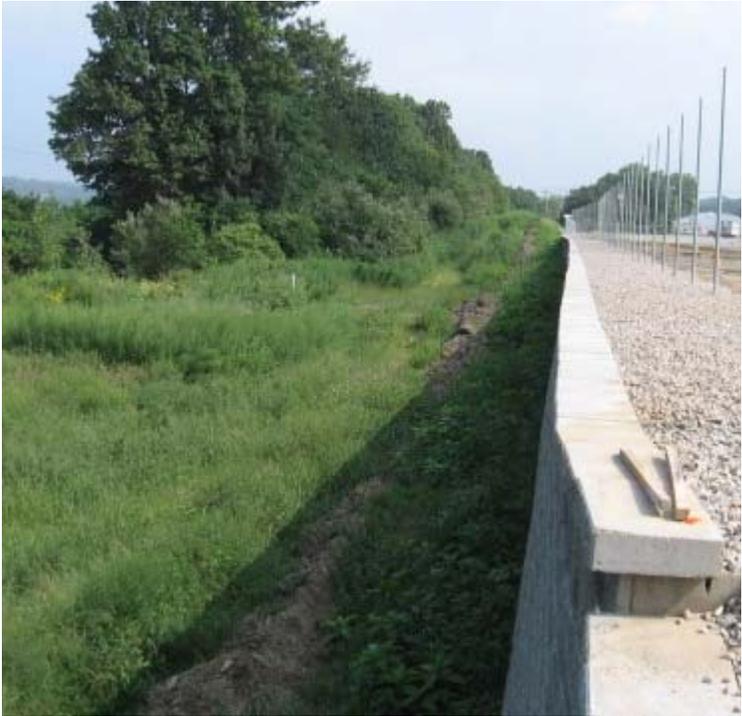
A view of the vegetative growth behind the retaining/perimeter wall located along the western site boundary.

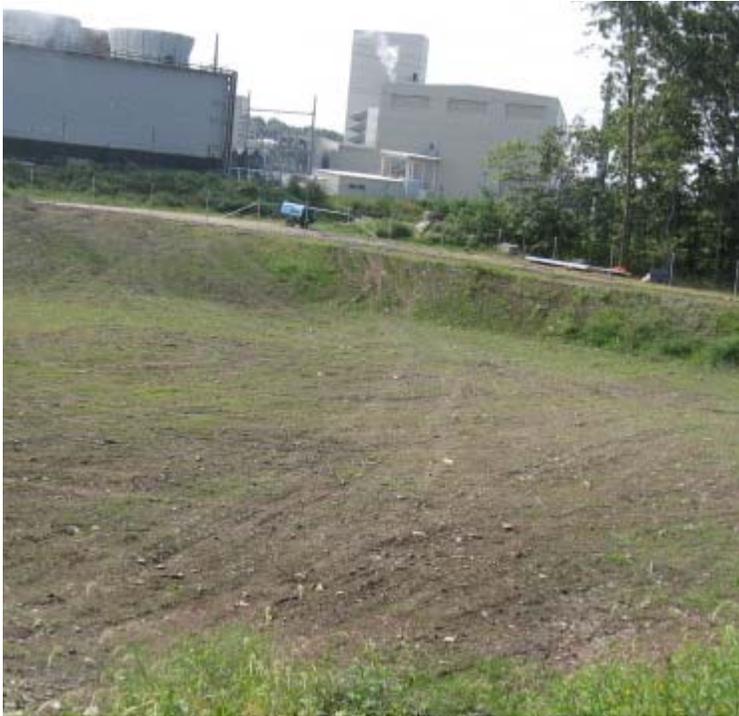
A view of the detention basin located along the southern boundary of the substation site.

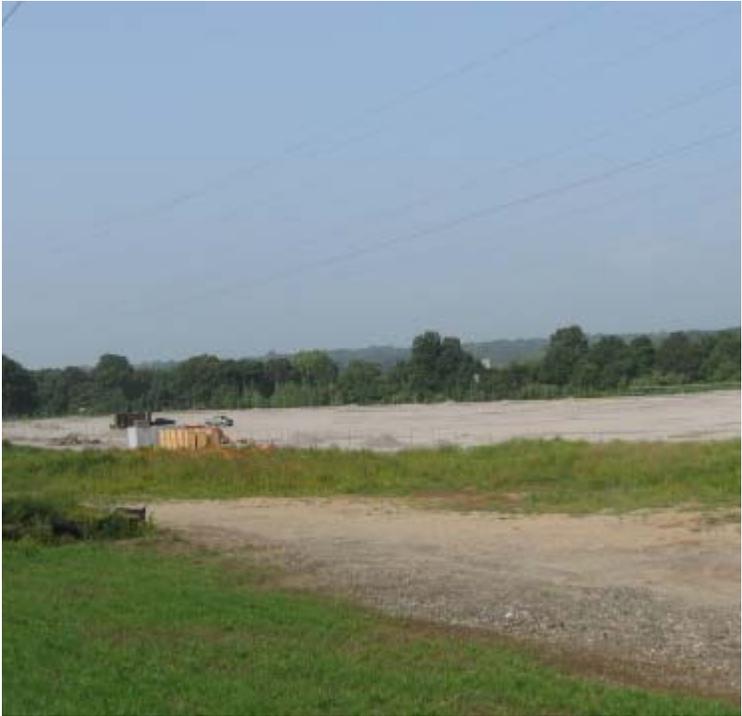
An overall view of the East Devon Substation site.
