**Docket No. 272 – Development and Management Plan Inspection**

**Segment 1b (Royal Oaks Bypass) Inspection**

**Date:** August 20, 2007

**Location:** Segment 1b (Royal Oaks Bypass)

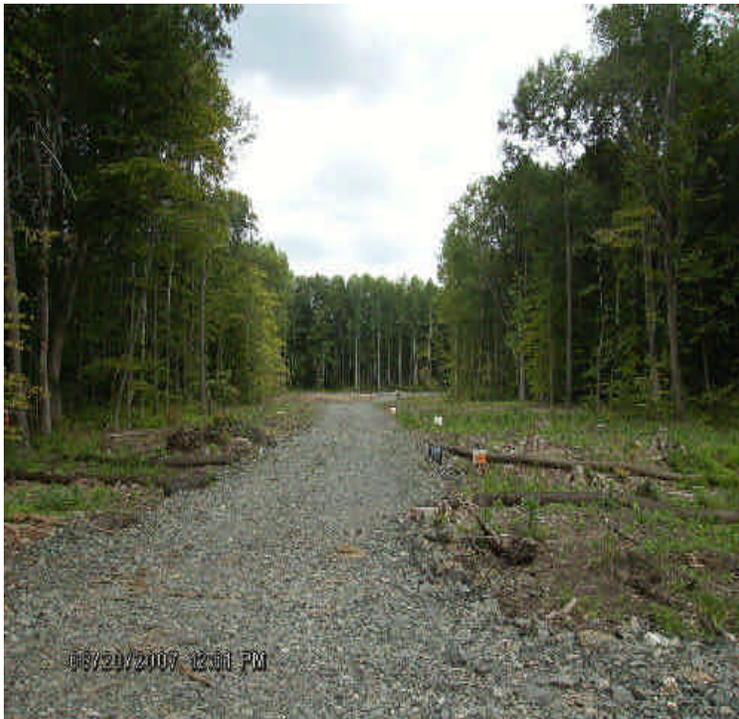
**Environmental controls in place along the access road near the shipping and receiving yard.**

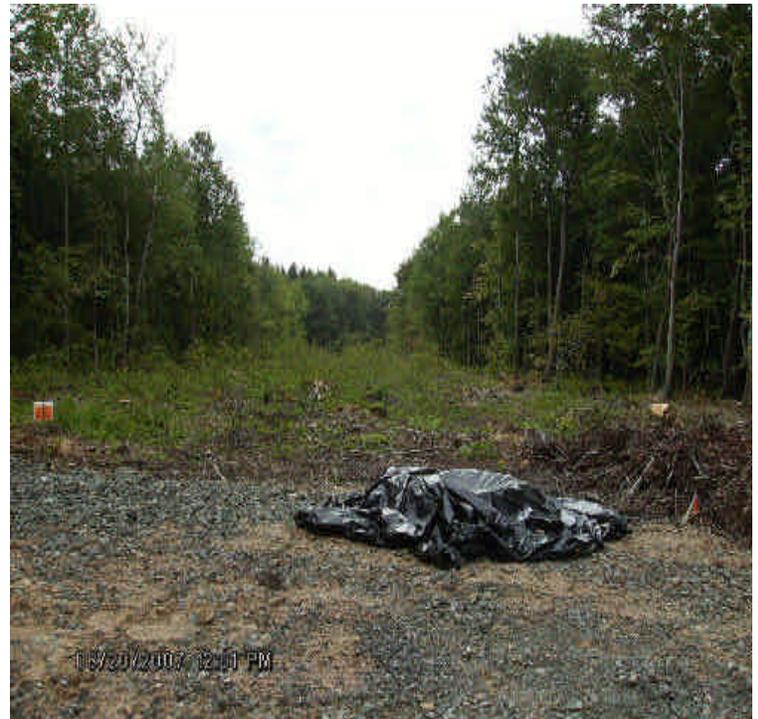
**Vegetative growth/cover continues to establish following the permitted clearing along the no access area near the shipping and receiving yard**

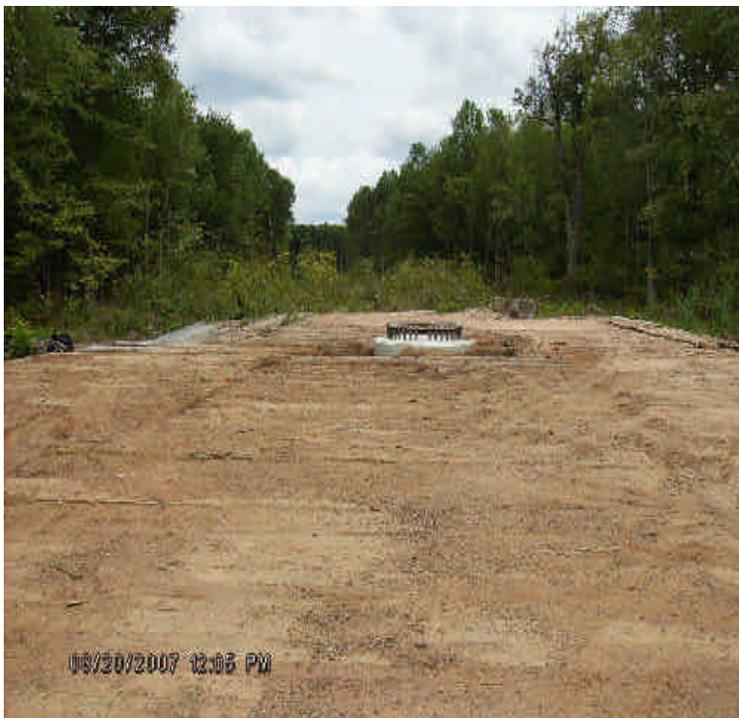
**Sediment accumulation was noted on the timber mats within the wetlands at the access off Rte 17. Remove sediment from pads to the extent feasible and monitor controls closely until the site is stabilized.**

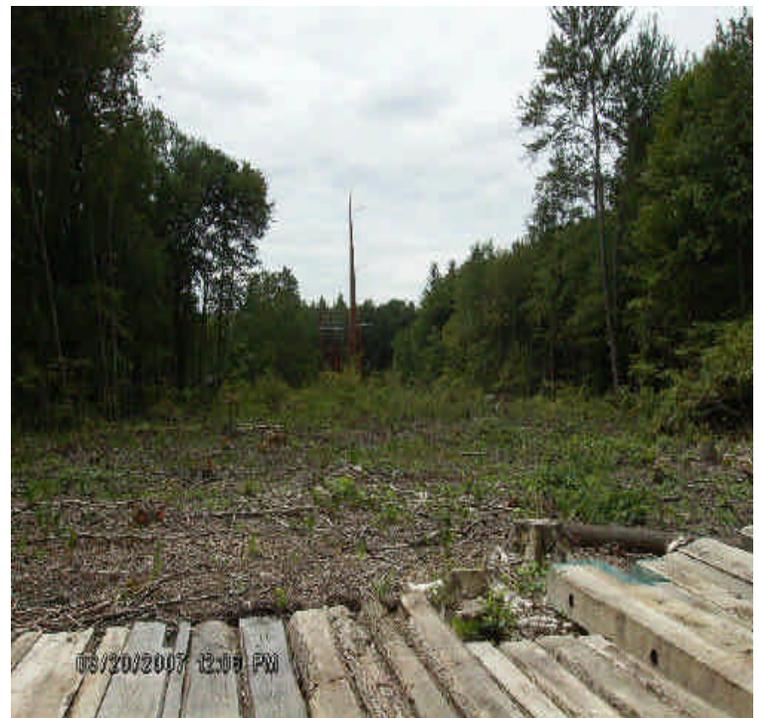
**View looking at the Little Lane intersection from access off Rte 17.**
