Docket No. 272 – Development and Management Plan Inspection

Segment 2a Inspection

Date: August 7, 2007

Location: Segment 2a – Beseck Switching Station to Cheshire/Hamden Town Line

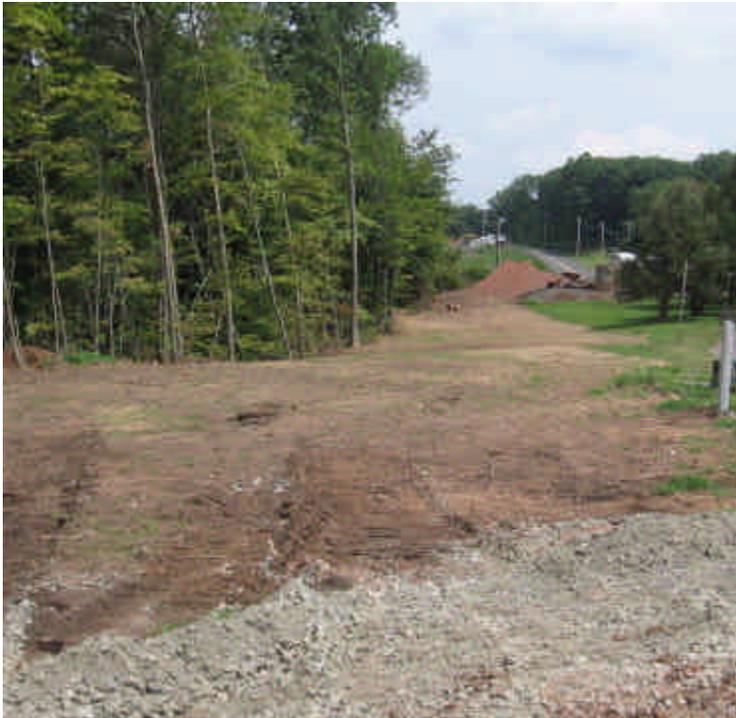
Harrison Rd./ Tradition Golf Course: Hydroseed had been applied to the exposed soils last week. Some grass growth was noted.

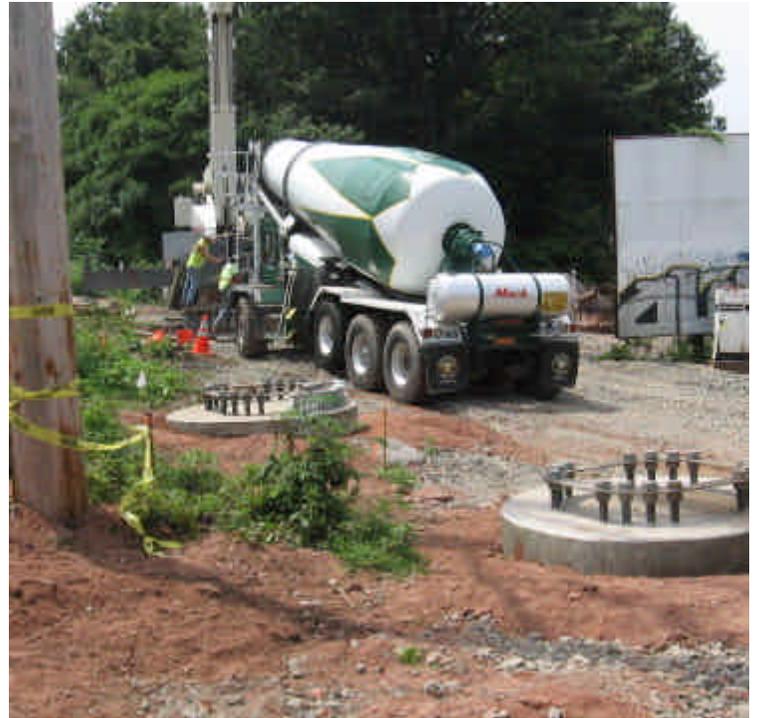
Harrison Rd./ Tradition Golf Course: The final foundation was poured in this area.

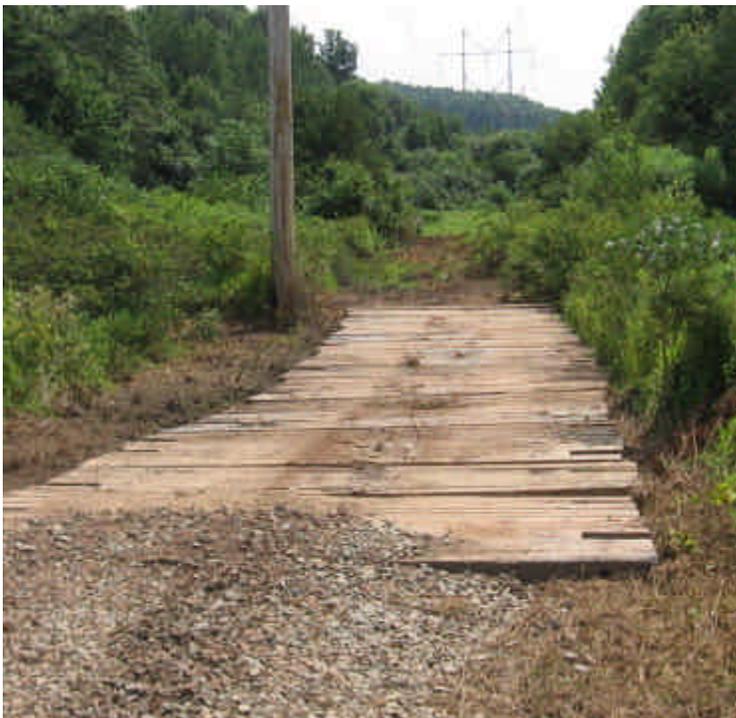
Durham Rd (south): Access road construction continues in this area. Timber mats have been installed at wetland crossings. Add adjacent controls as necessary.

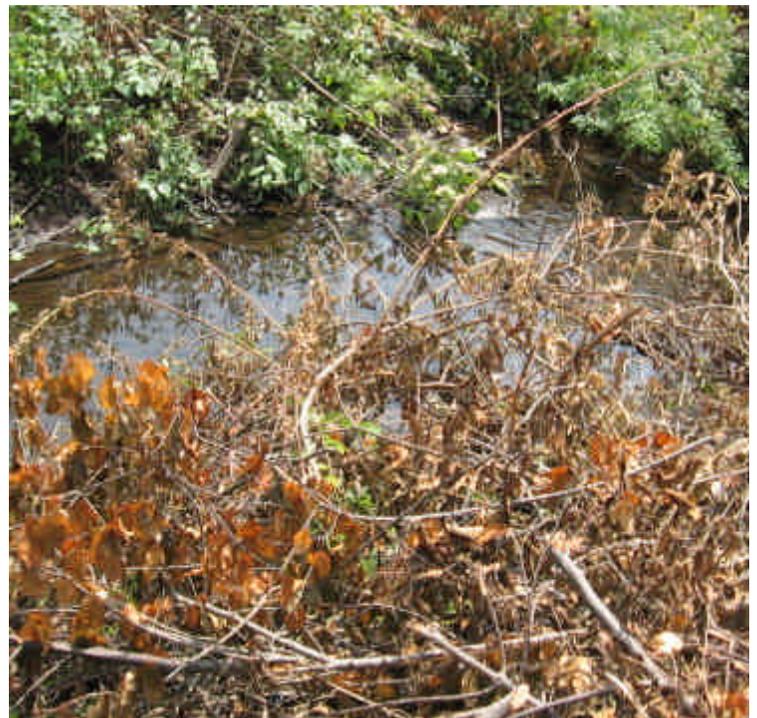
Durham Rd (south): This stream, a tributary of the Muddy River, will be crossed with a timber mat bridge.
