**Docket No. 272 – Development and Management Plan Inspection**

**Segment 2b Inspection**

**Date:** August 14, 2007

**Location:** Segment 2b – Cheshire/Hamden Town Line to East Devon Substation

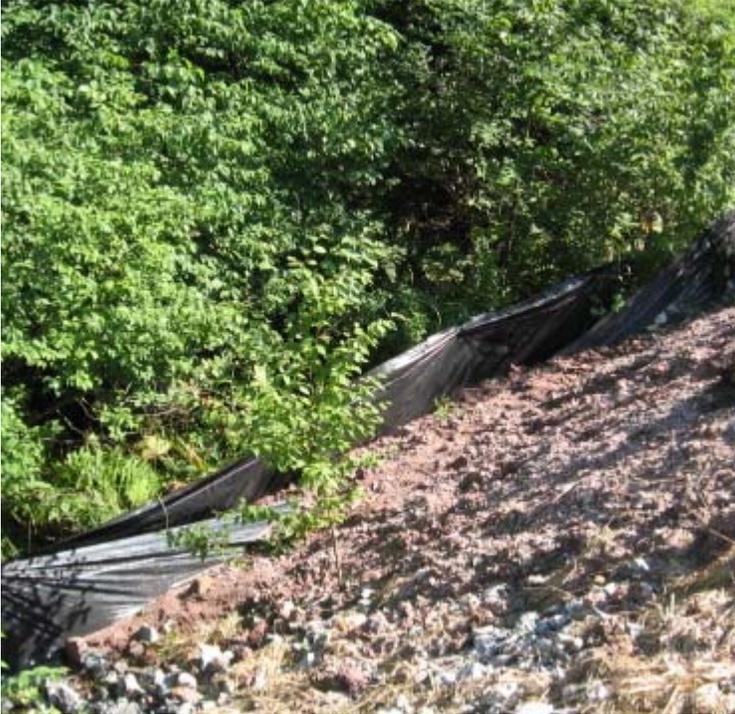
| Areas of Inspection | Observation | Recommended Action | Corrected Action |
|---|--|---|--|
| Brooksvale | <p>here. 8/14/07</p> <p>Mulch has been spread in washout areas near structure #3989 in an effort to temporarily stabilize disturbed soils here. 8/14/07</p> <p>A second line of silt fence was installed in the area where spoils had overwhelmed the initial silt fence at structure #3993 last week. Spoils were removed from the wetland here. 8/14/07</p> <p>Access roads were constructed on steep slopes located upgradient from wetland areas here. Haybales are in place but due to the nature of the terrain and location of the adjacent wetlands, additional controls may be necessary. 8/14/07</p> | <p>wetland area when feasible. 8/14/07</p> <p>Mulched areas should be seeded for further stabilization. Continue to monitor. Stone fill or similar may be needed to stabilize gullies/washouts. 8/14/07</p> <p>Continue to monitor and add/maintain controls as necessary. 8/14/07</p> <p>Haybales are in place but due to sloped terrain and proximity to the downgradient wetland, additional controls are recommended. 8/14/07</p> | <p>Needs proactive attention when feasible</p> <p>A second line of silt fence was installed and spoils were removed from the wetland</p> <p>Needs attention</p> |

West Todd (Hamden): A second line of silt fence has been added where spoils overwhelmed the initial silt fence here. Spoils have been removed from the wetland.

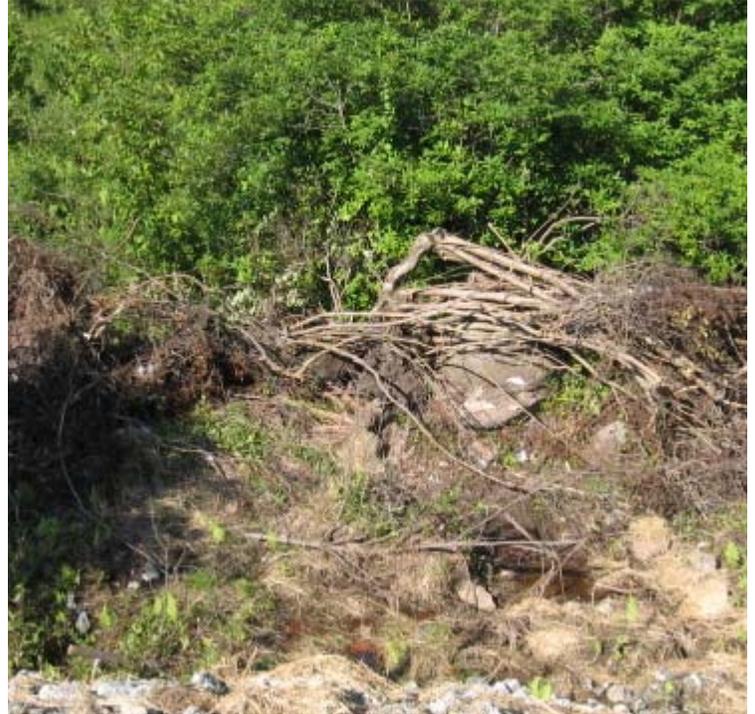
| Areas of Inspection | Observation | Recommended Action | Corrected Action |
|--|--|---|--|
| <b>Hamden, CT</b><br><br>Tom Swamp Rd/Arrow Rd, West Todd Street, Brooksvale Ave, Willow Street and Old Lane Rd. | Clearing appears to be complete in these sections at this time. Small trees and shrubs were retained where feasible. 8/14/07<br><br>Brush from clearing activities was observed in the wetland near structure #3993 this week. 8/14/07 | Continue to monitor. 8/14/07<br><br>Carefully remove brush from the wetland area when feasible. 8/14/07 | NA<br><br>Needs attention when feasible |

West Todd: Brush from clearing activities was noted in the wetland near structure #3993.

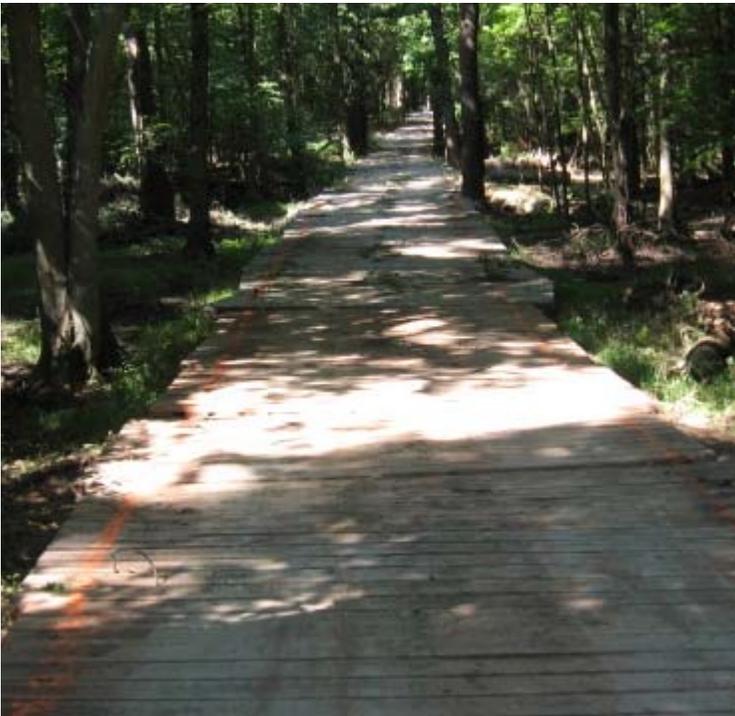
| Areas of Inspection | Observation | Recommended Action | Corrected Action |
|---|--|--|--|
| Clearview Lane to Rt 15 | Timber mat crossings were installed in the wetland area here. 8/14/07 | Continue to monitor. 8/14/07 | Timber mat crossings are in place within the wetland |

Clearview Ln. to Rte. 15 (Woodbridge): Timber mats and erosion controls have been installed at the wetland crossing between proposed structures #3899 and #3904.

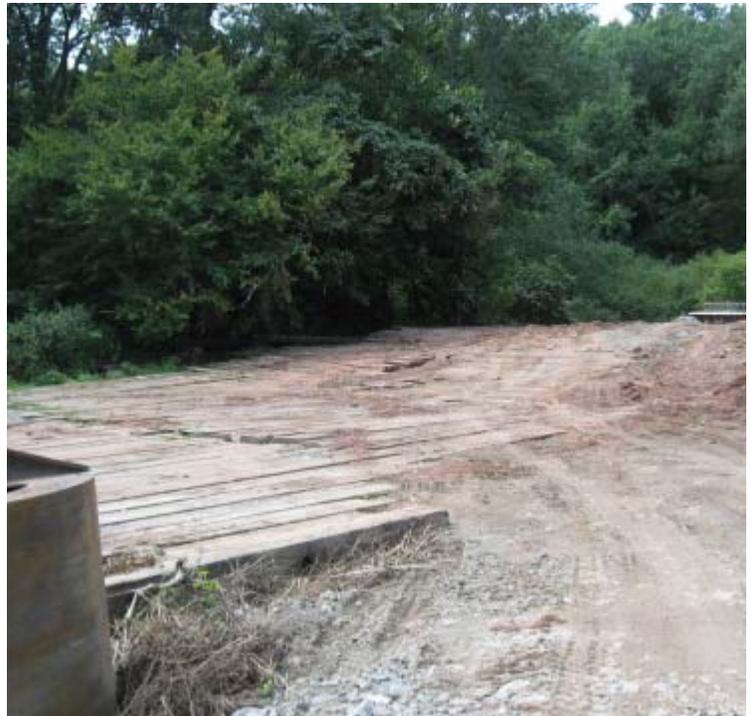
Willow St. (Hamden): A view of the newly installed foundation and timber mat crane pad at structure #4011.
