**Docket No. 272 – Development and Management Plan Inspection**

**Segment 3 Underground Line**

**Date:** August 8, 2007

**Location:** East Devon Substation to the Housatonic River Crossing

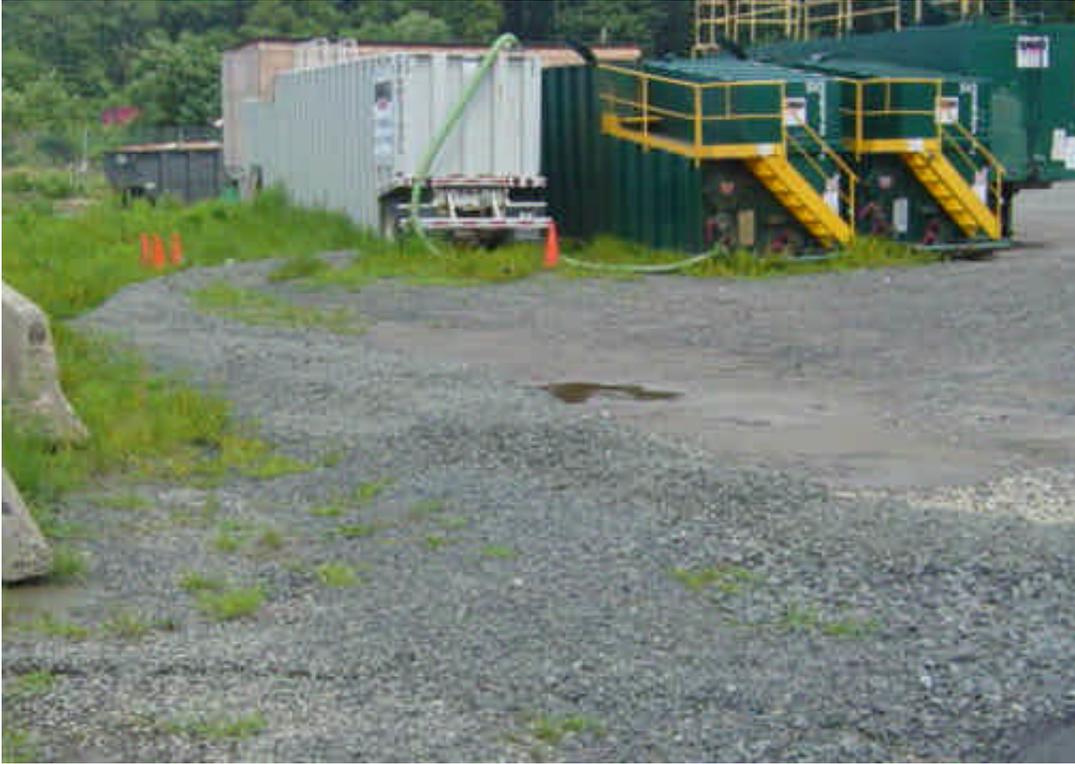
**A sufficiently sized stone berm has been installed within the Milford lay-down yard to control sediment migration beyond the limits of yard.**

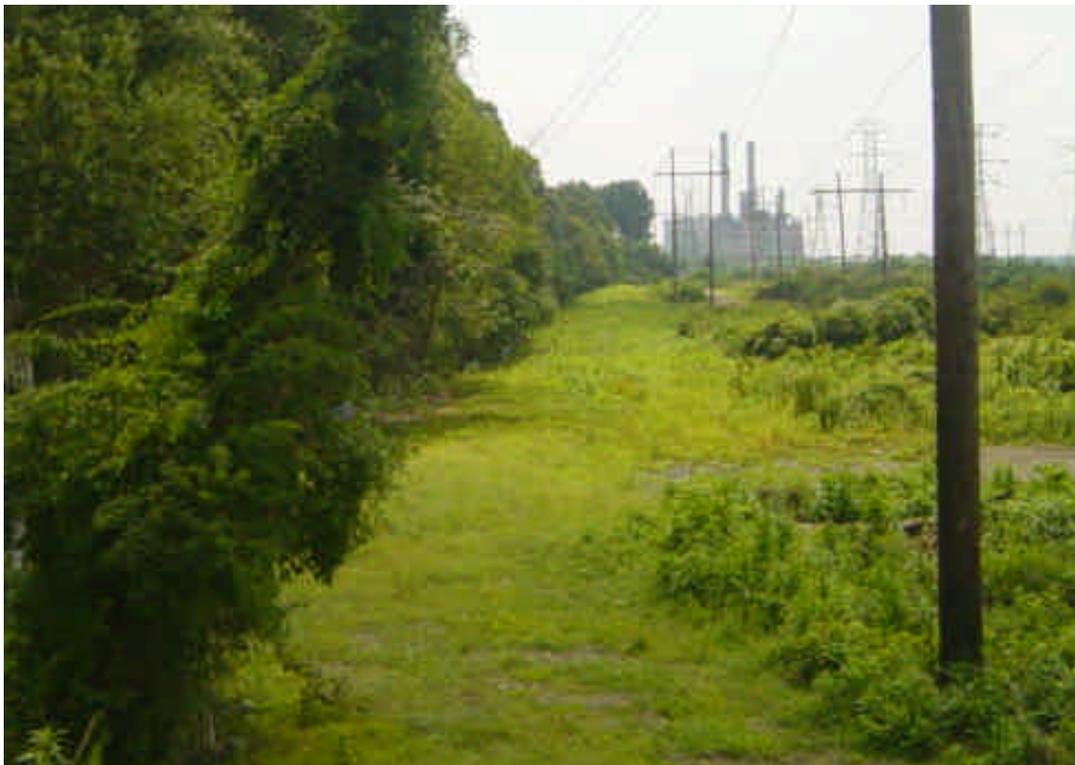
**The majority of the ROW between Bic Drive and Naugatuck Ave. is permanently stabilized with vegetative cover.**
