Docket No. 272 – Development and Management Plan Inspection

Segment 3 Underground Line

Date: August 21, 2007

Location: East Devon Substation to the Housatonic River Crossing

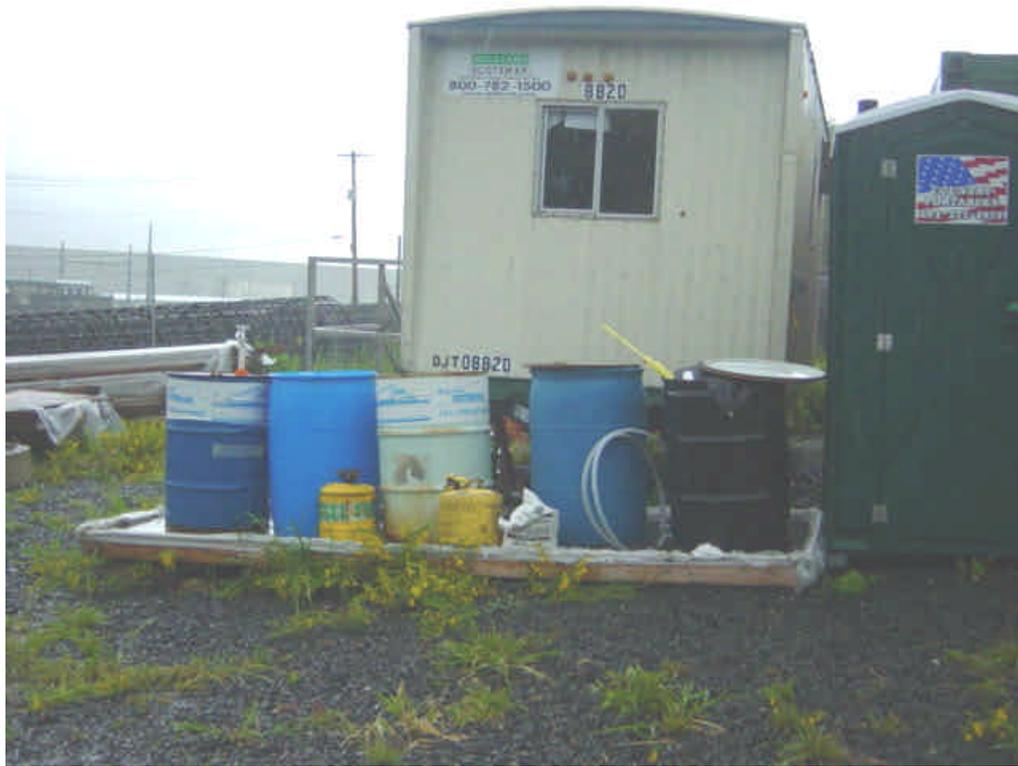
Materials/fluid are being properly and proactively contained within the Milford lay-down yard.
