Docket No. 272 – Development and Management Plan Inspection

Segment 4a Underground Line

Date: August 8, 2007

Location: Singer Substation to Fairfield/Westport Town Line

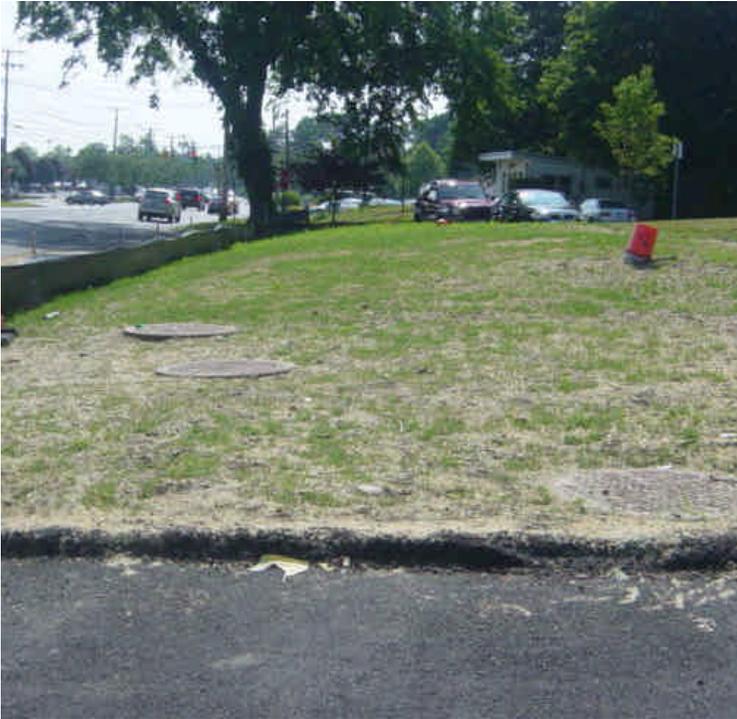
<p>Vegetation at vault #36 and #37 continues to establish. Silt fence at vault #37 has been compromised in one location since 7/19/07. 8/08/07</p>	<p>Continue to monitor until final stabilization is achieved. Repair compromised silt fence at vault #37. 8/08/07</p>	<p>Grass growth continues. Silt fence needs repair.</p>
Bridgeport	<p>Minimal sediment was observed within the roadway this week. Sediment tracking and accumulation in the catch basins are regularly observed at the Railroad and Myrtle Ave. intersection. Sediment is originating from a stockpile yard identified as being associated with the Glenbrook Cable project. This is not covered under this D&amp;M plan. 8/08/07</p>	<p>Noted for the record since contractors stated the sediment is not related to this project. 8/08/07</p>	<p>NA</p>
	<p>Sediment and debris was accumulating in the controls at the catch basins at the intersection of Railroad and Hancock</p>	<p>Remove sediment and debris from the catch basins, restoring their capacity. Sweep and properly dispose of any</p>	<p>Needs attention</p>

Photo of vault #36. Grass cover/growth continues to stabilize the exposed soils in this location.

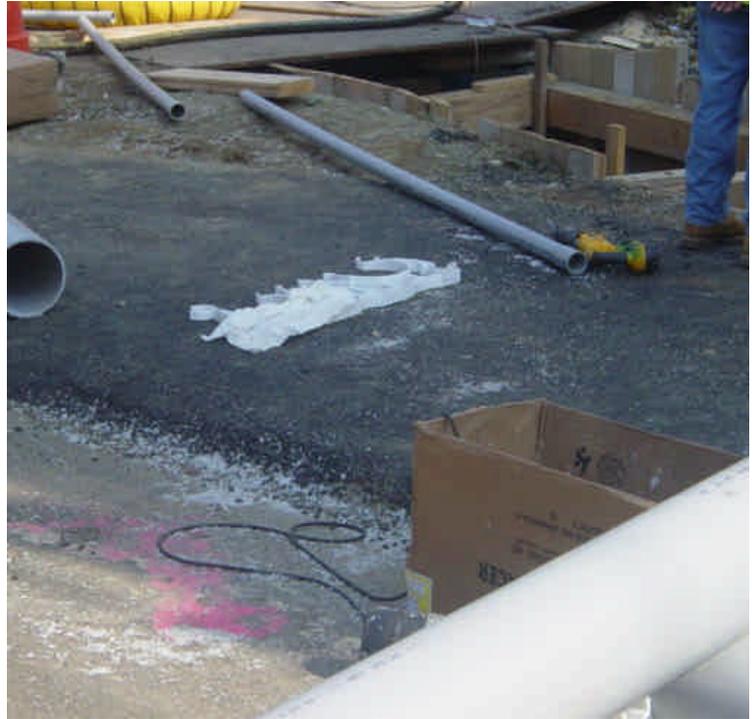
PVC shavings from conduit installation at sta. #789 were observed within the roadway. Uncontained shavings have the potential to enter a waterway via stormwater run-off to a nearby catch basin.

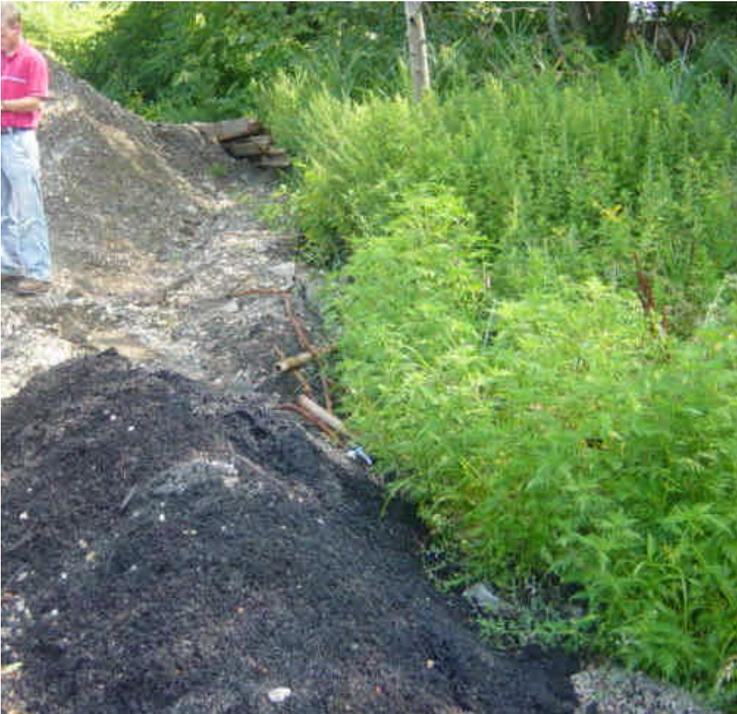
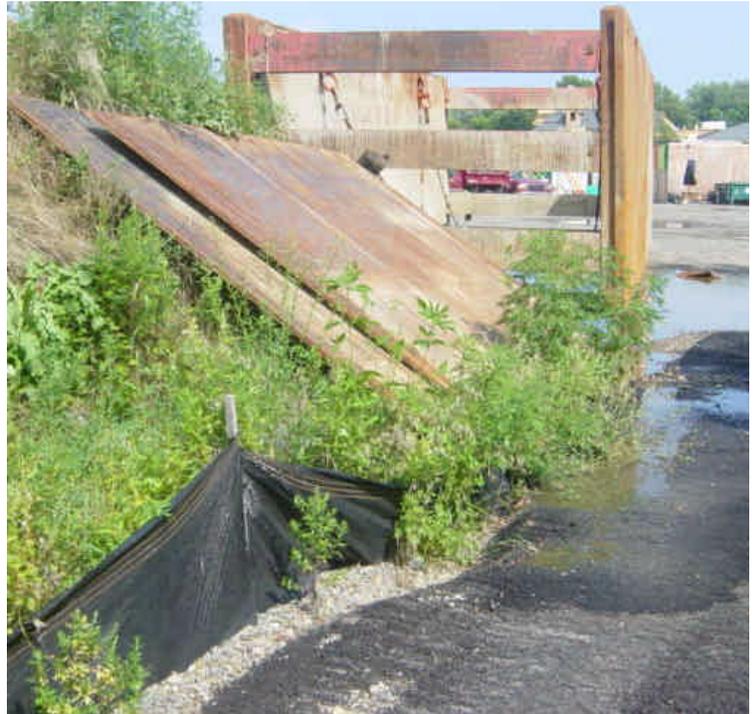
Both photos were taken within the King's Highway lay-down yard. Materials were observed overwhelming perimeter barrier controls in two locations.
