Docket No. 272 – Development and Management Plan Inspection

The Connecticut Light and Power Company Certificate of Environmental Compatibility and Public Need for the construction of a new 345-kV electric transmission line and associated facilities between Scovill Rock Switching Station in Middletown and Norwalk Substation in Norwalk, Connecticut, including reconstruction of portions of existing 115-kV and 345-kV electric transmission line, the construction of Beseck Switching Station in Wallingford, East Devon Substation in Milford, (and Singer Substation in Bridgeport), modifications at Scovill Rock Switching Station and Norwalk Substation, and the reconfiguration of certain interconnections.

Segment 4b Underground Line

Date: August 2, 2007

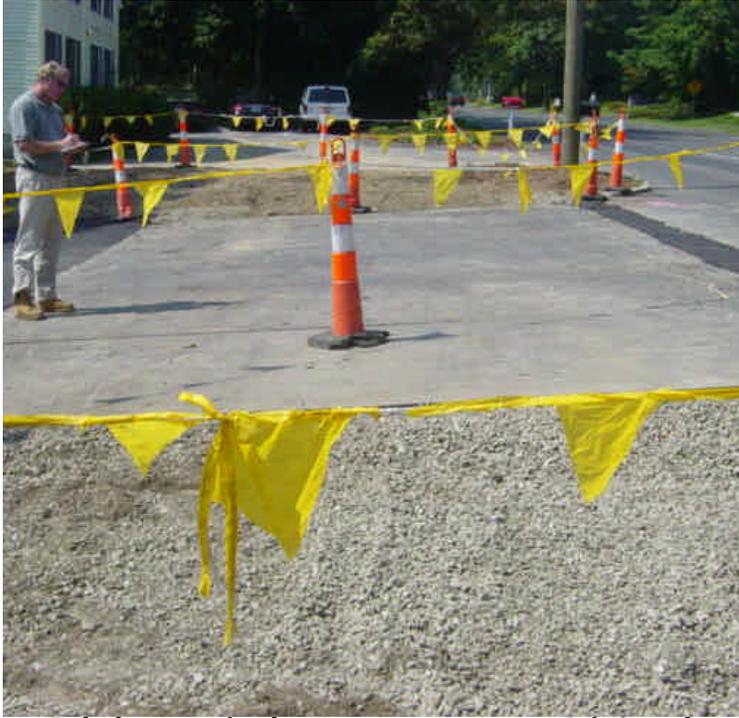
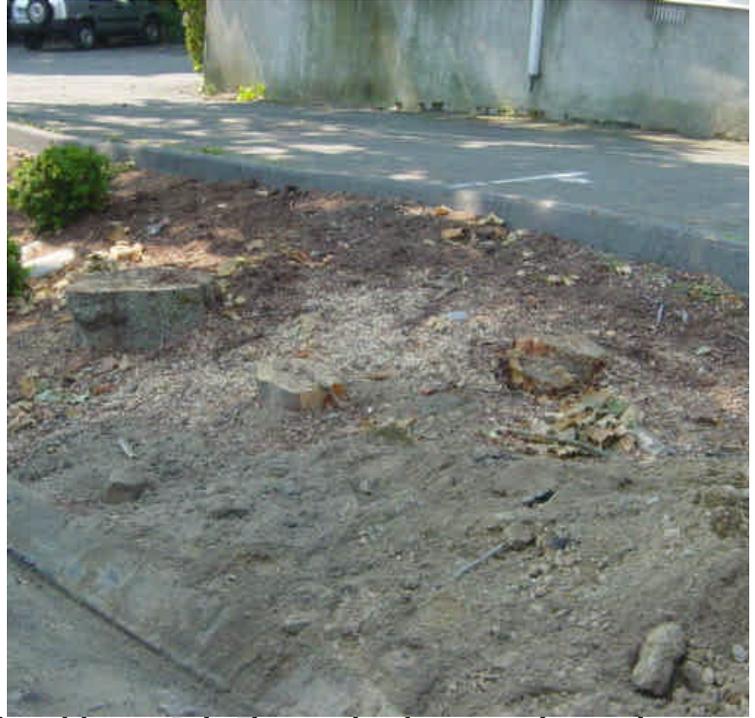
Both photos are of vault #12 construction activities. Left: General view of the vault location. Right: Three trees have been removed in accordance with the D & M Plan to accommodate trenching activities. The D&M plan recommends installation of erosion controls in this location to prevent sediment migration. Catch basin protection/controls should also be installed down gradient of activities (behind building).

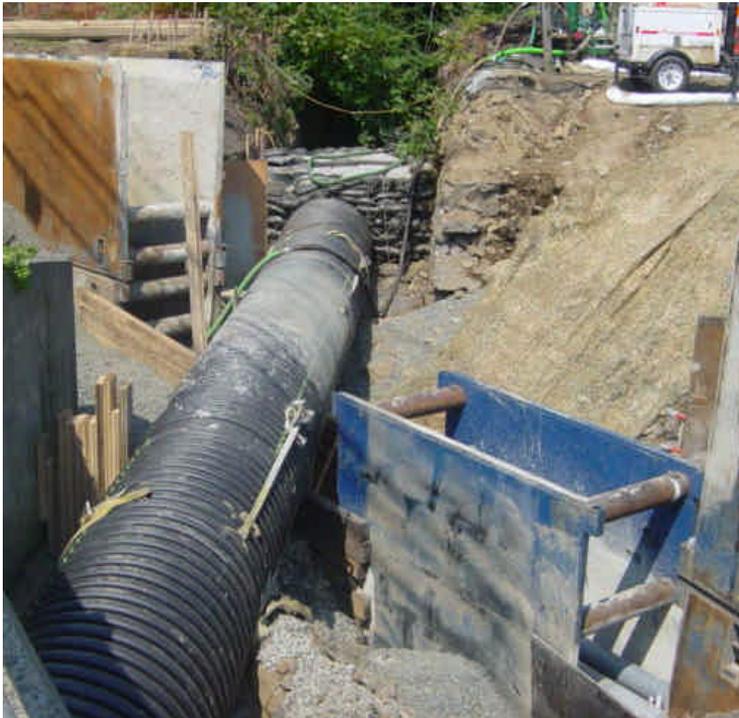
Photo of Stony Brook flow being diverted through a flume during construction activities. Exposed slopes on either side of the brook have been stabilized with erosion control blankets. The trench was being dewatered during the inspection.

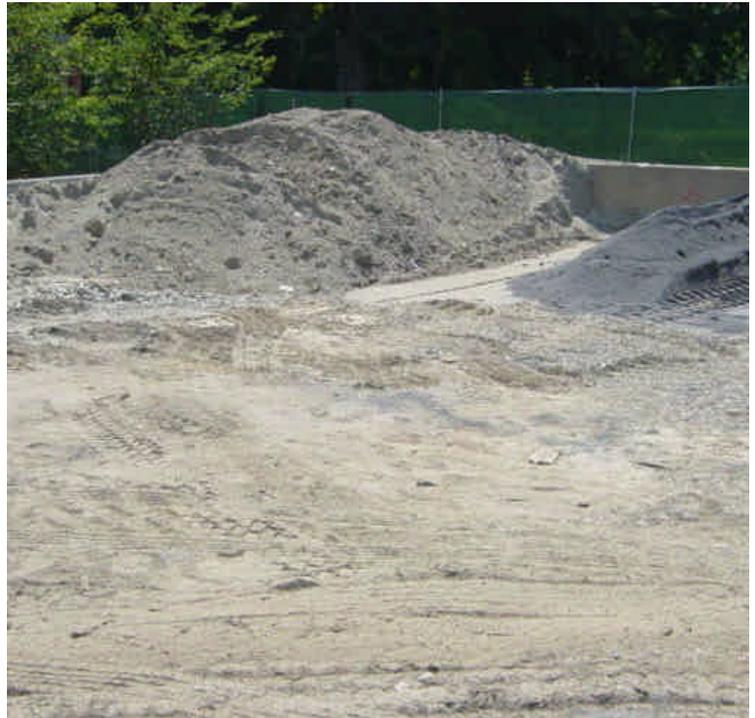
Slurry from the sweeper within the Sherwood Island lay-down yard has been removed.
