Docket No. 272 – Development and Management Plan Inspection

Segment 4b Underground Line

Date: August 8, 2007

Location: Fairfield/Westport Town Line to Westport Avenue in Norwalk

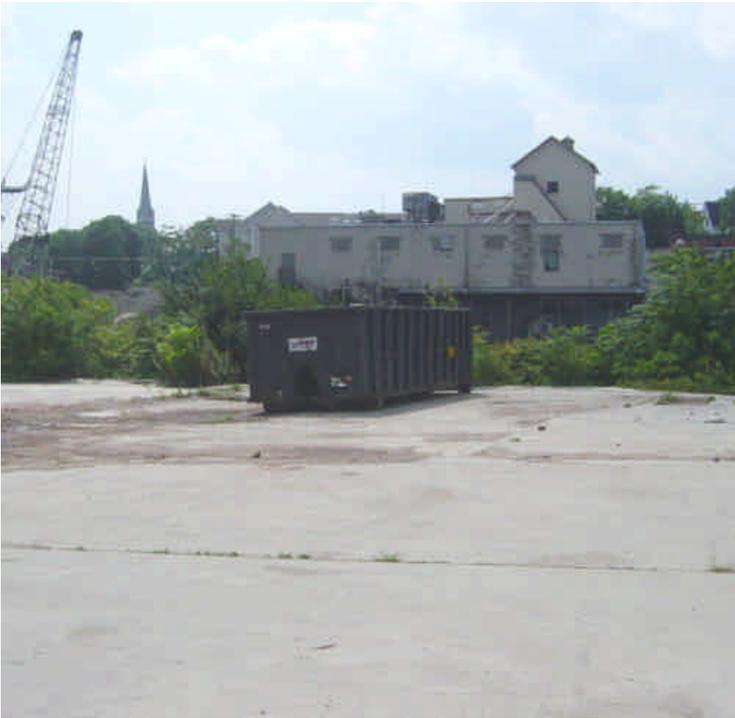
Areas of Inspection	Observation	Recommended Action	Corrected Action
	7/25-8/08/07 A roll-away container was noted immediately adjacent to the gap in controls 8/8/07	Consider relocating the container if feasible. 8/8/07	
Soils	No issues with soil storage were observed at this time. 8/08/07	Continue to restore exposed soils when feasible and mitigate for dust as necessary. See access road section. 8/08/07	NA
State species of concern, threatened and endangered species.	According to the D&M plan, state-listed species are not located in this work area.	None	NA
Vegetative clearing (including trees to save or danger trees noted) or stabilization	<p>Minor amounts of soil have been exposed as part of the vault #7, #8, #19, and #20 construction activities. Portions of the exposed soil near the vaults remain stabilized with hard-pack material or mulch. 8/08/07</p> <p>The area immediately adjacent to Stony Brook (sta. #217) had been grubbed in preparation for stream crossing activities (7/25). The exposed soils on the bank remain temporarily stabilized with EC blankets. 8/08/07</p>	<p>Continue to stabilize the exposed soil. If exposed soils are not to be worked within 30 days, they should be stabilized within 7 days of the last activity. 8/08/07</p> <p>Cleared trees have been approved for removal in accordance with the D&M plan. See the Erosion Control and Inland Wetlands sections for more details 8/08/07</p>	<p>Continue to restore the areas.</p> <p>NA at this time</p>

Photo of the Norwalk lay-down yard. The Norwalk River is located directly adjacent to the roll off container. Perimeter controls should be installed between the container and the resource area.

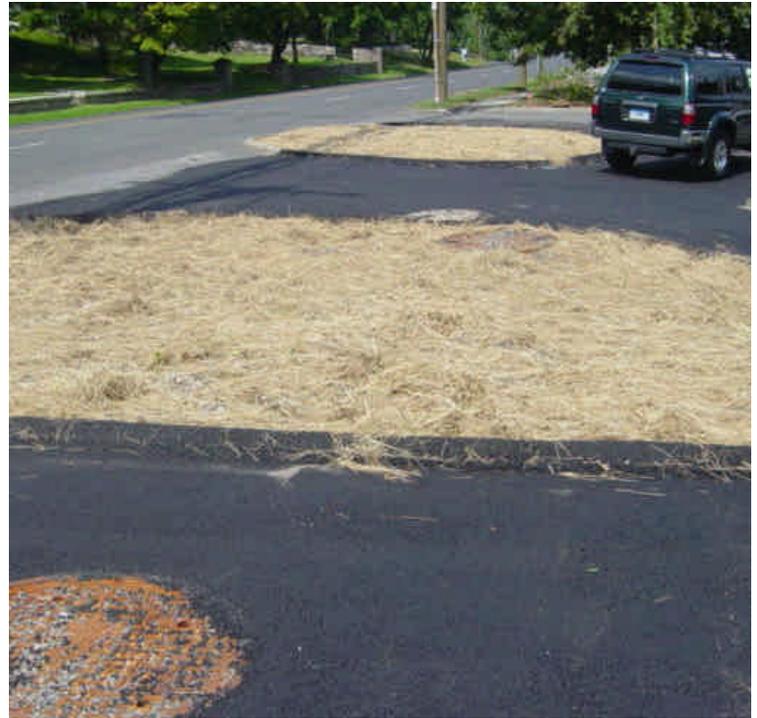
Exposed soils at vault #12 have been temporarily stabilized with hay mulch. Curbing and the adjacent area have recently been repaved. The catch basin located down gradient of the work area remains unprotected.

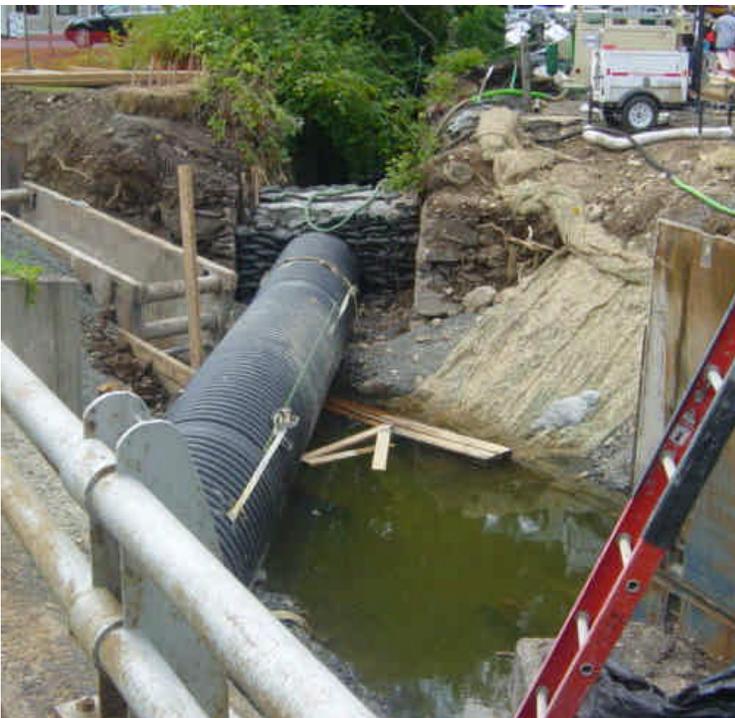
Areas of Inspection	Observation	Recommended Action	Corrected Action
	<p>seeping through the upstream stone wall and barrier. All seepage appeared to have stopped at the time of inspection. 8/08/07</p> <p>The Norwalk River is located immediately to the west of the contractor yard on Smith St. in Norwalk. 8/8/07</p>	<p>See staging, storage, and parking area section. 8/2/07</p>	<p>NA</p>
<p>Staging, Storage, and Parking Areas</p>	<p>A contractor lay-down yard is located off of Kings Highway near the Rt. 1 rotary. This is being used for both 4a and 4b activities. 8/08/07</p> <p>A contractor lay-down yard originally located off of Imperial Ave. in Westport has been vacated. The chain link fence around the perimeter remains and will be used to accommodate the future directional boring activities. 8/08/07</p> <p>A contractor lay-down yard is located within Sherwood Island State Park. Multiple controls were used to stabilize the yard. Multiple pieces of equipment have been observed, stored outside the fenced perimeter of the yard (some since 6/21). 8/08/07</p> <p>A contractor lay-down yard is located at 6 Smith Street in Norwalk. The yard is bordered on the westerly side by the Norwalk River. Perimeter erosion controls were installed with the exception of one area. The yard does not appear to be active at this time.</p>	<p>See Erosion Control section section for more detail. 8/08/07</p> <p>None. 8/08/07</p> <p>Continue to monitor the one stormwater discharge point. Ensure that the yard limits are observed and review the agreement for storage 8/08/07</p> <p>Continue to properly control the yard to prevent any impacts to the Norwalk River. Remain aware of floodplain boundaries on site if any. 7/25-8/08/07</p>	<p>NA</p> <p>NA</p> <p>Needs evaluation</p> <p>NA</p>

Both photo are of the Stony Brook crossing. Left: Precipitation earlier in the day caused an increase in the flow of the Brook. Pondered water within construction area is a result of runoff, and flows seeping through the upstream stonewall and barrier. Seepage had been controlled at the time of inspection. Right: View of the outfall of the flume/diversion. A boom is being used to reduce the flow velocity.

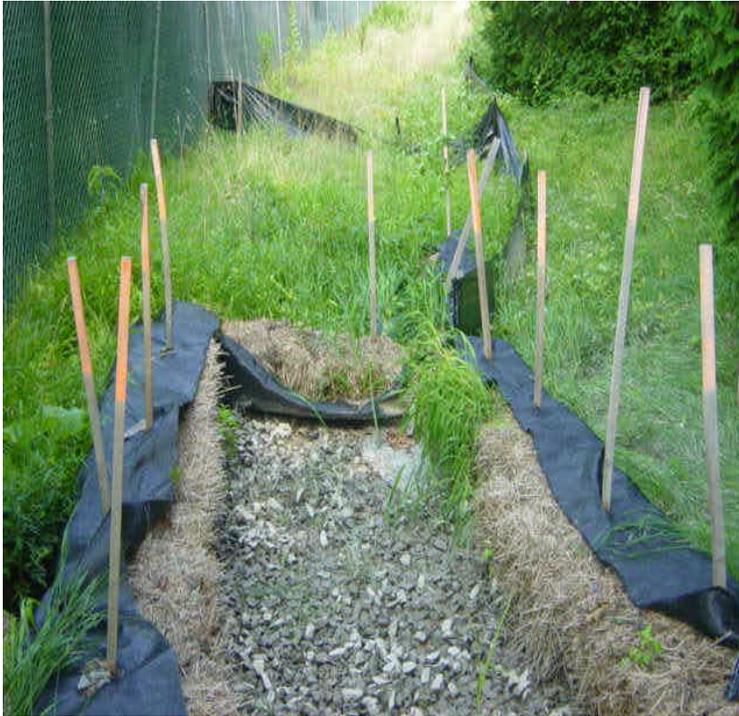
Photo of the stormwater discharge point within the Sherwood Island lay-down yard. No issues were noted with the erosion controls.

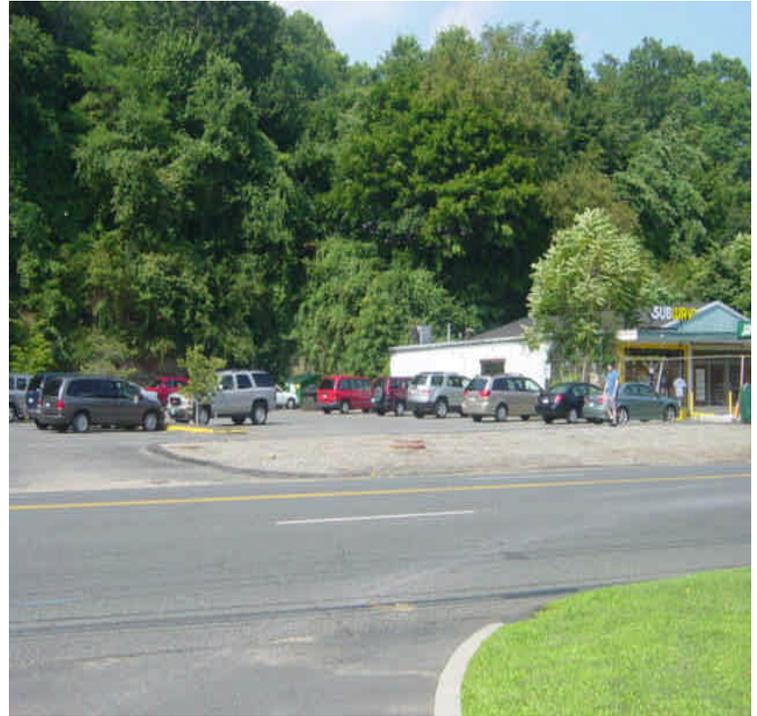
Photo of vault #20 in front of the Sherwood Diner. Exposed soils from vault continue to track/accumulate at the roadway. Install controls or further stabilize soils in order to contain them.

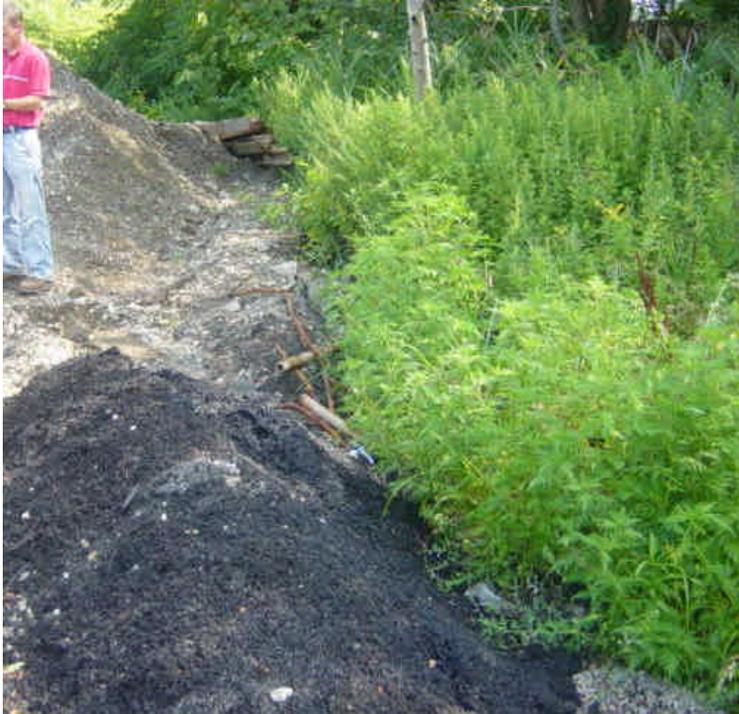
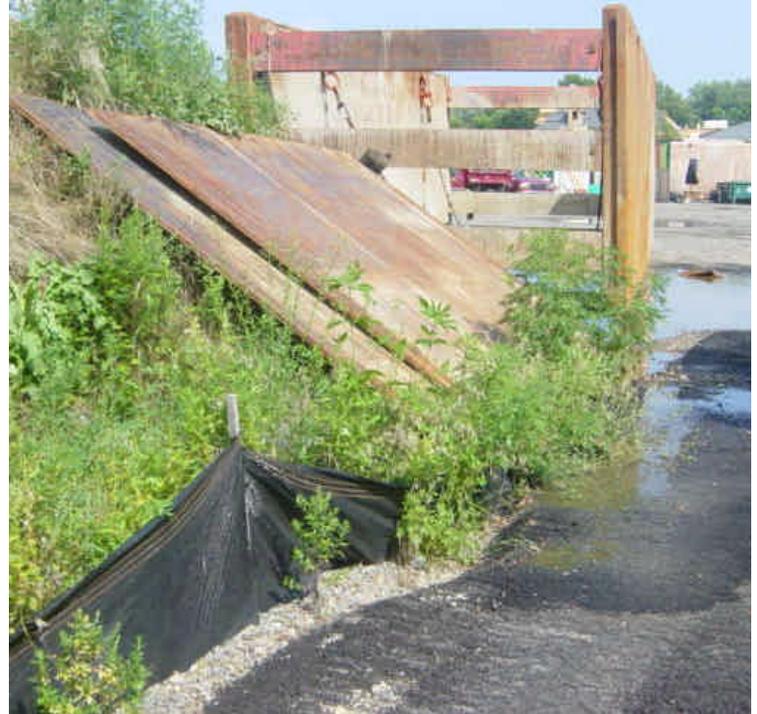
Both photos were taken within the King's Highway lay-down yard. Materials were observed overwhelming perimeter barrier controls in two locations.
