Docket No. 272 – Development and Management Plan Inspection

Segment 4b Underground Line

Date: August 15, 2007

Location: Fairfield/Westport Town Line to Westport Avenue in Norwalk

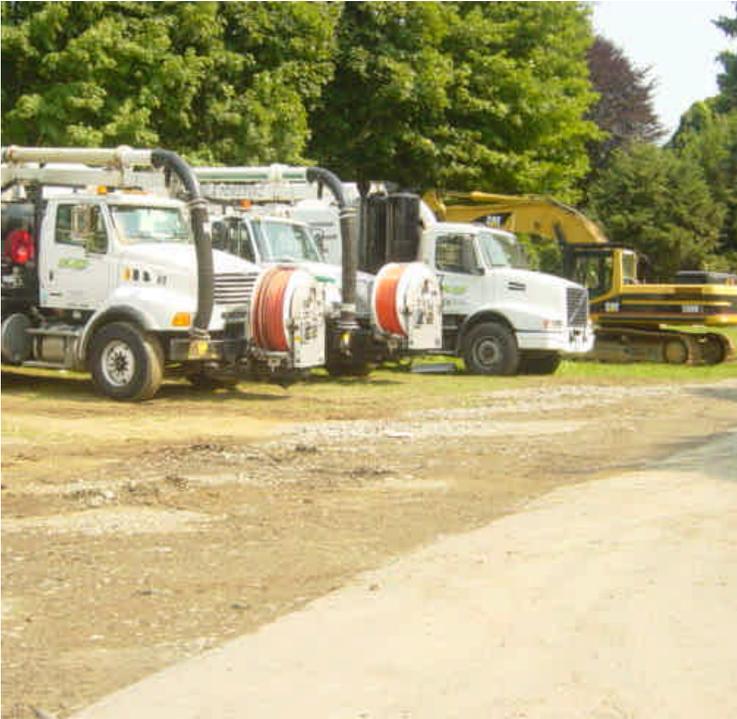
Vehicles and machinery were being stored outside of the fenced boundary of the Sherwood Island lay-down yard. Ensure that the agreement for yard use and storage allows this.

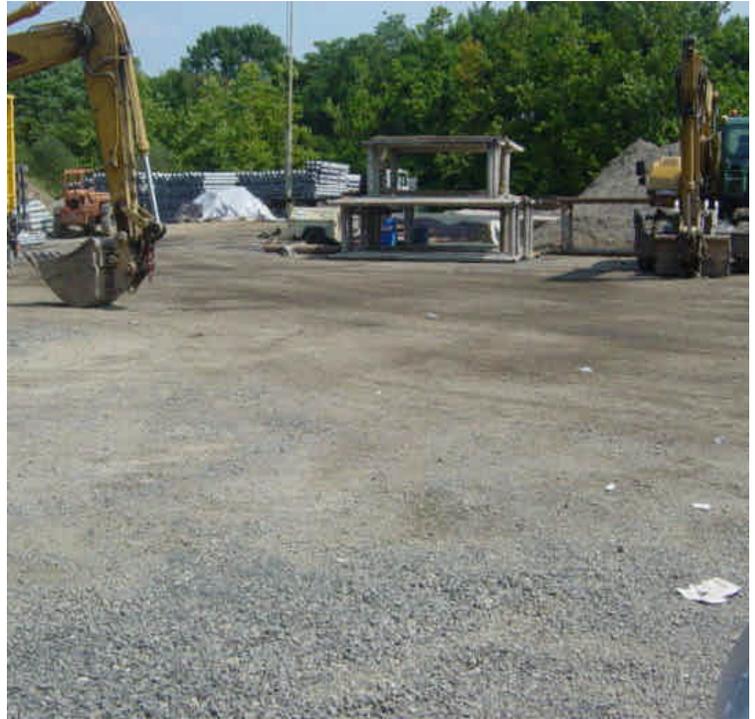
Calcium chloride has been spread throughout the King's Highway laydown yard to aid in reducing airborne dust generation.

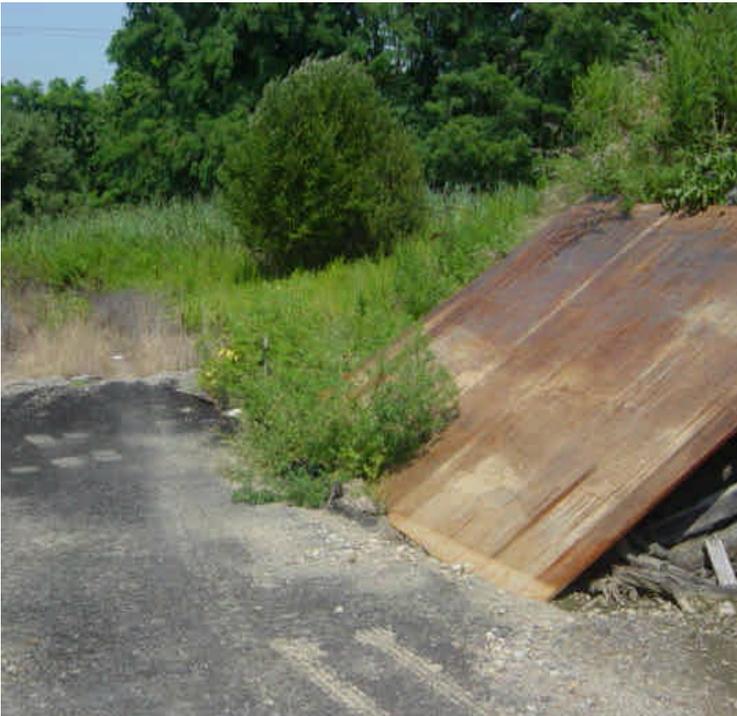
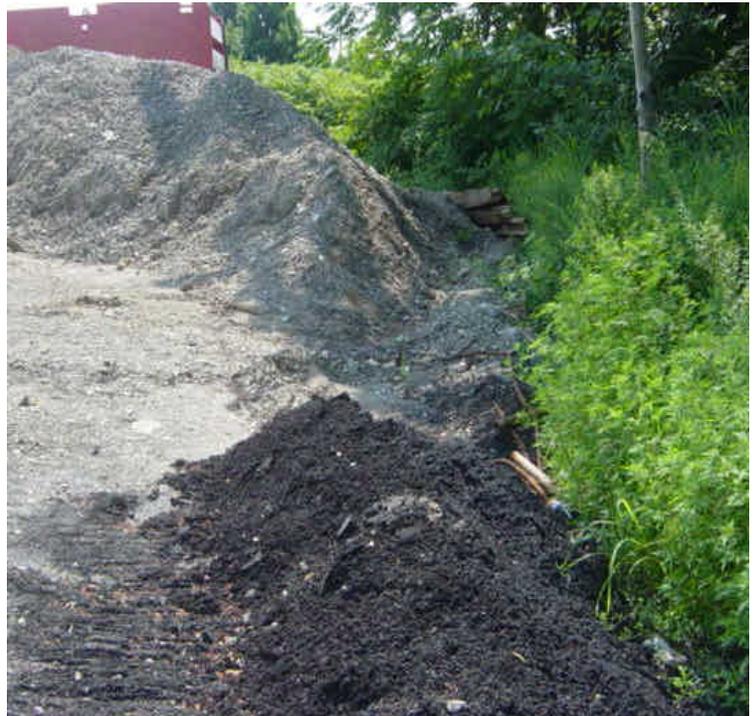
Both photos were taken within the King's Highway lay-down yard. Materials were observed overwhelming perimeter barrier controls in two locations.

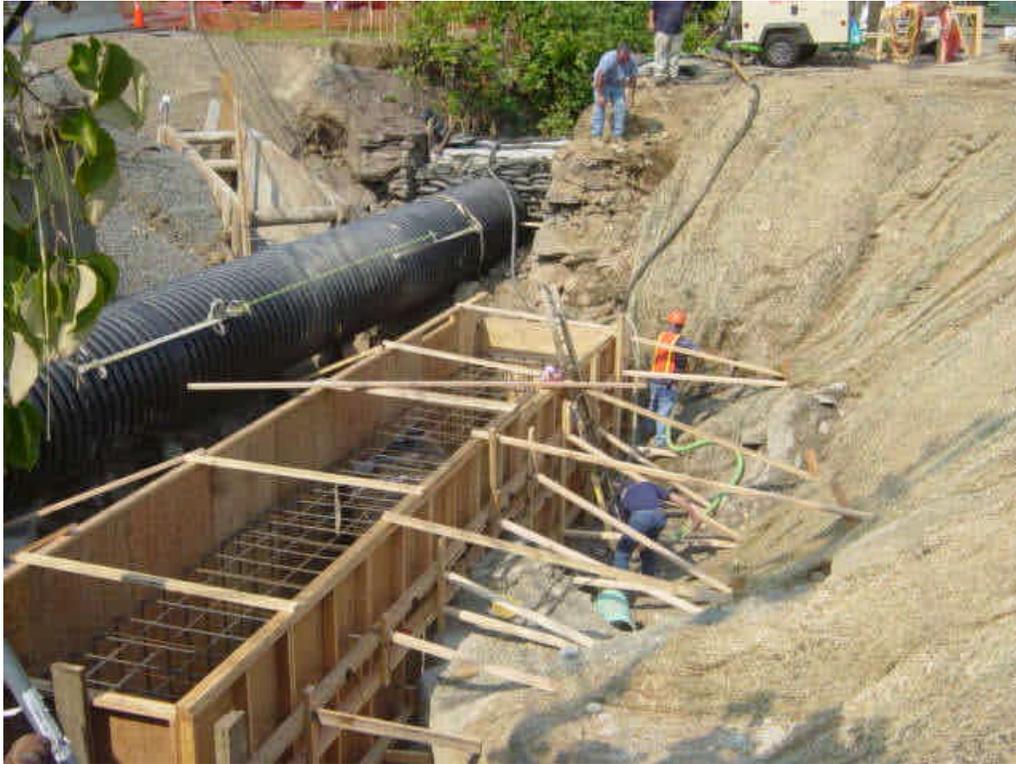
Photo of the Stony Brook crossing. Temporary work space was constructed and banks/slopes were covered with erosion control blankets. The diverted stream flow did not have sediment or turbidity issues.

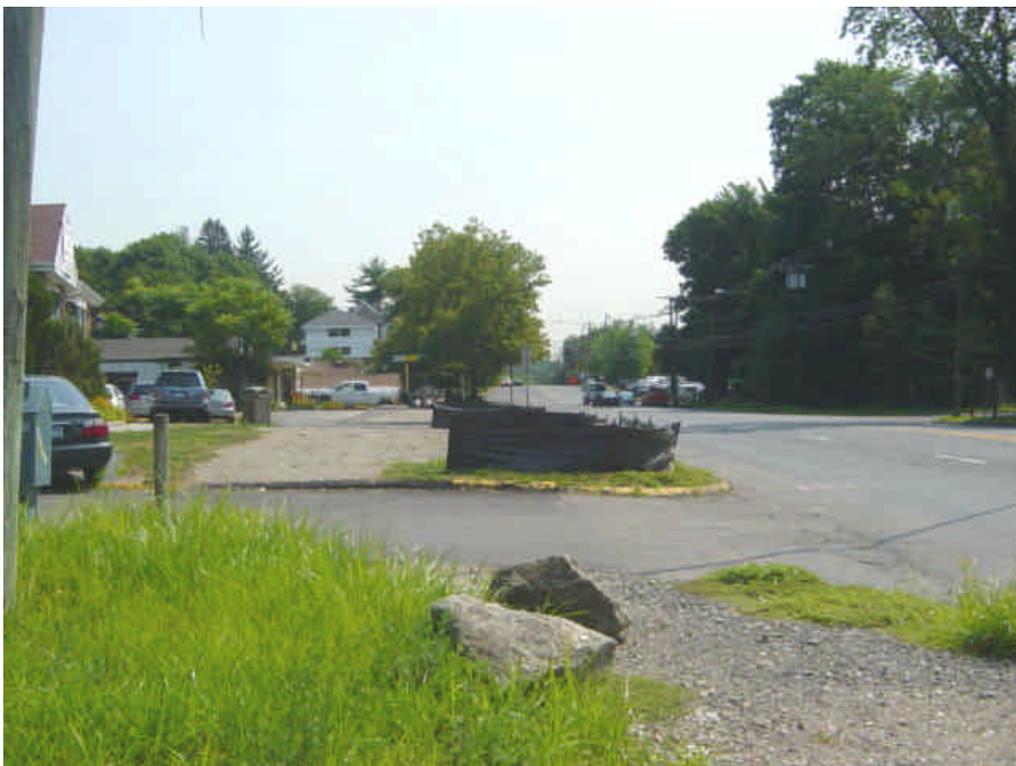
Erosion controls have been installed at vault #20 to contain exposed soil and reduce sediment migration to the roadway.
