Docket No. 272 – Development and Management Plan Inspection

Segment 4b Underground Line

Date: August 21, 2007

Location: Fairfield/Westport Town Line to Westport Avenue in Norwalk

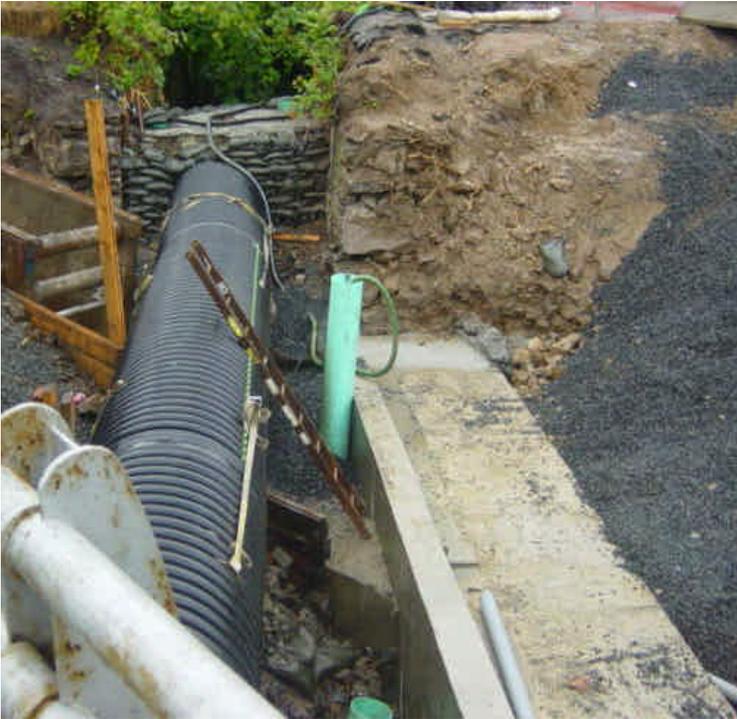
The flow of Stony Brook remains diverted past construction activities through a flume and slopes remain temporarily stabilized with erosion control blankets. 8/21/07	The area remains well controlled. See Inland Wetlands section for more details. 8/21/07	NA at this time
Kings Highway Lay-down Yard (Fairfield) (Currently being used for Segment 4a and 4b operations.)	Perimeter erosion controls are overwhelmed by stored materials in two locations at the yard. 8/8 8/21/07	Re-establish the controls where necessary. 8/8-8/21/07	Needs attention
Sherwood Island lay-down yard	The controls at the stormwater discharge point at the yard remain in place. 8/21/07	Continue to monitor and maintain the controls as necessary. 8/21/07	NA
Inland Wetland and Watercourse encroachment and mitigation	The Kings Highway lay-down yard is located adjacent to potential resource areas and a concrete	See erosion control section. 8/21/07	NA

View of the Stony Brook watercourse crossing. Flow is still being properly diverted.

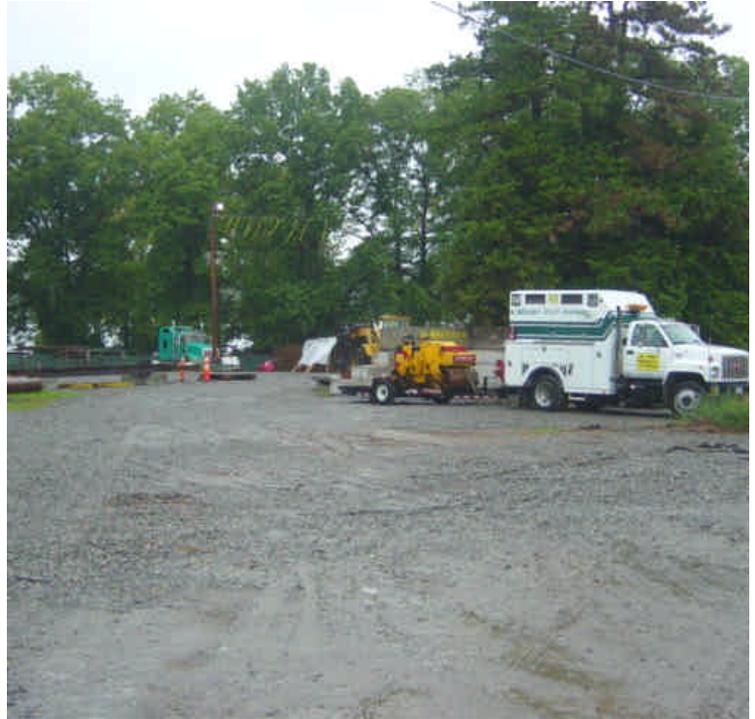
Stone has been added to a portion of the Sherwood Island lay-down yard to provide more room for storage and parking.

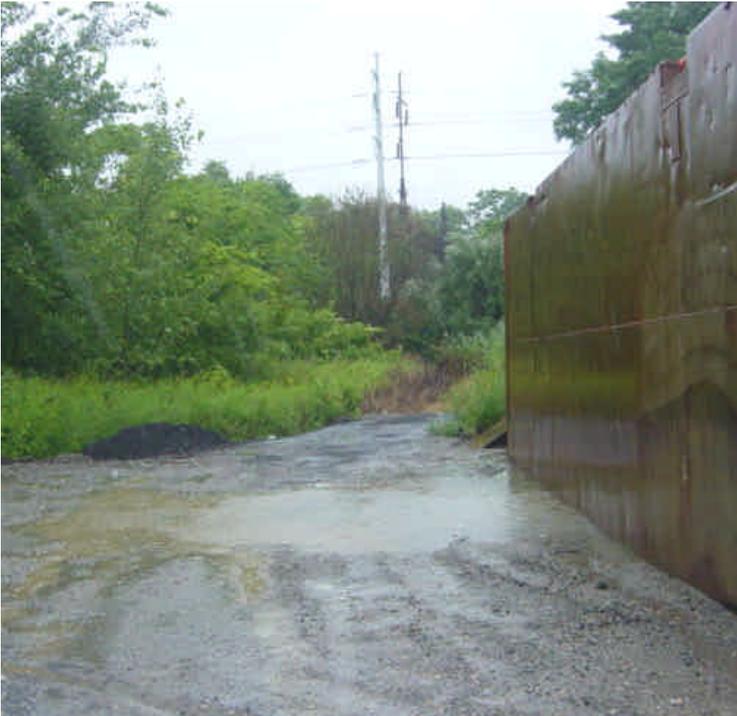
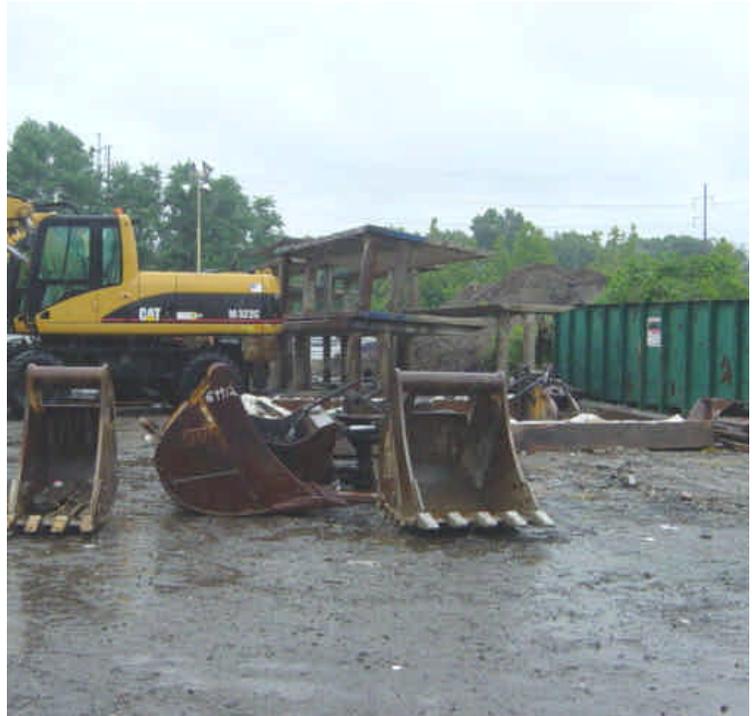
Both photos were taken within the King's Highway lay-down yard. Left: Materials were still observed overwhelming perimeter barrier controls in two locations to the left and right of photo view. Right: A fluid filled bucket/attachment was being stored just outside of the containment area but still within the yard. Continue to store fluid filled equipment proactively within the containment area.
