Docket No. 272 – Development and Management Plan Inspection

Segment 4b Underground Line

Date: August 30, 2007

Location: Fairfield/Westport Town Line to Westport Avenue in Norwalk

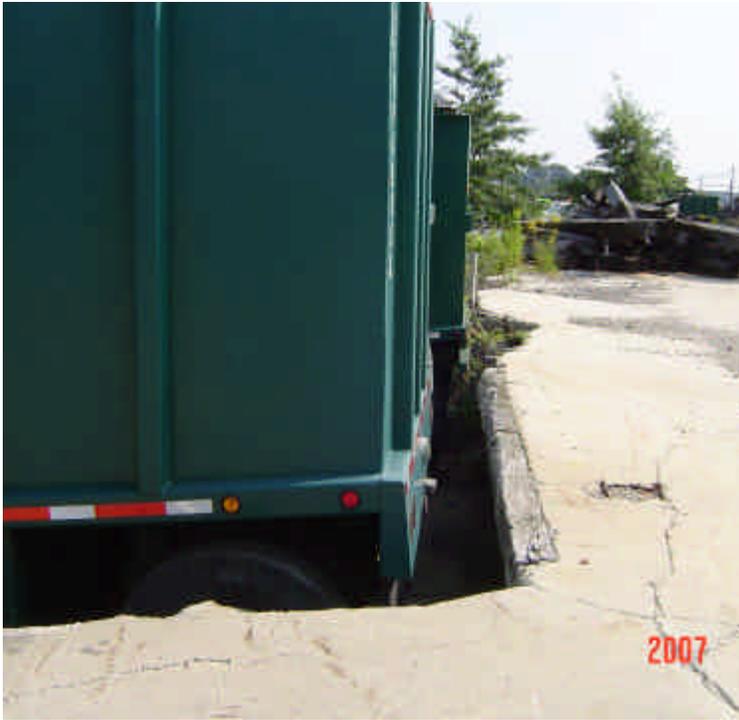
View of the Norwalk storage yard shared by 4b and 4c contractors. Frac tanks are stored and effectively contained in a depression/pit in an existing concrete loading dock.

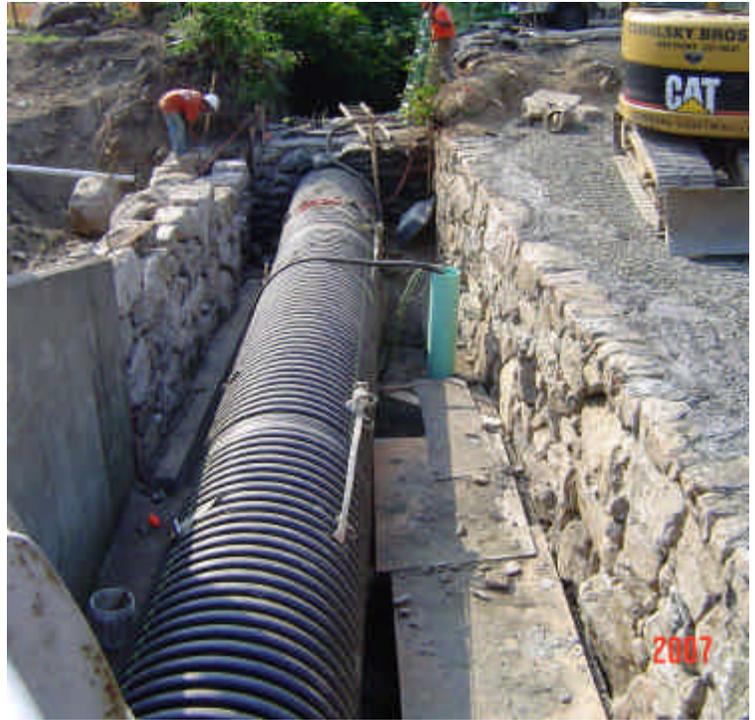
View of the Stony Brook crossing. The stone wall banks are being restored at this time. Water is still effectively diverted through the fume.

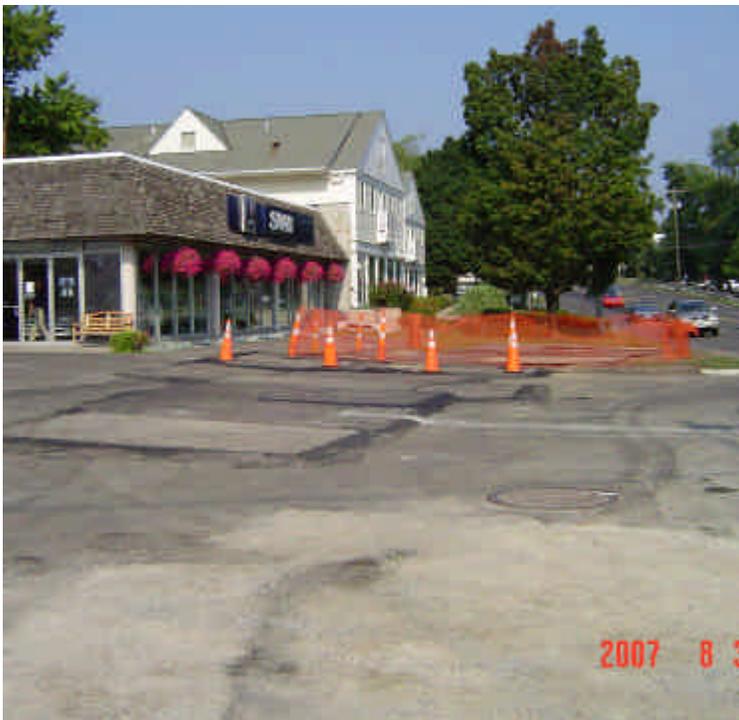
View of active trench work and plates just east of the Stony Brook crossing.

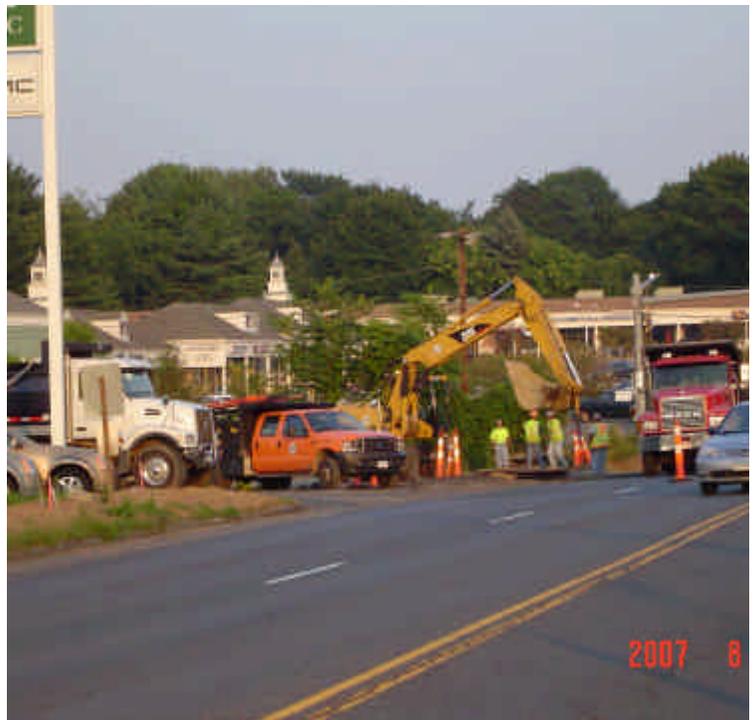
View of crews setting up for the evening near Vault #18. Trench work up to the vault was occurring. A vac truck was in place.

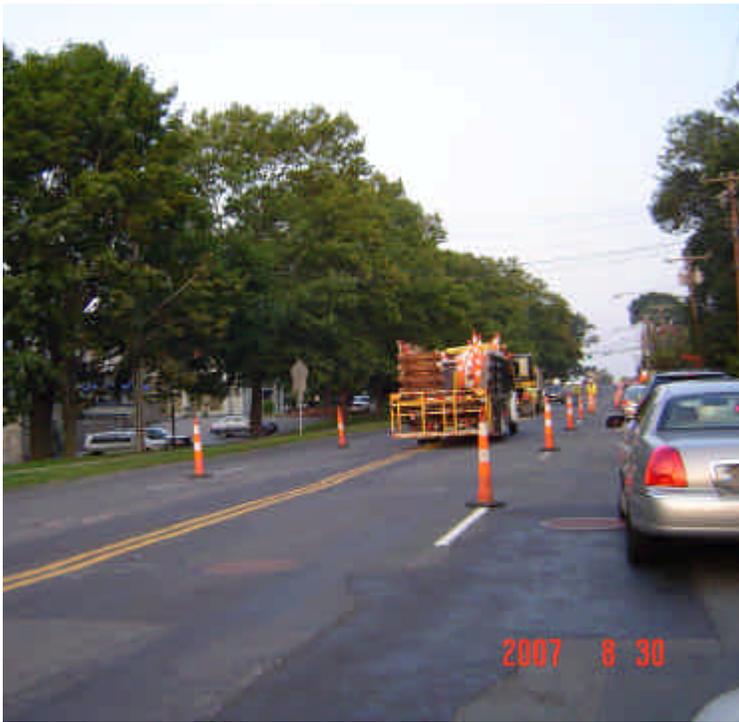
View of crews setting up traffic patterns for evening work along Rt 1 in Westport.

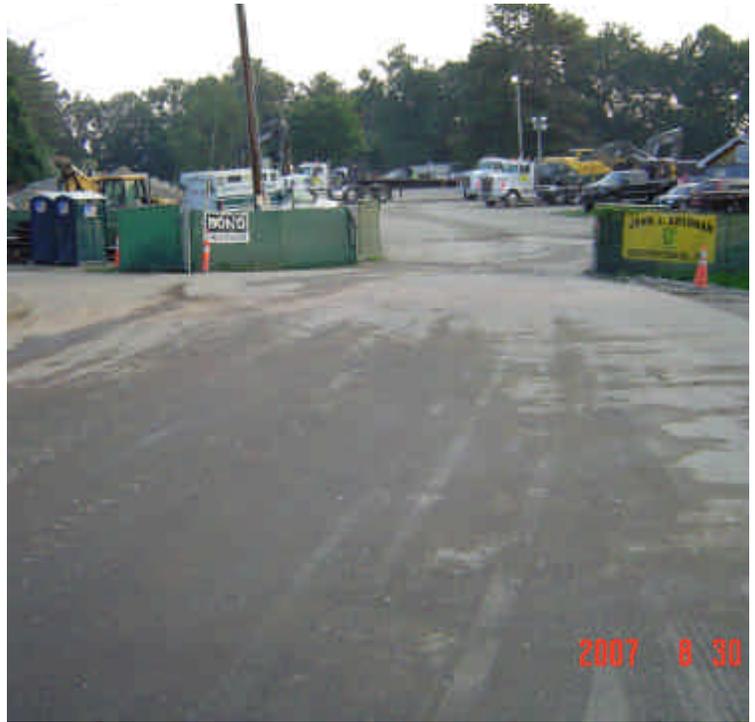
View of the entrance to the Sherwood Island lay-down yard. The access was recently swept and watered for dust control. Ensure run-off does not reach adjacent catch basins at the main park road.

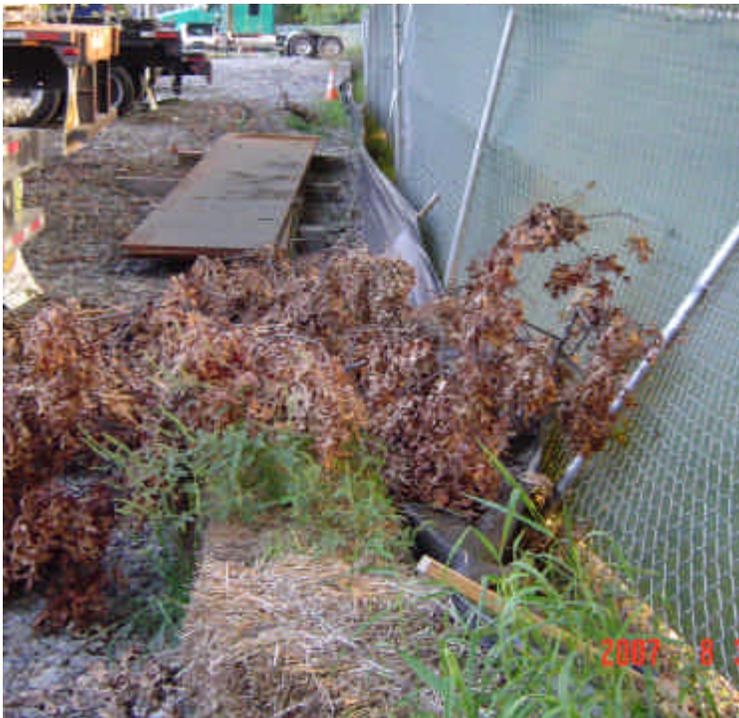
Areas of Inspection	Observation	Recommended Action	Corrected Action
Sherwood Island lay-down yard	<p>8/30/07 The yard was not observed this week so we could not confirm whether repairs were made. 8/30/07</p> <p>The controls at the stormwater discharge point at the yard remain in place but a tree branch has fallen on the silt fence at the rear of the yard. 8/30/07</p>	Continue to monitor and maintain the controls as necessary. Remove the branch and reestablish the small section of silt fence. 8/30/07	Needs some maintenance.
Inland Wetland and Watercourse encroachment and mitigation	<p>The Kings Highway lay-down yard is located adjacent to potential resource areas and a concrete lined waterway. The Norwalk yard is bound on the westerly side by the Norwalk River. 8/30/07</p> <p>Stony Brook is currently diverted/flumed to accommodate construction activities. A boom was in place during the inspection to aid in reducing the velocity of flow at the outlet of the flume pipe. Stone walls are being re-constructed along the banks. 8/30/07</p>	<p>See erosion control section. 8/30/07</p> <p>Continue to monitor activities for compliance with the D & M Plan. As trenching is completed through the stream, evaluate whether a trench breaker or plug will be needed to prevent flow from leaving the stream channel underground. 8/30/07</p>	<p>NA</p> <p>Needs evaluation.</p>

Both photos were taken at the Sherwood Island lay-down yard. Left: A branch fell on the controls, damaging the silt fence. Restore when feasible. Right: An excavator was being stored just outside of the yard on a trailer and a leak was noted. The material was contained to the trailer but the equipment should be repaired. Also, ensure the agreement with the park allows equipment storage outside of the yard.

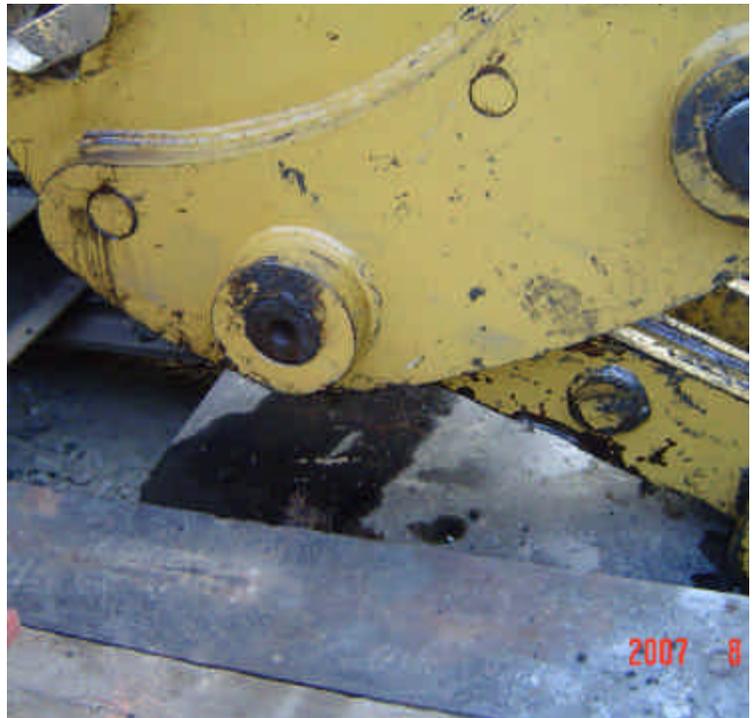
Areas of Inspection	Observation	Recommended Action	Corrected Action
	<p>the entrance to the car dealership last week. This area was not inspected this week to confirm whether materials were removed. 8/30/07</p> <p>An excavator stored on a trailer outside of the Sherwood Island yard boundaries was dripping/leaking. All material was contained to the trailer at this time. 8/30/07</p>	<p>concrete. Any concrete washout should be properly contained in an approved location. 8/30/07</p> <p>Repair the equipment and provide controls. See the storage yard section and determine whether equipment should be stored outside the yard. 8/30/07</p>	Needs attention.
Additional Observations	None 8/30/07	None 8/30/07	NA
