**Docket No. 272 – Development and Management Plan Inspection**

**Segment 4c Underground Line**

Date: August 30, 2007

Location: Westport Avenue to the Norwalk Substation in the City of Norwalk

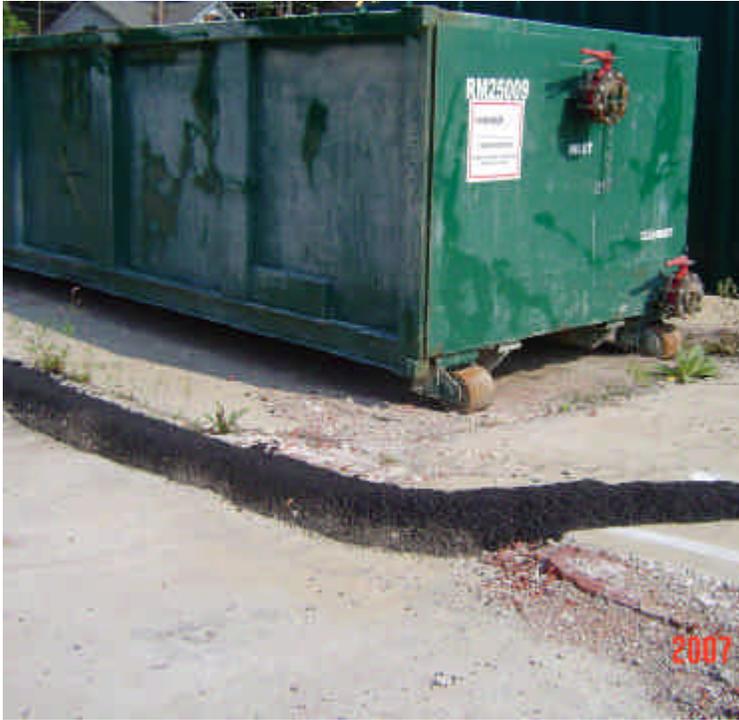
Both photos show the Smith St. Norwalk storage yard. Left: An asphalt berm was installed adjacent to one of the tanks on site. Right: Most of the frac/dewatering tanks stored on site were placed in a contained depression in an old concrete dock. This is isolated from the Norwalk River.

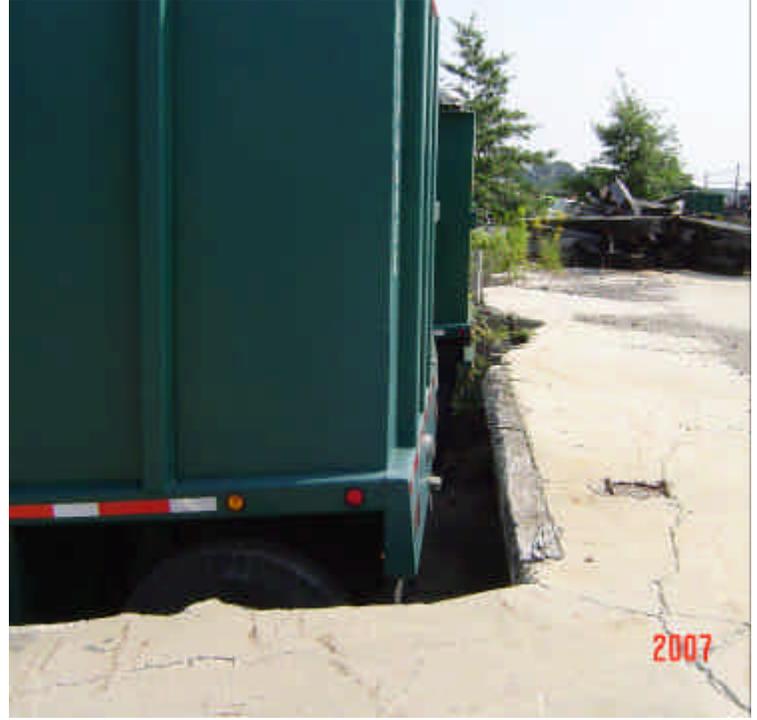
<p>Inland Wetland and Watercourse encroachment and mitigation</p>	<p>The Norwalk storage yard is bound on the westerly side by the Norwalk River. The existing concrete dock provides good containment. 8/30/07</p>	<p>See erosion control section. 8/30/07</p>	<p>NA</p>
<p>Staging, Storage, and Parking Areas</p>	<p>A contractor lay-down yard is located at 6 Smith Street in Norwalk. An existing concrete slab and depression/pit is in place which provides good containment. The yard does not appear to be active at this time. 8/30/07</p>	<p>Continue to properly isolate yard from Norwalk River to prevent any impacts to the watercourse. If any loose materials are stored on top of the slab, more controls will be needed. 8/30/07</p>	<p>Needs attention if working within exposed area</p>

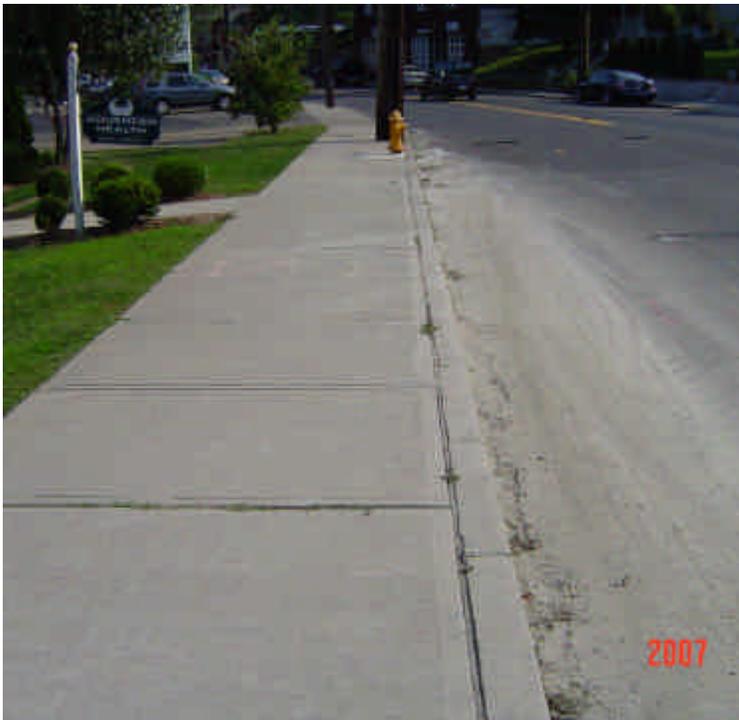
Photo on the left shows saw-cutting clurry dust on the roadway of Rt. 123 in the vicinity of Vault #4. However, the contractor's representative stated that this is likely from a different utility project since the sawcut trench was too narrow. If the work is related to Middletown/Norwalk, sweep the area and attend to the dust. Photo on the right: Vault #4 was completed within the parking lot. Very minor dust tracking was noted.

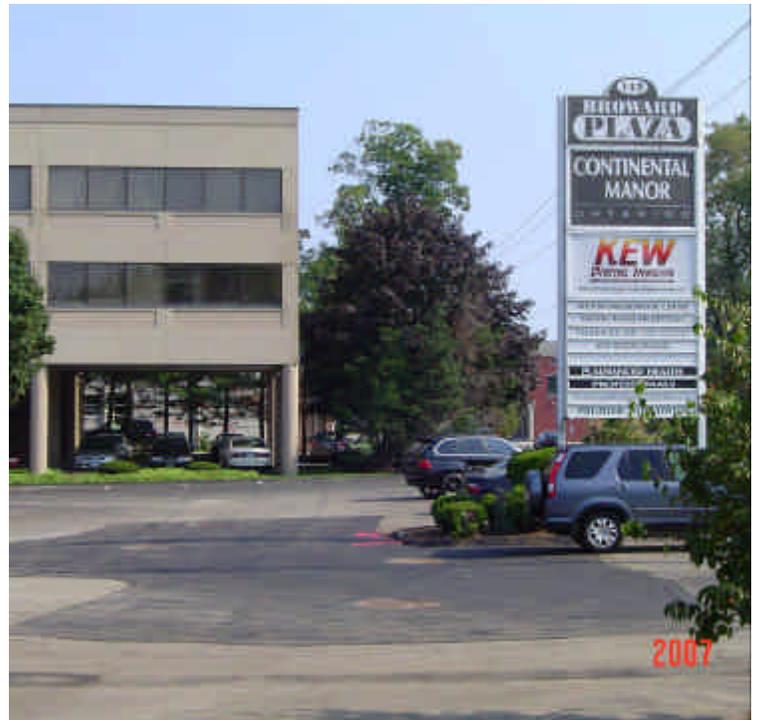
Areas of Inspection	Observation	Recommended Action	Corrected Action
Access Roads and Adjacent Roadways	All work is within existing paved roadways and parking lots at this time. 8/30/07	None. 8/30/07	NA (Not applicable)
	Very minor dust tracking was noted just off the parking lot where Vault #4 was installed. 8/30/07	In general, continue to reduce tracking and dust and sweep roadways as needed. 8/30/07	No issues noted but needs regular attention.
	Some dried saw-cut slurry dust was noted along Rt 123 in the vicinity of Vault #4 but the contractor stated that this was likely from a separate utility project. 8/30/07	Contractor stated it was not Middletown/Norwalk activities. In general, attend to slurry as it is generated. 8/30/07	NA
Vault Openings and Trench Construction Norwalk	Work had just started and was limited in this section. Vault #4 has been installed and the area was repaved within a parking lot. 8/30/07	None. 8/30/07	NA
