Docket No. 272 – Development and Management Plan Inspection

Beseck Switching Station

Date: May 11, 2006

Location: Beseck Switching Station

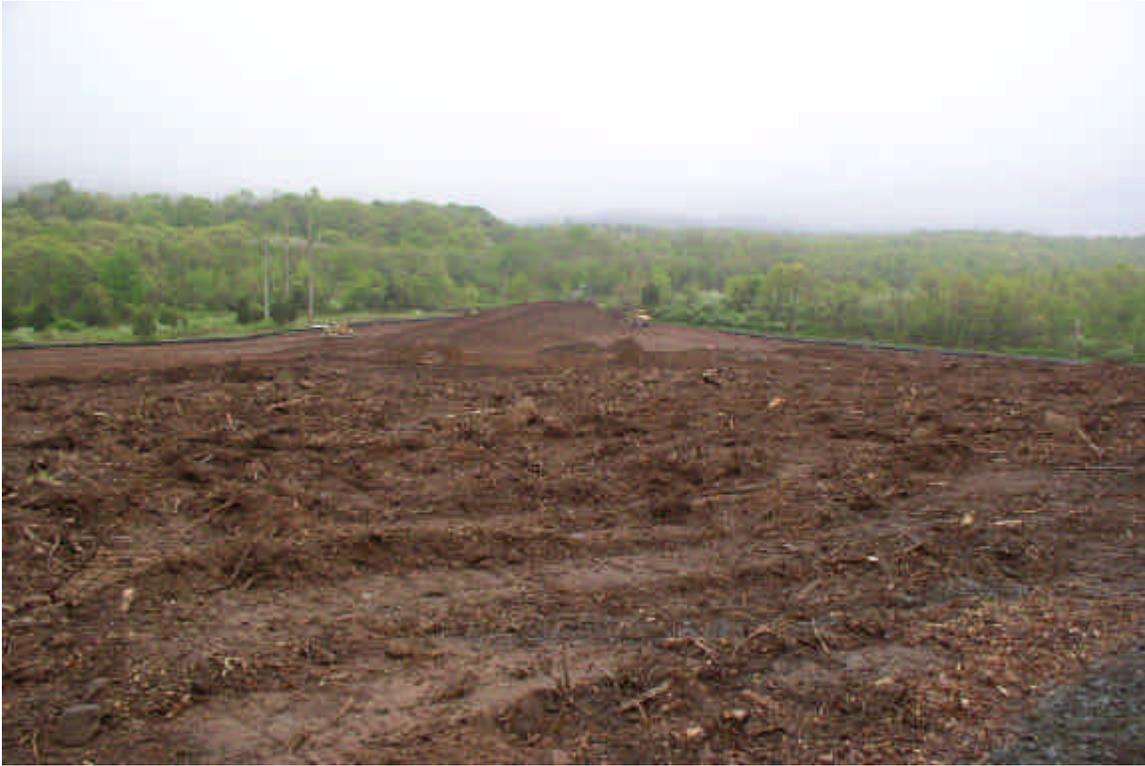
Entire site viewed from the northeast corner toward southeast.

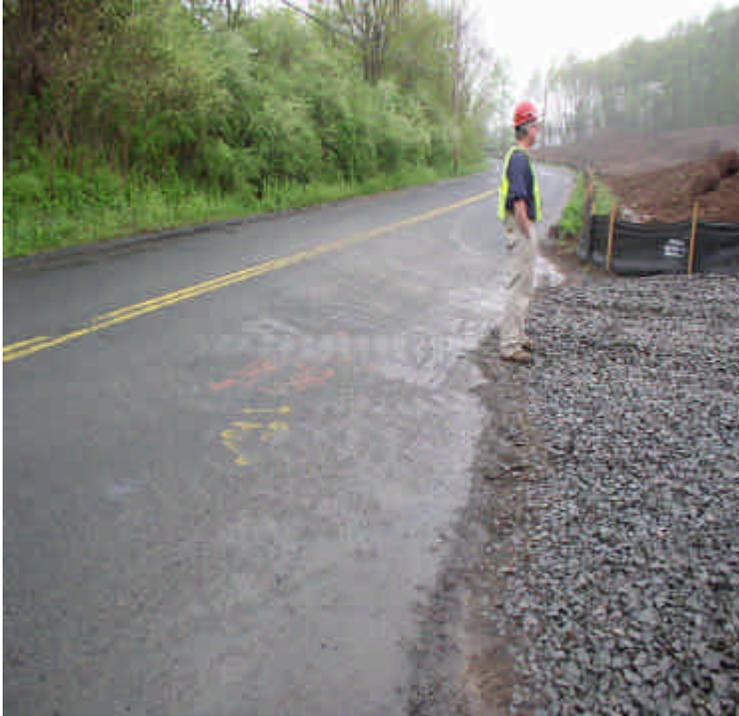
Carpenter Lane at the construction entrance. Sediment tracking was not an issue.

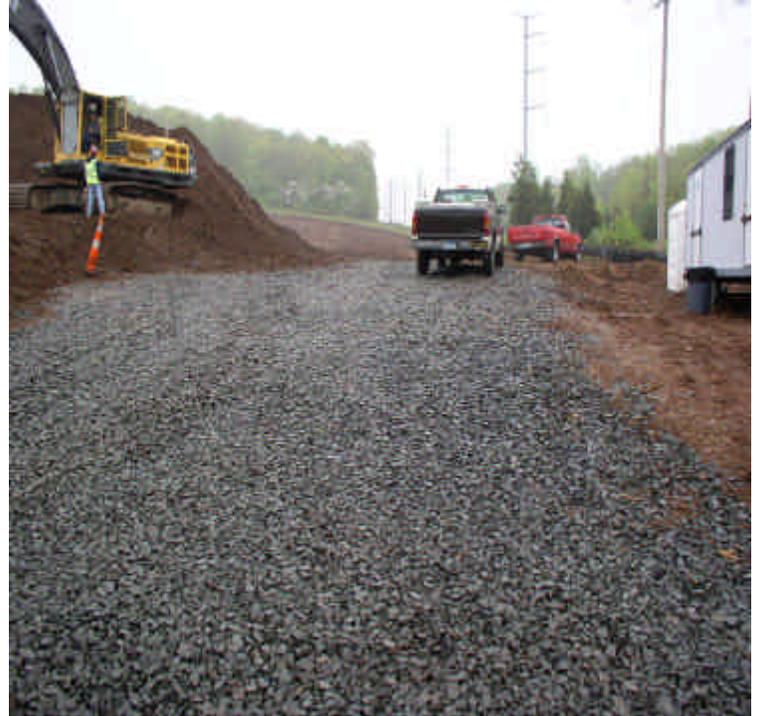
Crushed stone construction entrance.

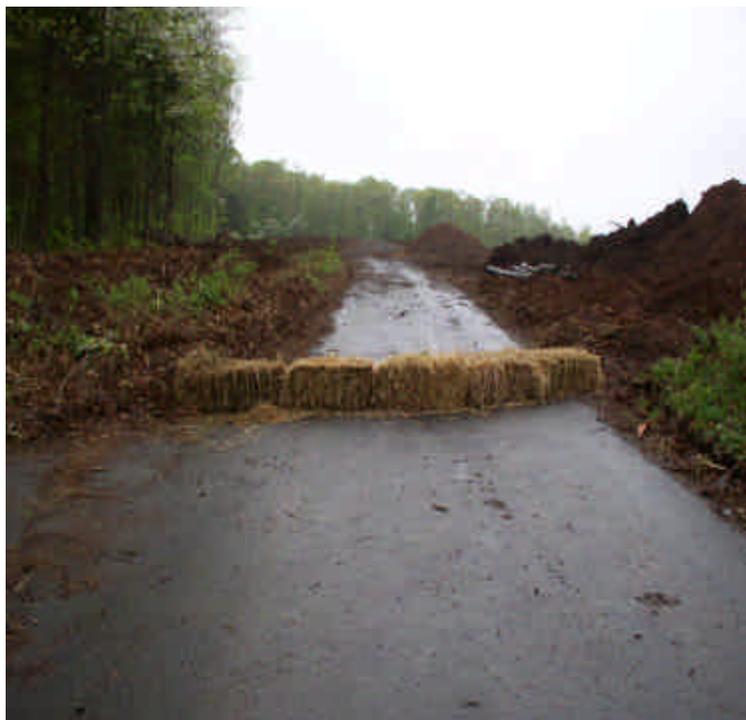
Haybales installed at western driveway to prevent run-off and sedimentation.

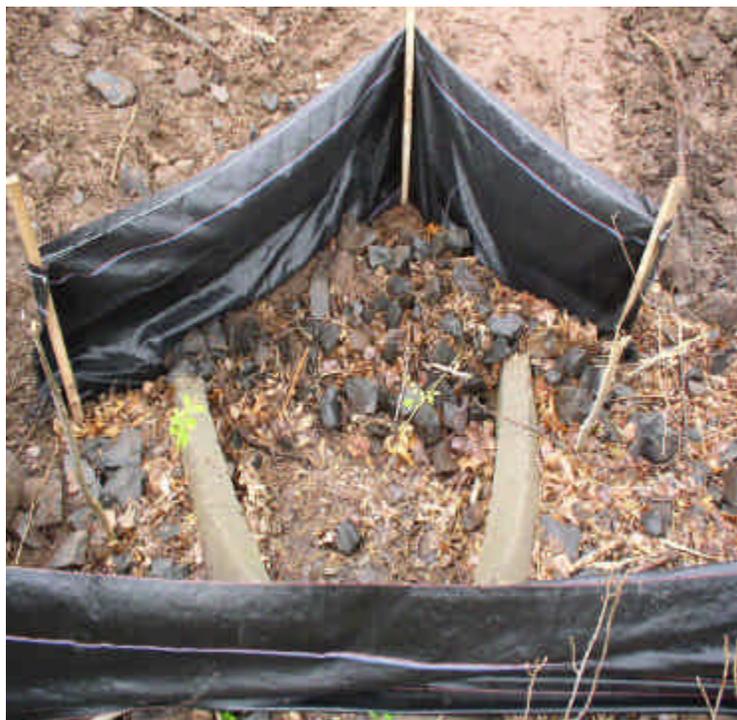
Storm drain inlet (leading to wetland across Carpenter Lane), with secondary silt fence and riprap in place.

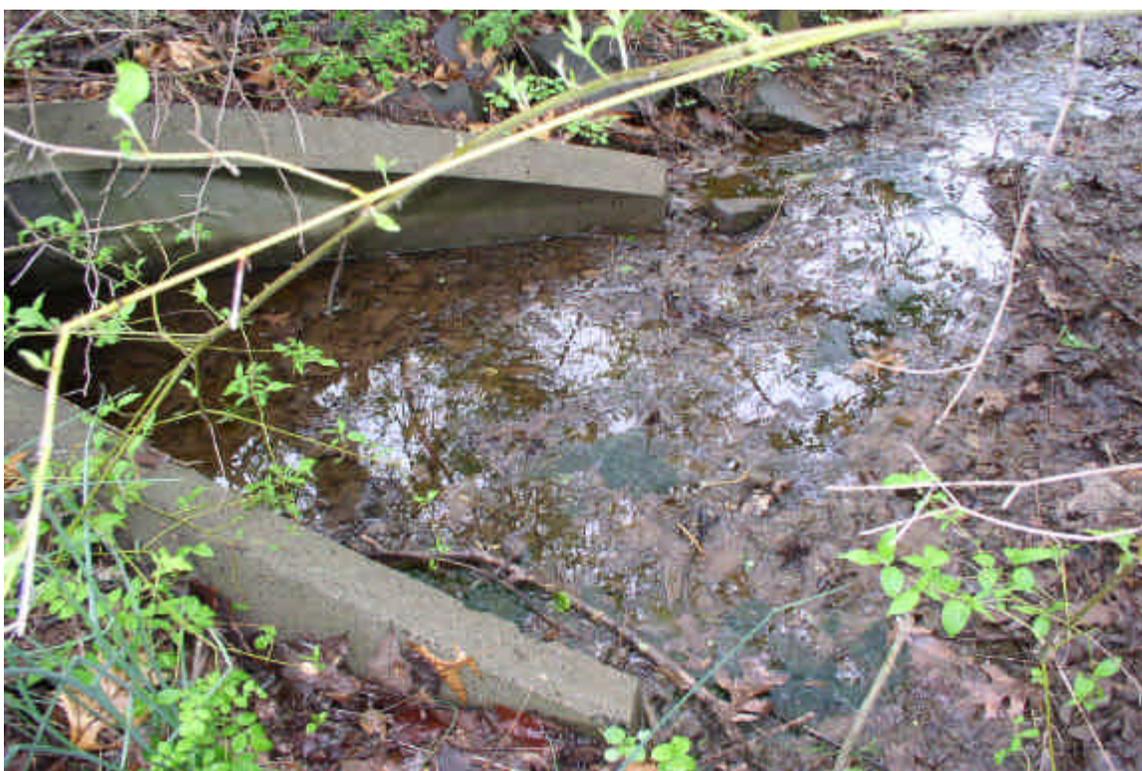
Storm drain outlet across Carpenter Lane entering the wetland area. Water was clear with no signs of turbidity.
