**Docket No. 272 – Development and Management Plan Inspection**

**Beseck Switching Station Inspection**

**Date:** August 3, 2006

**Location:** Beseck Switching Station

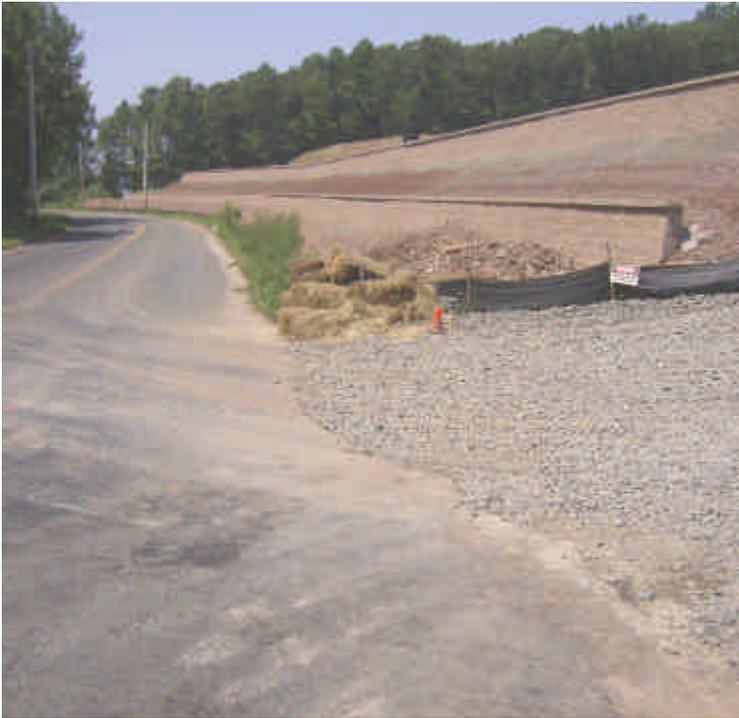
**Crushed stone construction entrance pad is mostly clean; some minor tracking was noted on Carpenter Lane and the road should continue to be cleaned/swept, including the gutters by hand if necessary (photograph courtesy of Tom Degnan)**

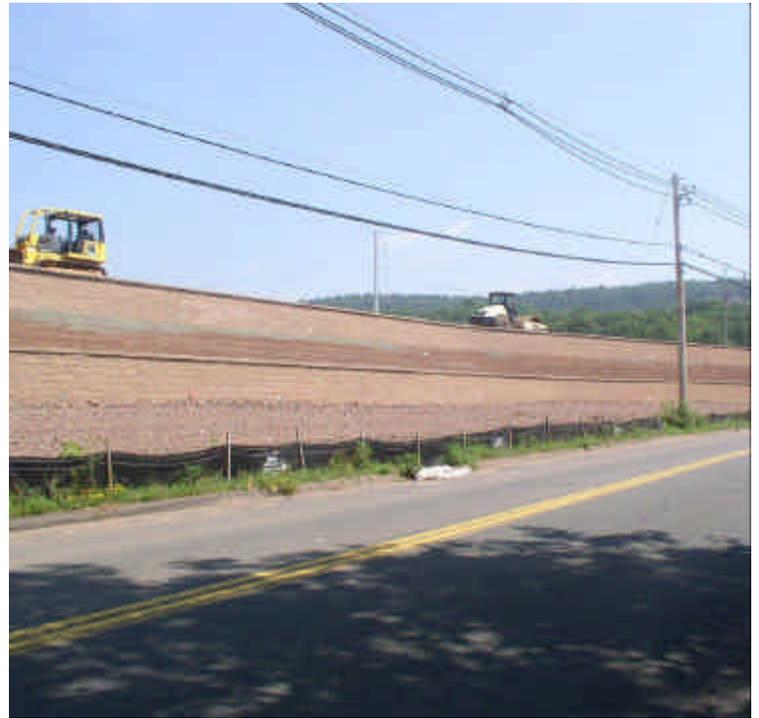
**Grading and seeding remain to be done between Carpenter Lane and retaining walls.**

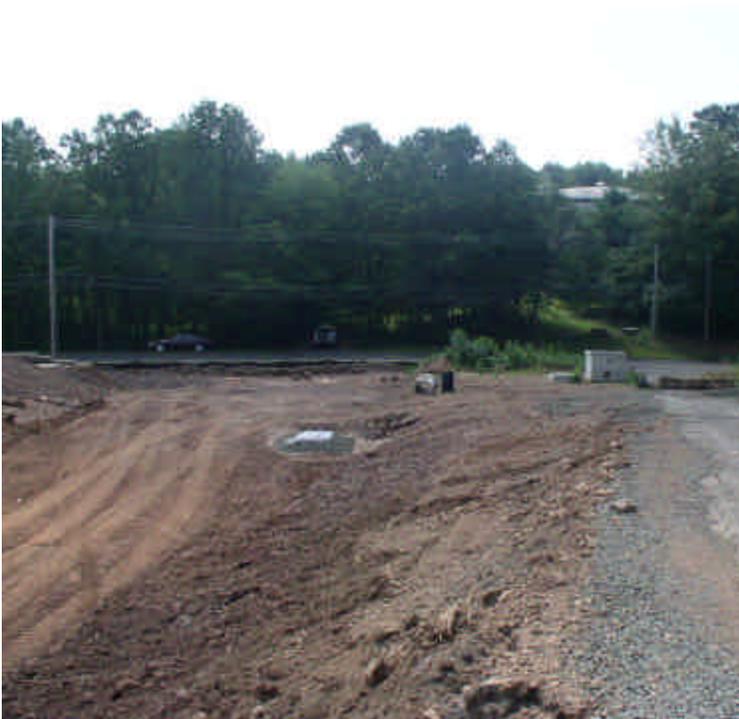
**New site entrance to be constructed in this location with a recently installed catch basin.**

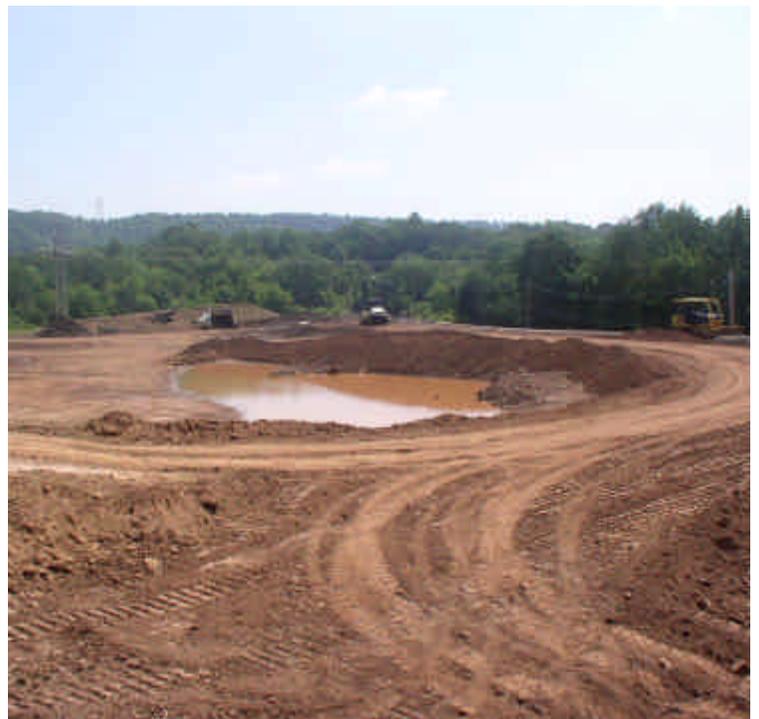
**Detention pond/settling area retaining ponded run-off.**

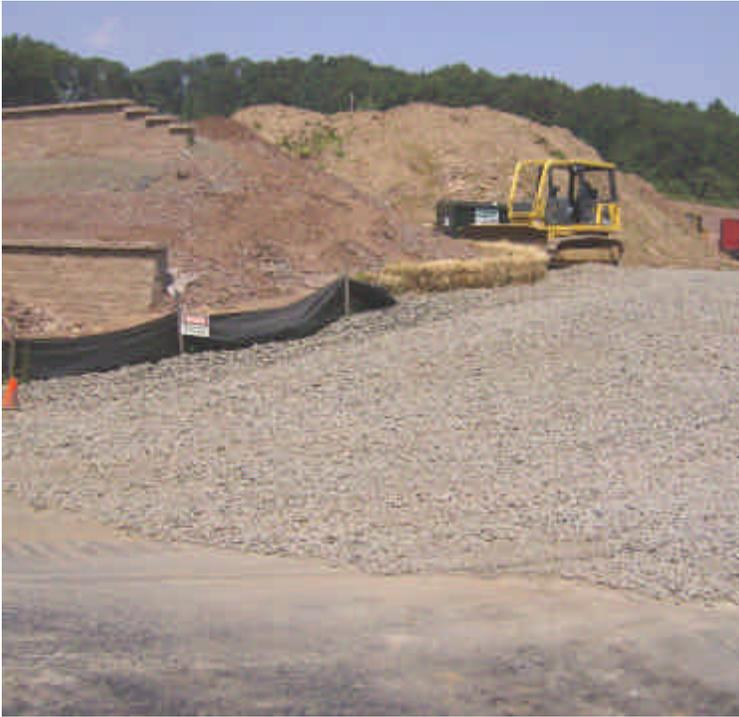
**New haybale line installed to prevent sedimentation to the stone entrance pad (photograph courtesy of Tom Degnan)**

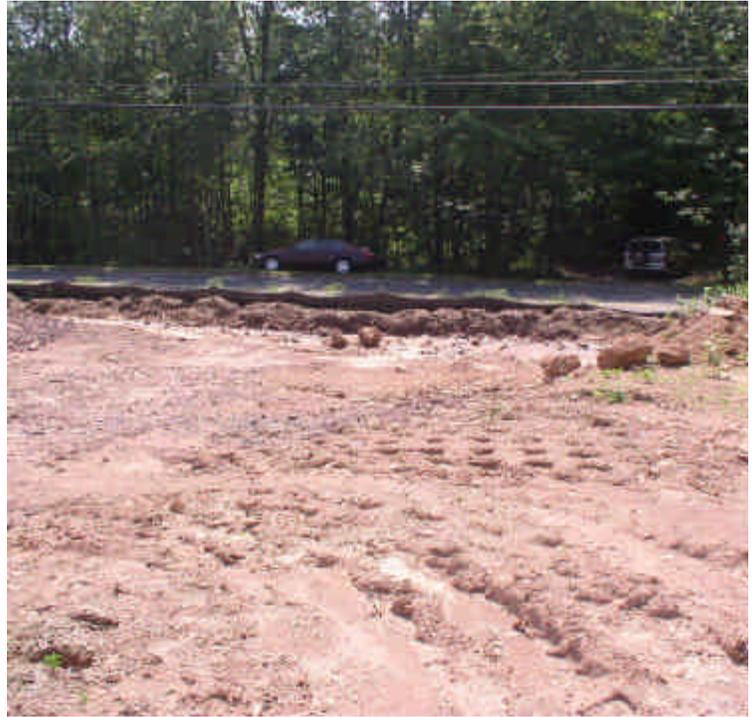
**The temporary settling area in the southwest corner of the site remains in place but holds very little water.**

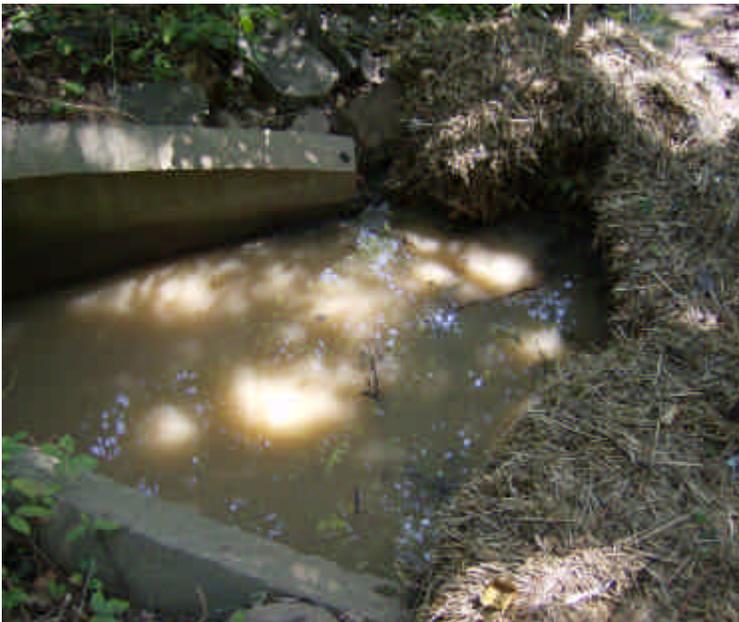
**Haybales remain staked in place for additional filtration at the storm drain outlet. Water flowing from the outlet was turbid. (photograph courtesy of Tom Degnan)**

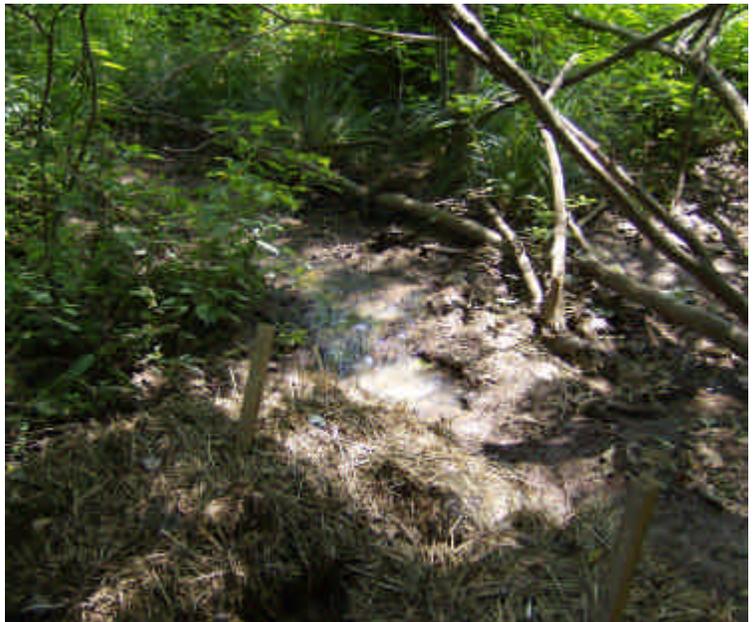
**Flow from the culvert is being filtered by haybales prior to entering the wetland. Water remains slightly turbid. Sediment accumulation from the previous rain events will be removed when dry. (photograph courtesy of Tom Degnan)**
