**Docket No. 272 – Development and Management Plan Inspection**

**Beseck Switching Station Inspection**

**Date:** August 9, 2006

**Location:** Beseck Switching Station

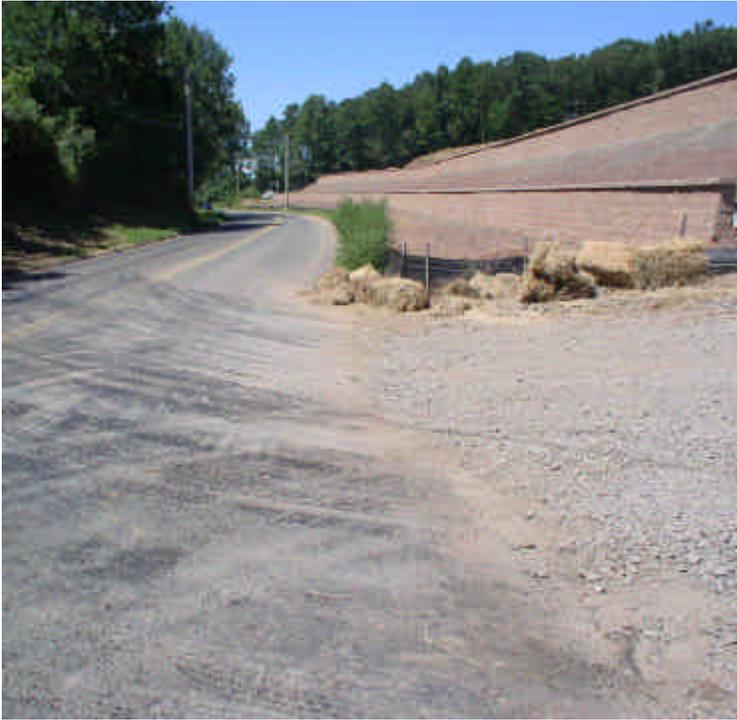
**Crushed stone construction entrance pad is mostly clean; some minor tracking was noted on Carpenter Lane and the road should continue to be cleaned/swept, including the gutters by hand if necessary.**

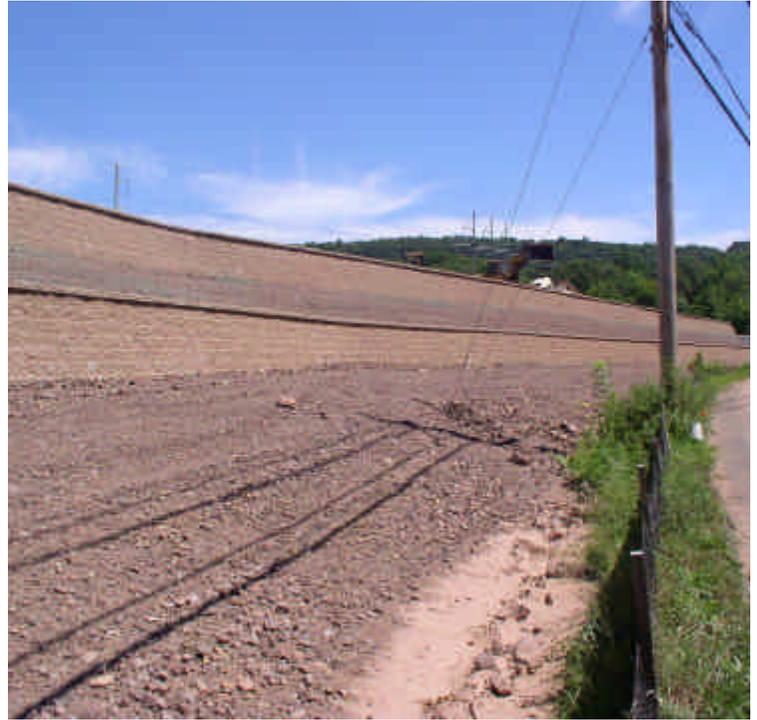
**Grading and stabilization remain to be done between Carpenter Lane and the newly completed retaining walls.**

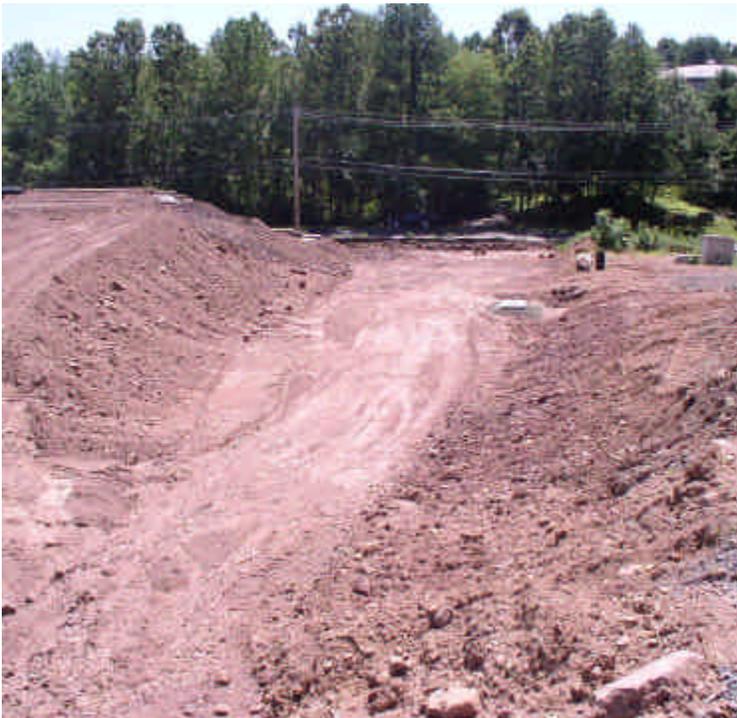
**New site entrance to be constructed in this location with a recently installed catch basin.**

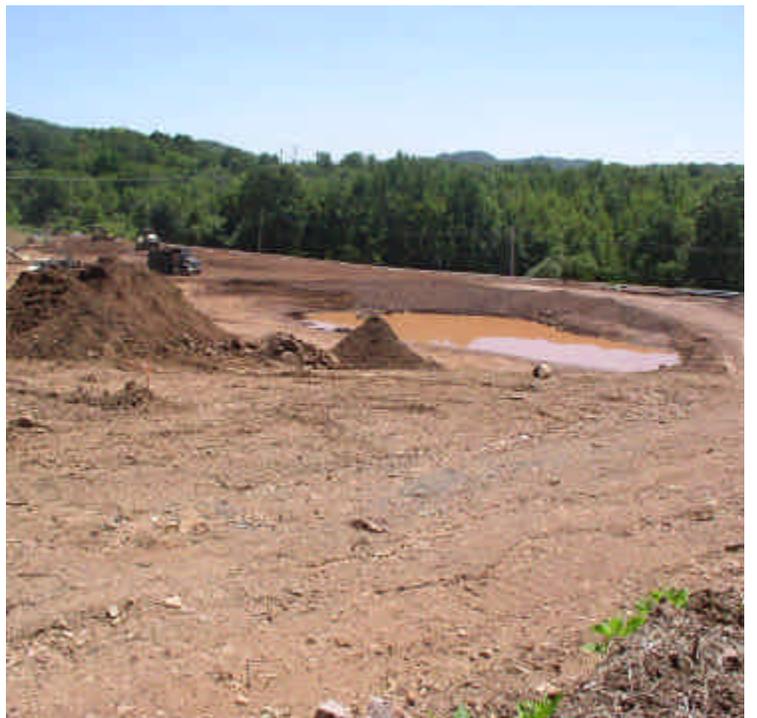
**Detention pond/settling area retaining stormwater run-off.**

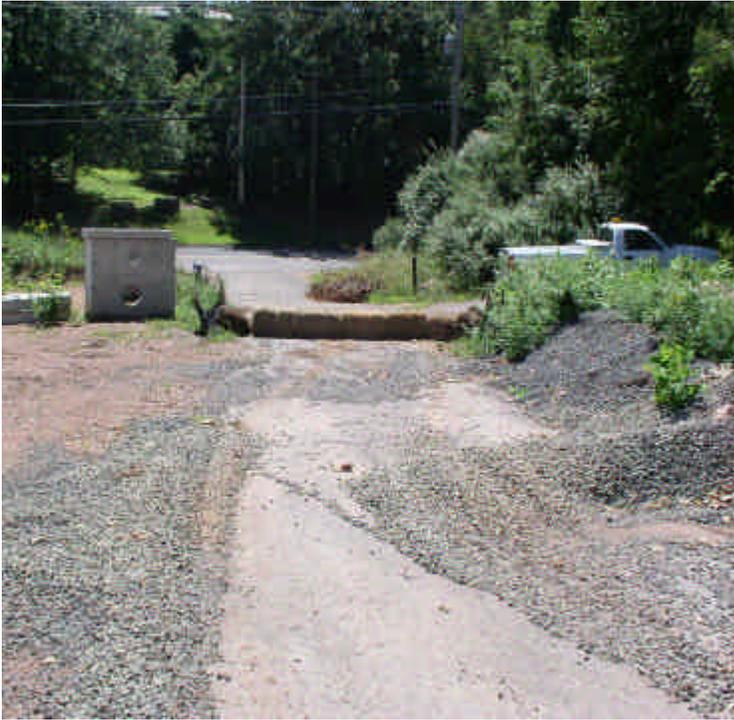
**New haybale lines remain installed across the old Zolnik driveway**

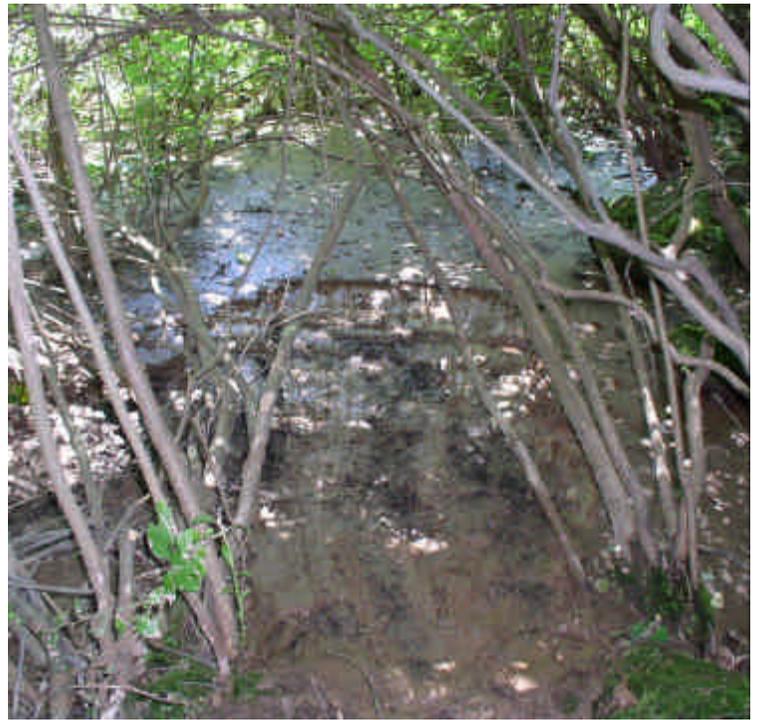
**Sediment removal from wetland has started and should be finished as soon as possible.**

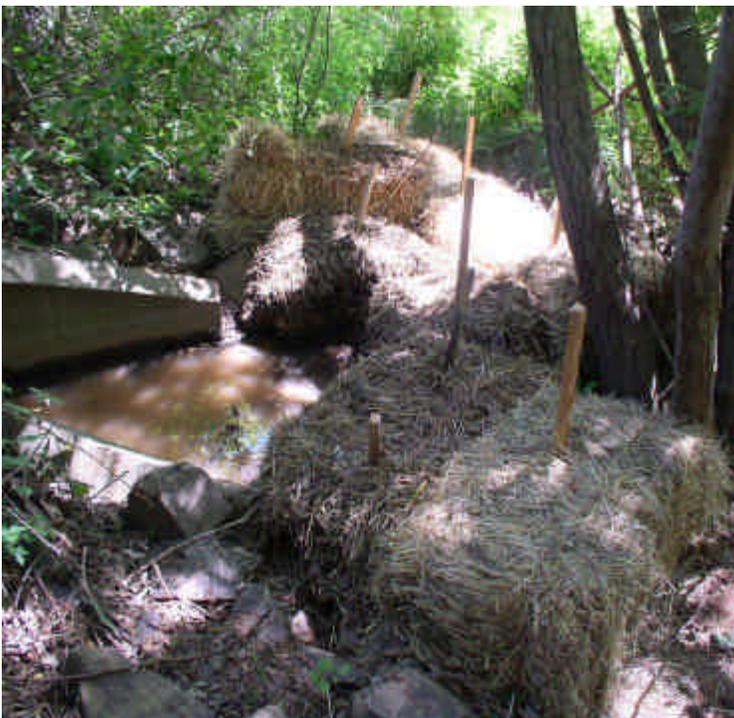
**New haybales installed for additional filtration at the storm drain outlet. Water flowing from the outlet was still turbid.**

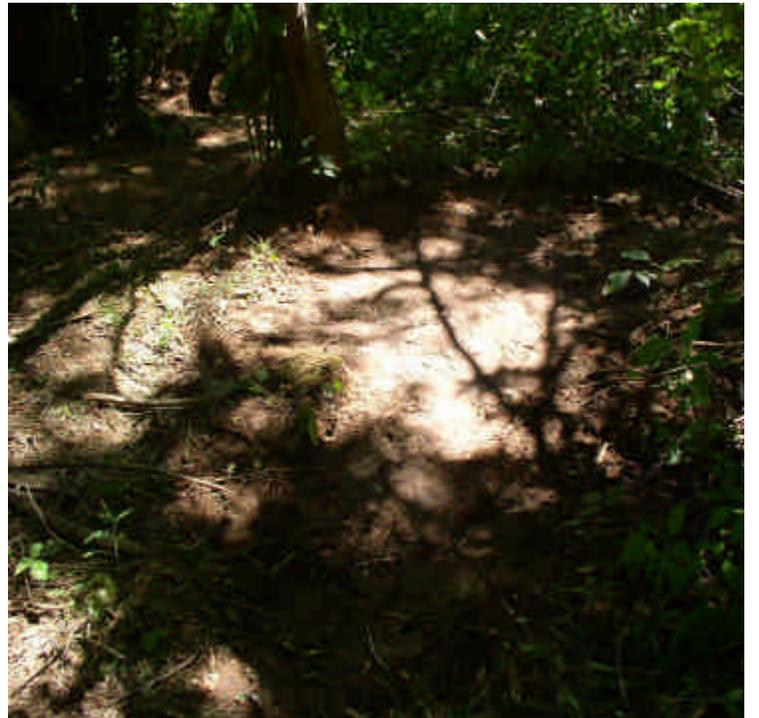
**Sediment was removed from this area within the wetland across Carpenter Lane.**
