Docket No. 272 – Development and Management Plan Inspection

Beseck Switching Station Inspection

Date: August 31, 2006

Location: Beseck Switching Station

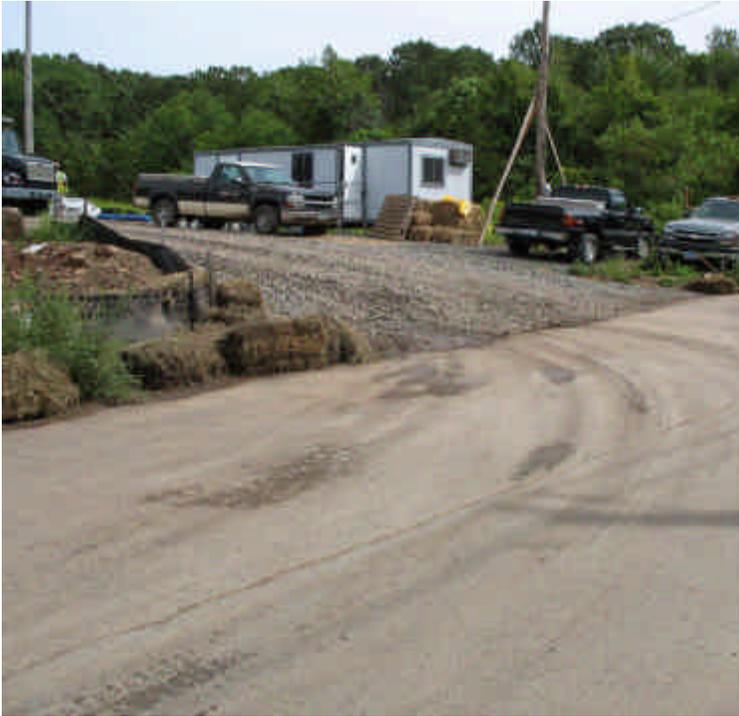
Equipment has done some damage to the road surface. 8/24-8/31/06	Clean and repair road surface as needed. 8/24-8/31/06	Needs attention when feasible
	Haybales remain at the edge of the entrance pad, with small stones at the corners of the catch basins (CBs) to secure the filter fabric. 8/31/06	Continue to monitor the stormwater leaving the site and replace erosion controls as needed. 8/31/06	Haybales are placed across the stone entrance prior to any rain event.
	Silt barrier liners in CBs	Continue to monitor and	Silt liners were

Crushed stone construction entrance pad needs cleaning some tracking and road damage was noted on Carpenter Lane. The road should continue to be cleaned and swept, including the gutters, by hand if necessary.

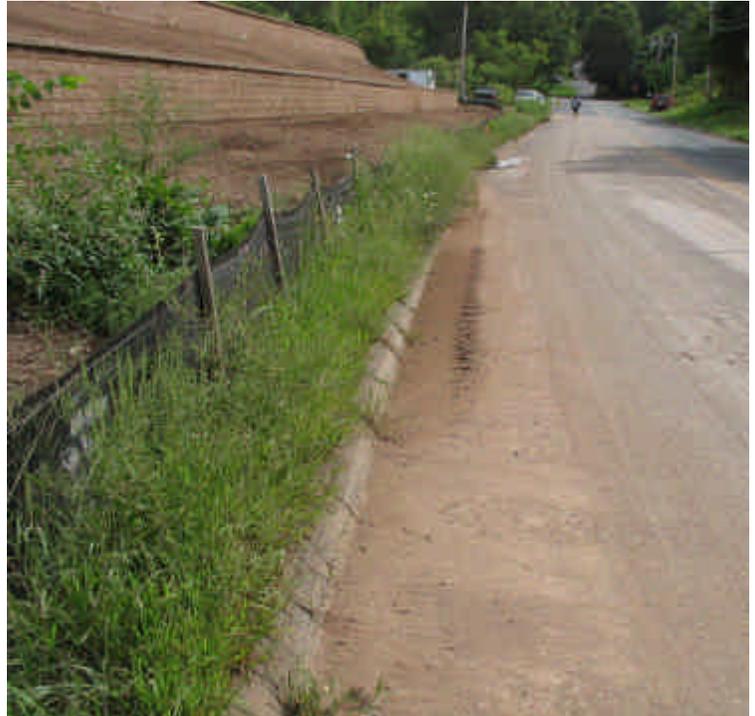
Clean/remove sediment along the gutter of Carpenter Lane as needed to prevent turbid run-off to the catch basins.

Areas of Inspection	Observation	Recommended Action	Corrected Action
Access roads and adjacent roadways	All truck traffic is using stone entrance on east side (clean). New stone is regularly pulled back from the road. 8/31/06	Continue to clean/refresh stone construction entrance. Continue to keep Carpenter Lane clear of stone. 8/31/06	Stone continues to be pulled back from roadway as needed.
	Small settling area was created from recent rains near the stone entrance, which cleans truck wheels before leaving the site. Soil has built up on stone and is being tracked by trucks. 8/31/06	Monitor water levels and clean stone as needed. 8/31/06	Water was used to clean truck wheels but stone needs some attention.
	Street sweeping continues at the site, some sediment has accumulated along the edge (gutter) of Carpenter Lane. 8/31/06	Street sweeping should continue to be performed and soil removed from the gutter, by hand if necessary. 8/31/06	Needs attention.

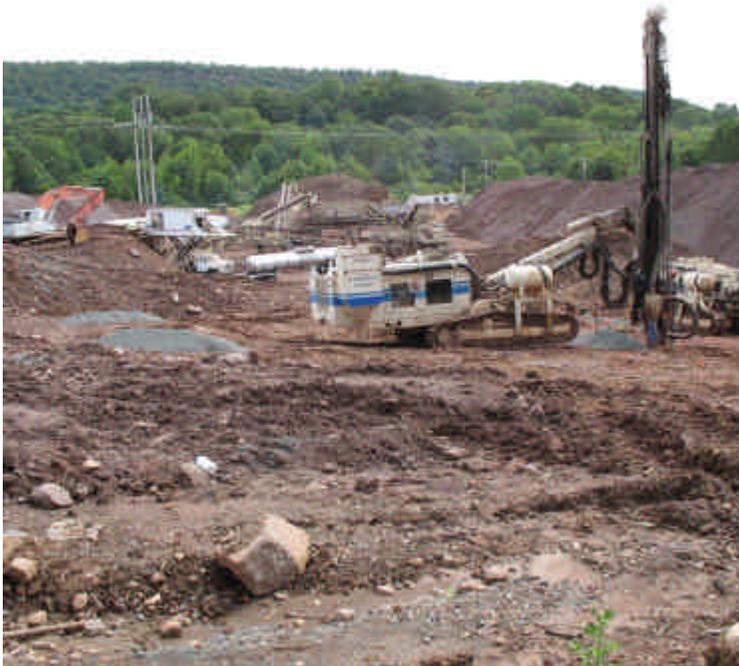
Major grading operations looking from northwest to southeast.

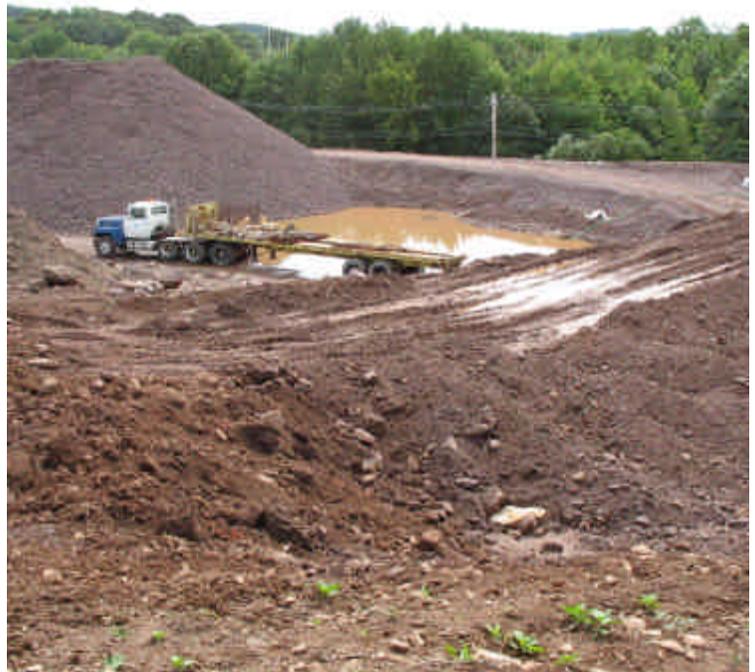
Detention pond/settling area retaining stormwater run-off. Large stockpiles are also present.

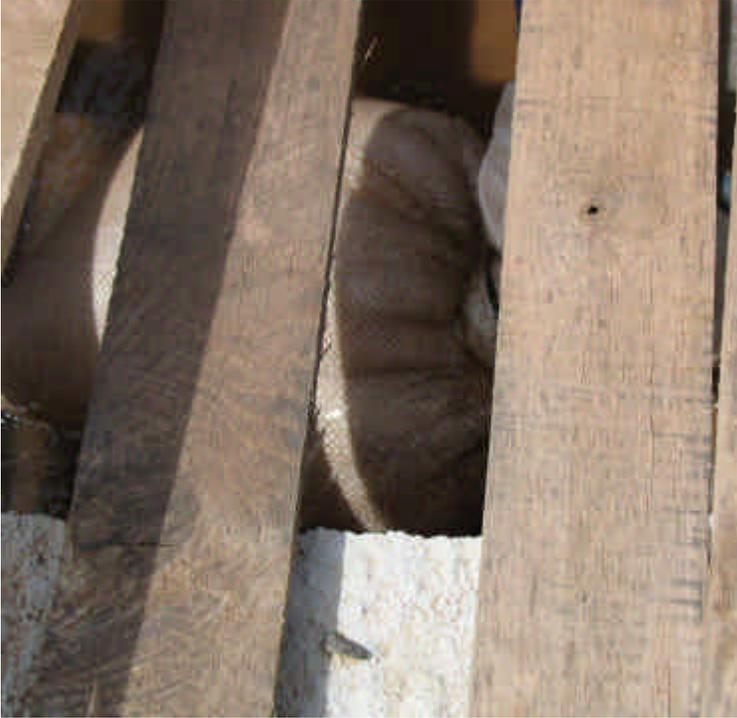
Erosion and sediment controls	<p>Silt fence is secure and well-maintained. South and east sides are reinforced with bark mulch. 8/31/06</p> <p>The settling basin north of inlet is reaching holding capacity and is being pumped into a sand bag filter and released into the CB to prevent overflow. This also serves to flush existing accumulated sediment from the system. 8/31/06</p> <p>Haybales are used at the outlet across Carpenter Lane to filter turbid water before entering the wetland. Water levels are too high at outlet due to pumping and turbid water is overflowing into the wetland. Haybales are also degrading quickly. 8/31/06</p> <p>New CBs remain</p>	<p>Continue to inspect and maintain silt fence throughout site and repair as needed. 8/31/06</p> <p>This is overwhelming the established controls. Set a schedule for water pumping that allows the water to flush the system and settle/filter prior to overflowing or consider removing some of the water from the settling basin with a vac truck 8/31/06</p> <p>Once settled, sediment should be removed and haybales inspected and changed as needed. Set and maintain schedule throughout pumping. 8/31/06.</p> <p>Inspect and maintain CB</p>	<p>NA.</p> <p>Water is being pumped from settling area prior to overflow but this needs more evaluation.</p> <p>Needs evaluation</p> <p>NA</p>

Sand bag filter used to clean pumped water for the settling area.

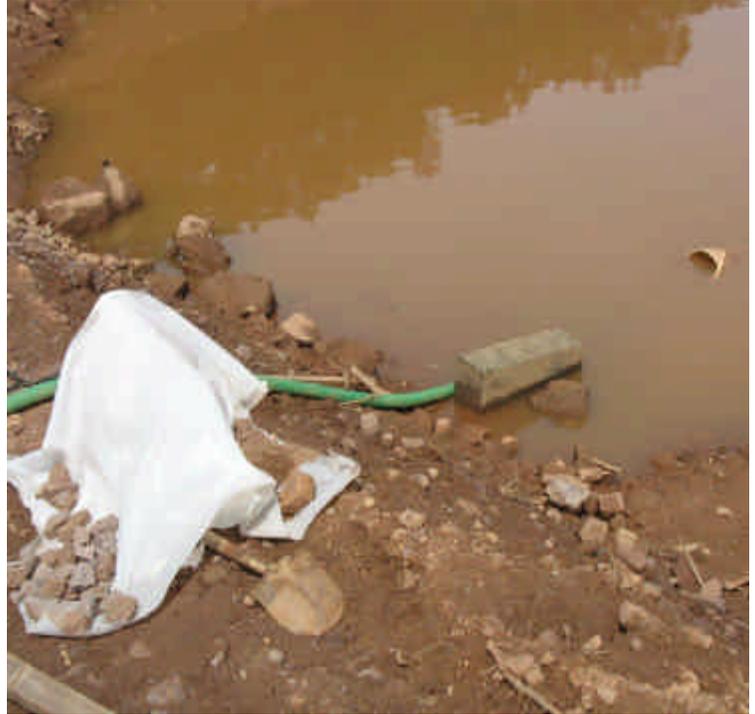
Dewatering	Dewatering of the larger settling basin is underway. Water is being pumped, filtered and released in the new CB system. See Erosion control section for details. 8/31/06	Establish a schedule for pumping and maintenance. See Erosion Control section for recommended actions. Also, consider using a vac truck to remove water from site. 8/31/06	NA
Blasting	<p>Blasting continues; blast areas are first covered by rubber containment mats. Blasting will continue through the beginning of next week. 8/31/06</p> <p>Rock crushing and loam screening are occurring and materials are being removed or used on site. 8/31/06</p>	<p>Caution should continue to be taken that no blast material is allowed to leave the site. 8/31/06</p> <p>Monitor dust formation and wet soil as needed. 8/17/06-8/31/06</p>	<p>Rubber mats prevent material movement.</p> <p>NA</p>
Spills, soils and material storage	<p>Several large piles of new soil will be removed from the site. The remaining soil will stay onsite for use as fill. 8/31/06</p> <p>Large expanses of disturbed soil on site will continue to make sediment attenuation difficult at stormwater inlet areas. Any areas that will be unworked for several weeks should be</p>	<p>Soils appear to be handled appropriately. 8/31/06</p> <p>Consider placing seed, straw, mulch, or stone as a temporary stabilization measure to reduce sediment loads where work is not actively occurring or not expected to occur for 14 days.</p>	<p>NA</p> <p>Needs evaluation for feasibility.</p>

Water being pumped from the settling area.

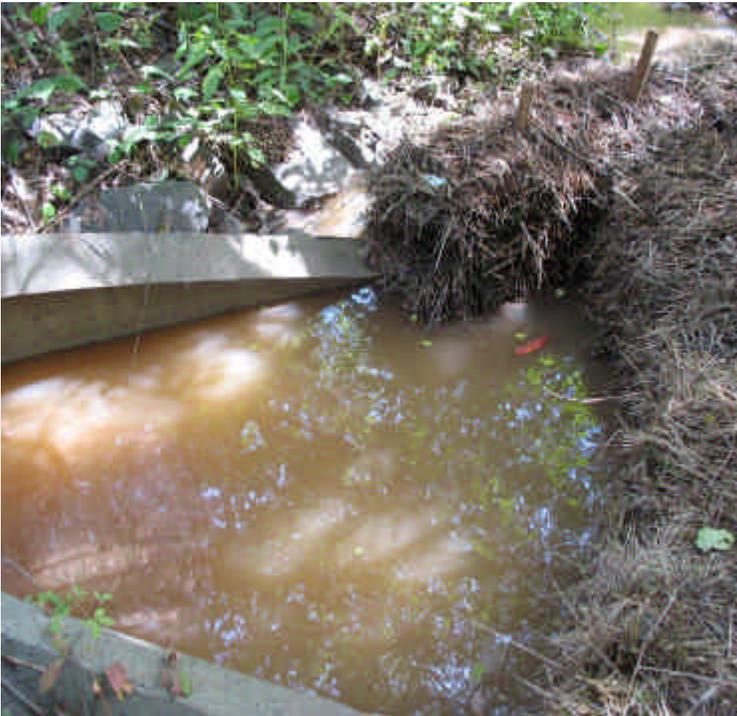
<p>Inland Wetland and Watercourse encroachment and mitigation</p>	<p>Wetlands on east side of site were clean and well protected. 8/31/06</p> <p>The wetlands across Carpenter Lane have additional sediment accumulation and turbid water due to pumping from the settling basin overwhelming the existing controls. 8/31/06</p>	<p>Continue to monitor. 8/31/06</p> <p>Create a pumping schedule that protects the wetland. Perform necessary sediment removal and haybale inspection/ replacement. 8/31/06</p>	<p>NA</p> <p>Needs evaluation.</p>

Sediment filled water being flushed from the storm drain system and overflowing into the wetlands. Haybales cannot contain the present volume.

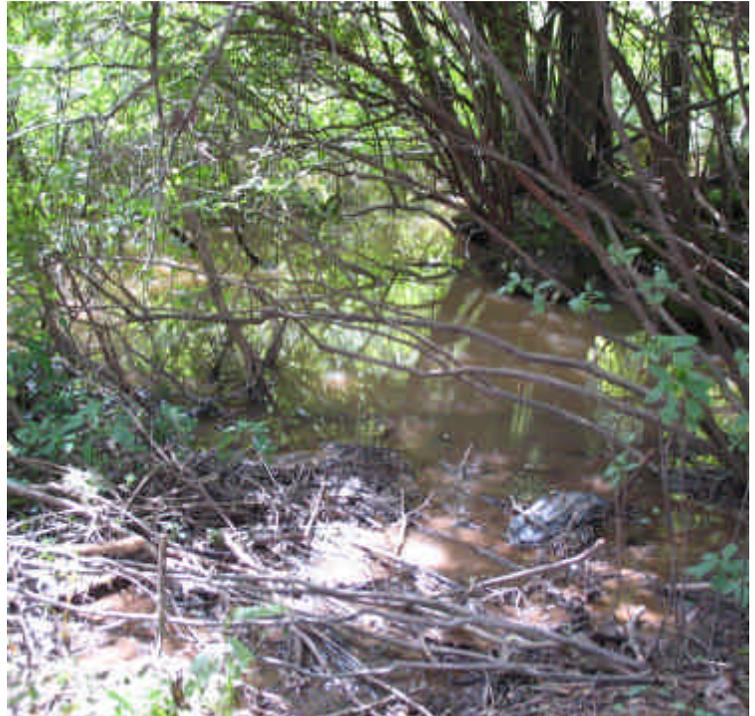
Turbid standing water is now present in the wetland again due to overflow from the outlet.
