Docket No. 272 – Development and Management Plan Inspection

Beseck Switching Station Inspection

Date: September 7, 2006

Location: Beseck Switching Station

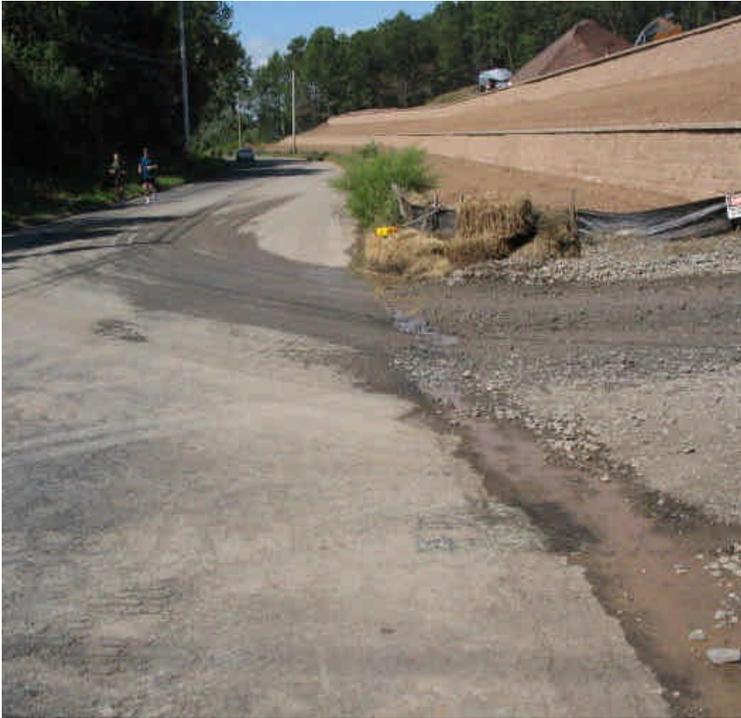
Crushed stone construction entrance pad needs cleaning. Runoff into Carpenter Lane contains sediment; and some tracking and minor road damage were noted. The road should continue to be cleaned and swept, including the gutters, by hand if necessary.

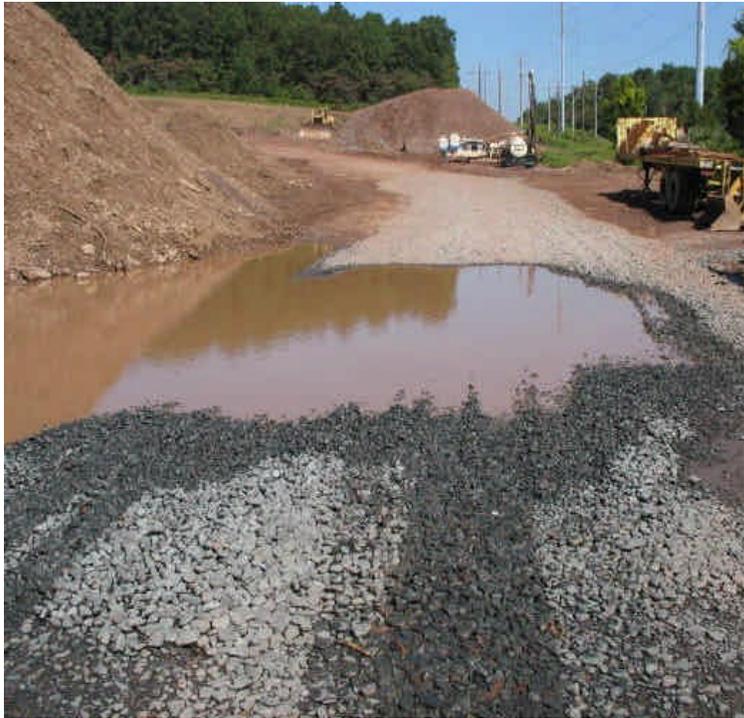
New stone was added at wheel wash area; this area is helping to reduce sediment tracking on Carpenter Lane.

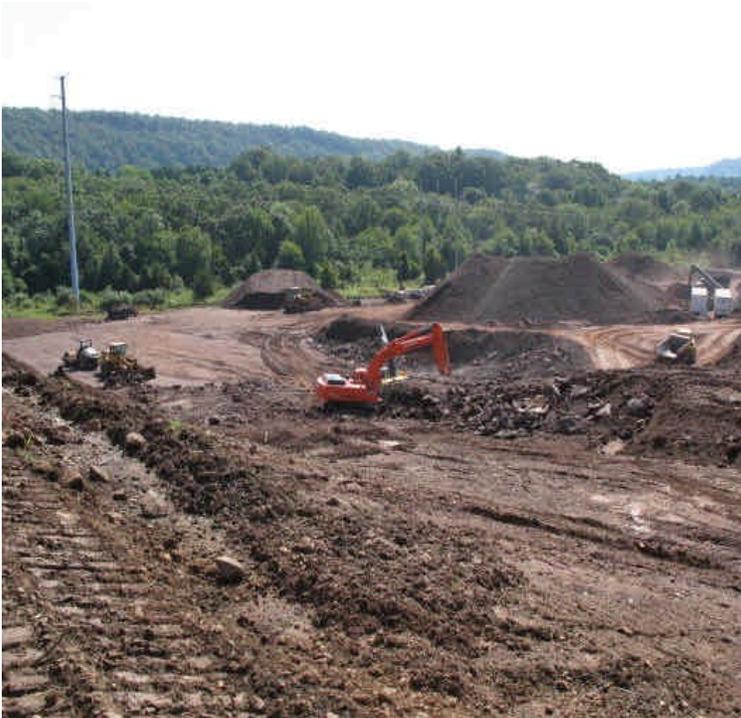
Major grading operations looking from northwest to southeast.

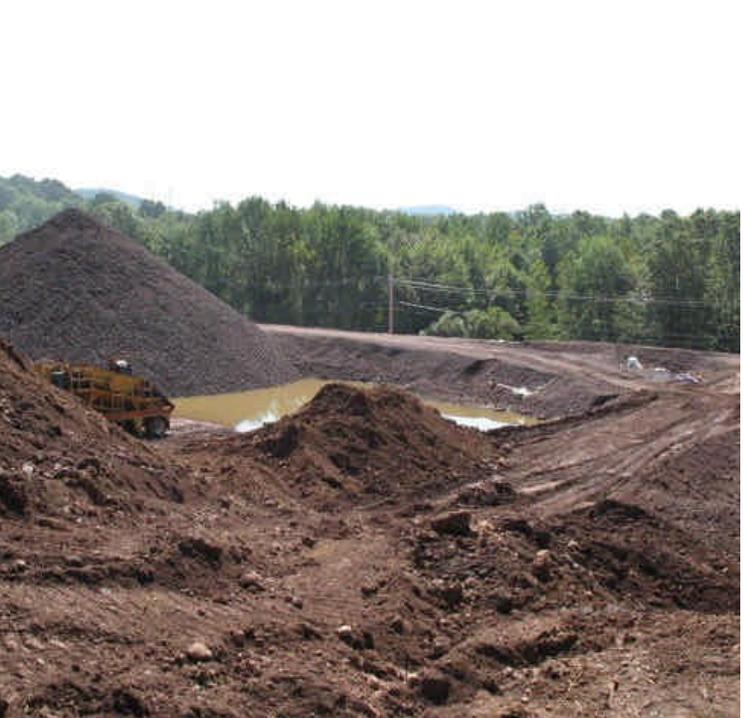
Detention pond/settling area retaining stormwater run-off. Large stockpiles are also present.

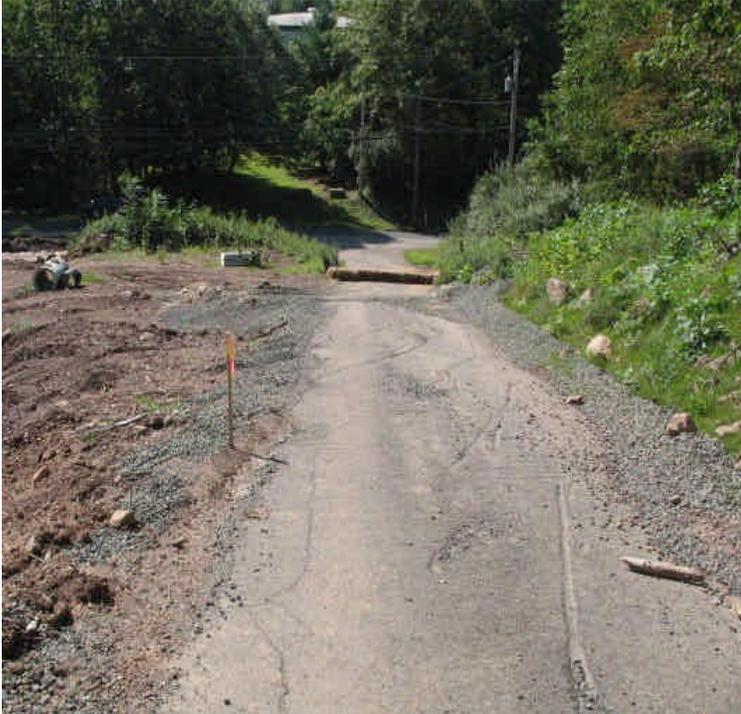
New haybale line across old Zolnik driveway, western slope is vegetated.

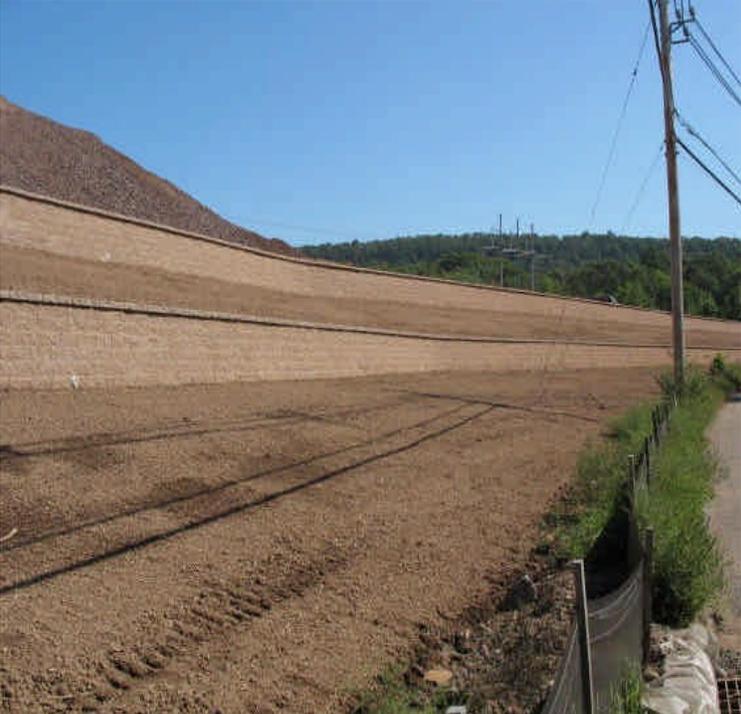
Loamed area adjacent to the finished retaining walls should be seeded soon.

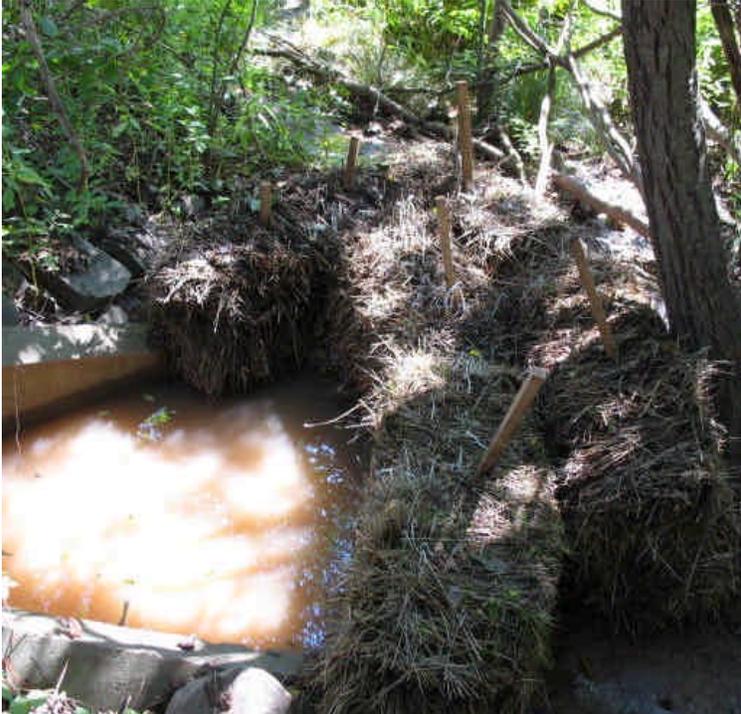
Sediment-laden water being flushed from the storm drain system and filtered before entering wetlands. Water pumping has stopped for the time.

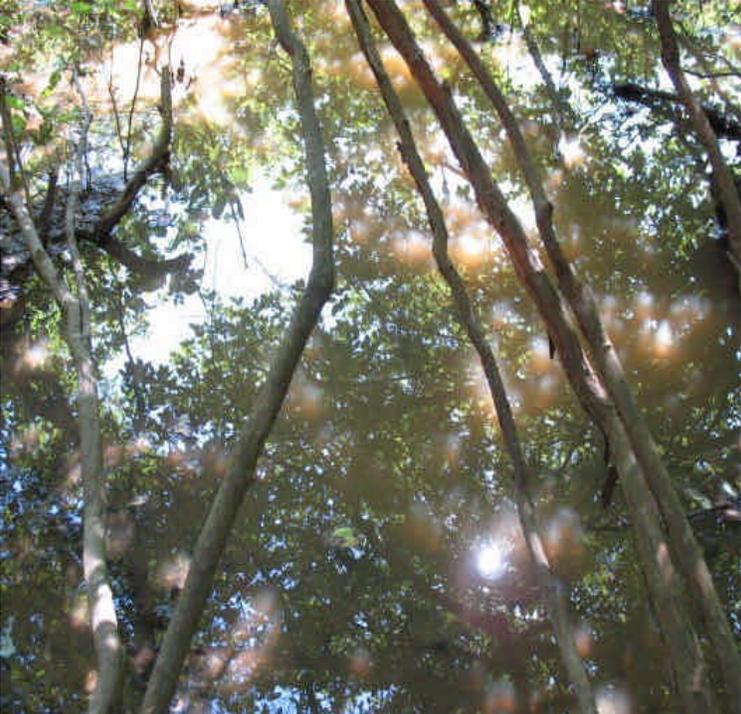
Turbid standing water is now present in the wetland again due to overflow from the outlet.
