Docket No. 272 – Development and Management Plan Inspection

Beseck Switching Station Inspection

Date: October 19, 2006

Location: Beseck Switching Station

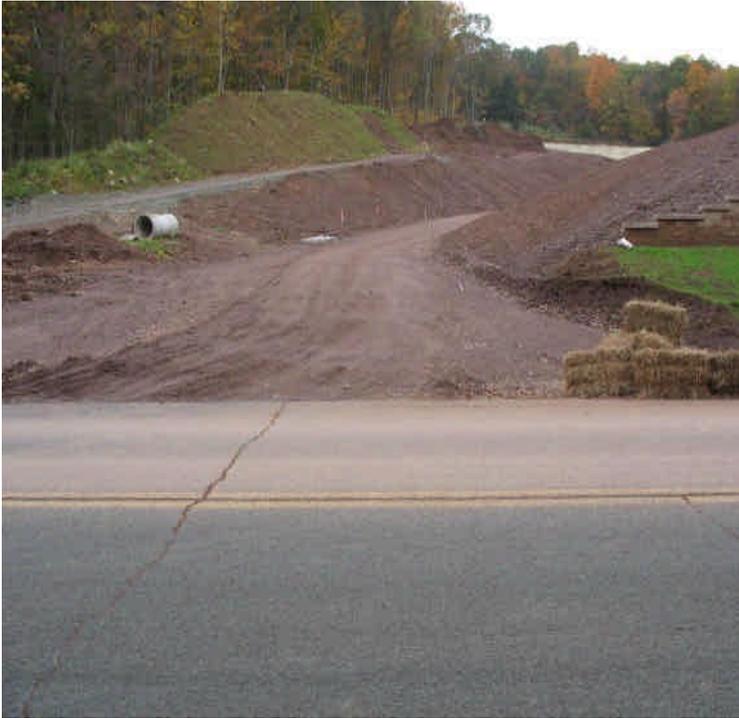
New site entrance along Carpenter Lane.

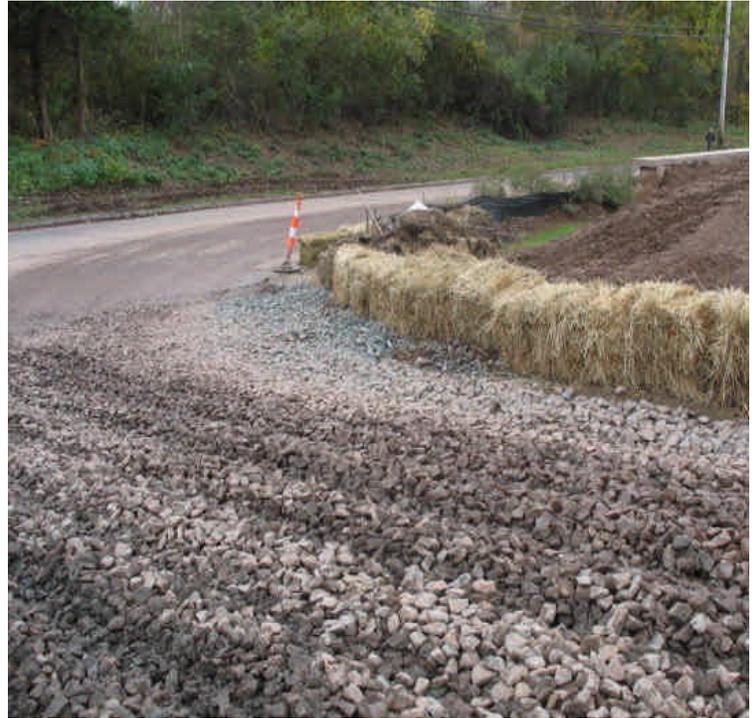
Carpenter Lane has observable sediment tracking and the roadway should be swept regularly. The entrance pad was cleaned. Entrance pad improvements are planned in the near future.

Areas of Inspection	Observation	Recommended Action	Corrected Action
Access roads and adjacent roadways	All truck traffic leaving the site is using stone entrance on east side. Sediment and dust have accumulated on Carpenter Lane however the roadway is being swept daily. 10/19/06	Clean/sweep roadway regularly; clean gutter by hand. Continue to monitor stormwater leaving the site; replace and add more controls as needed. 10/19/06	Needs attention: Contractors are discussing improving/re-working the stone pad.
	Stone access pad was being raked out in an attempt to removed accumulated mud as part of the proposed improvements. 10/19/06	Continue to clean/refresh stone construction entrance; Trucking from site will be ending soon, reducing tracking potential. 10/19/06	Contractors are discussing grading out the stone pad and installing a berm.
	Equipment has done some damage to the road surface. 8/24-10/19/06	Clean and repair road surface as needed. 8/24-10/19/06	Roadway repairs will start once equipment is moved off site.

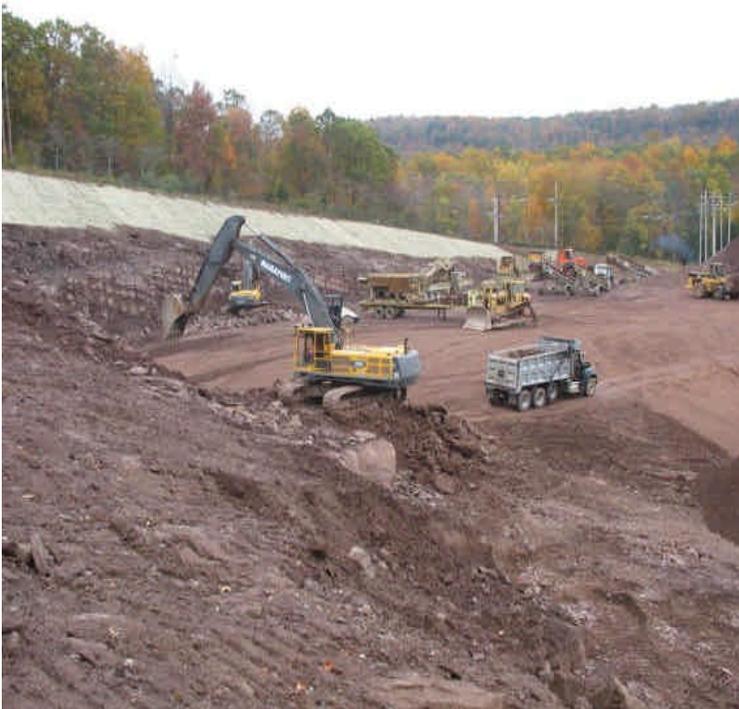
Remaining soil removal and grading along the northern slope.

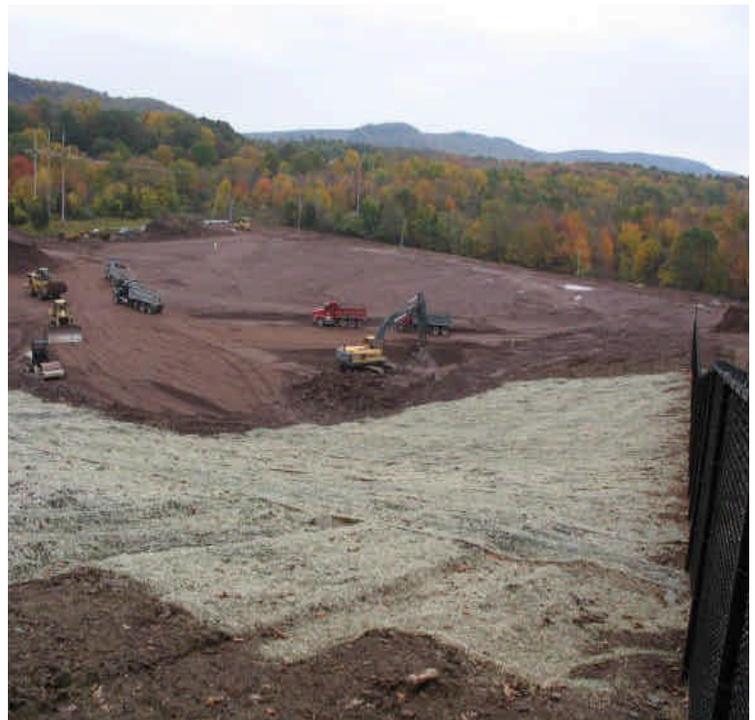
Southern side of site, looking from northwest to southeast.

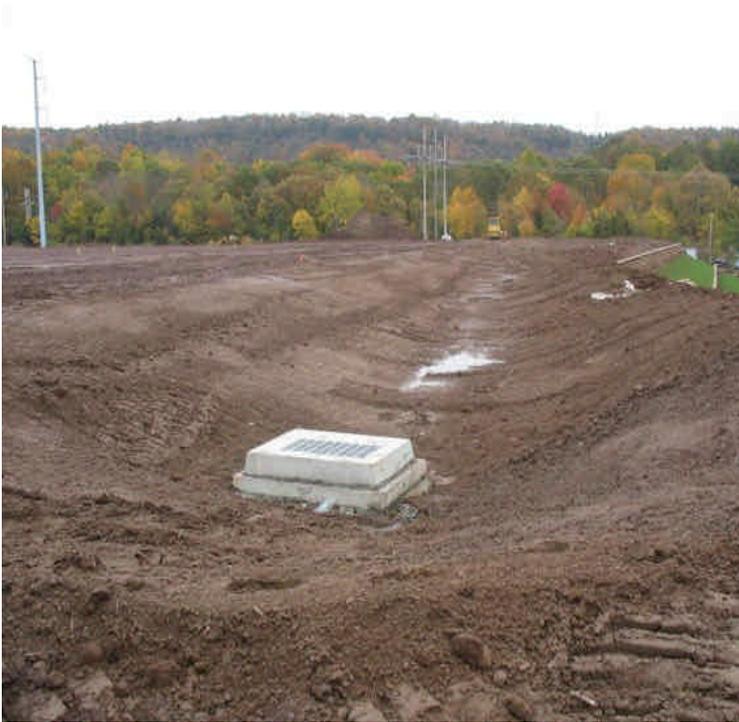
Final grading and installation of detention basins above the new retaining walls along Carpenter Lane.

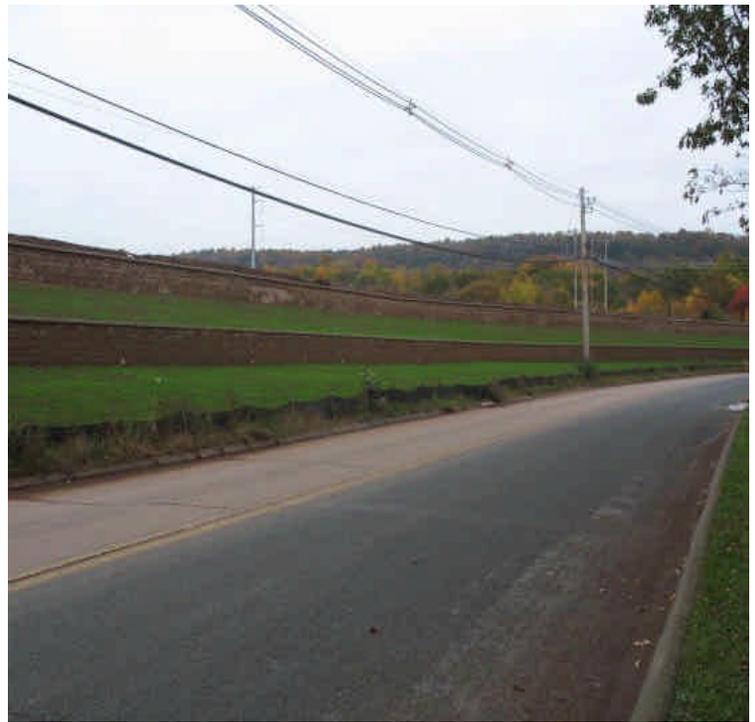
Grass growth is present along retaining walls at Carpenter Lane; Area is stabilizing.

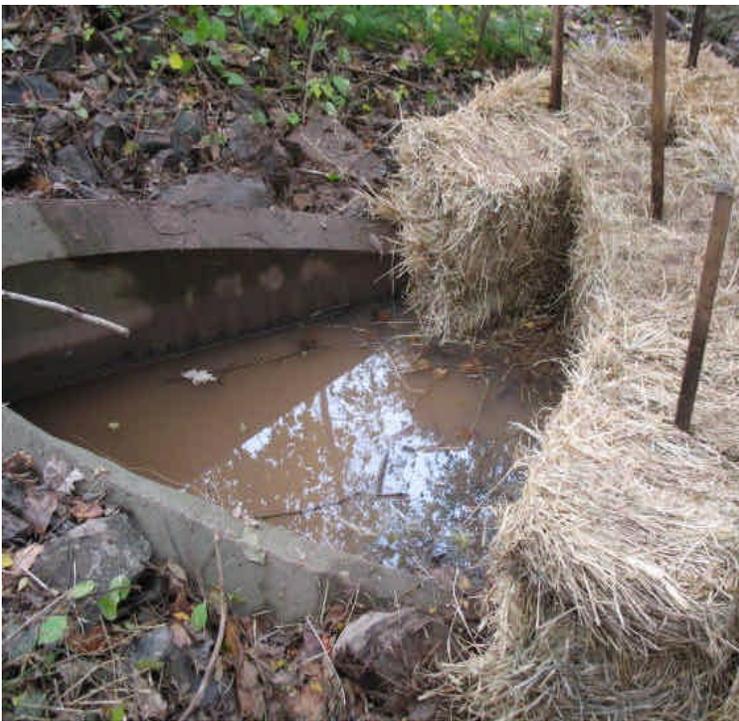
Sediment has started to settle out in the bottom of the storm drain outlet. New haybales have been installed.

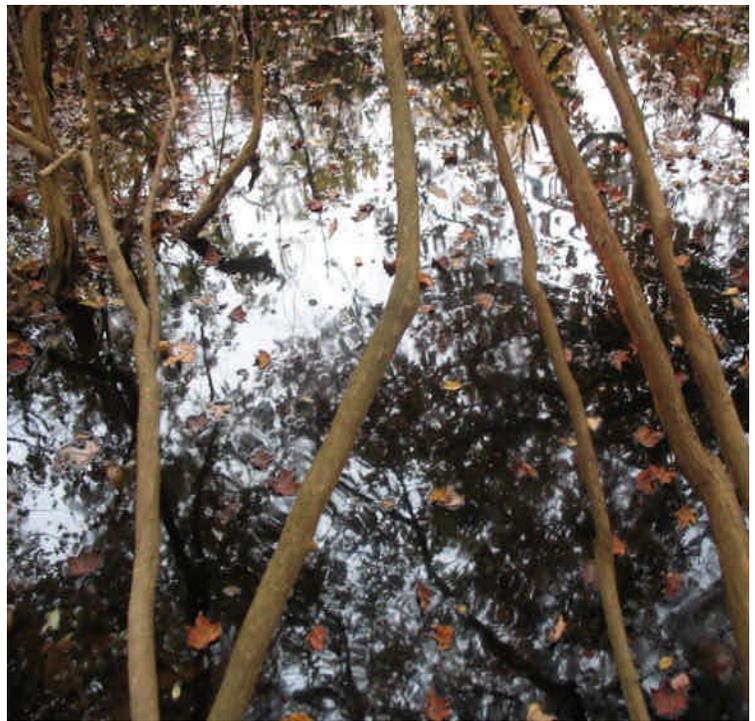
Areas of Inspection	Observation	Recommended Action	Corrected Action
	10/19/06	recommended fall seeding season ended October 15 th , but seed may still germinate. 10/19/06	
Inland Wetland and Watercourse encroachment and mitigation	Sediment in wetlands across Carpenter Lane has settled out. The outlet pipe contained standing water with settled sediment in the bottom of the pipe. 10/19/06 Wetlands on east side of site were clean and well protected. 10/19/06	Accumulated sediment in wetland does not appear to warrant removal at this time but continue to evaluate. Sediment in the pipe outlet could be removed. New haybales were added. 10/19/06 Continue to monitor. 10/19/06	Needs to be monitored. NA
State species of concern, threatened and endangered species.	According to the D&M plan, state-listed species are not located in this work area.	None 10/19/06	NA
Vegetative clearing or stabilization	Soil stockpiles in the old Zolnik property are vegetated and stable. The northern slope has been hydroseeded and erosion control mats remain in place, seed may not germinate until spring. Southern slopes are vegetated and stable. 10/19/06 The generally-recommended fall seeding season ended October 15 th . 10/19/06	Stockpiles should continue to be located away from the road and drains. Place winter rye seed for temporary stabilization of any stockpiles that will remain in place for more than 14 days. 10/19/06 Attempt to seed temporarily or permanently inactive areas with winter rye as soon as possible. 10/19/06	Grass is growing in some seeded areas. NA

Sediment in the wetland has settled out and water is no longer turbid. It does not appear that sediment removal is needed at this time. Continue to evaluate.
