Docket No. 272 – Development and Management Plan Inspection

Beseck Switching Station Inspection

Date: October 31, 2006

Location: Beseck Switching Station

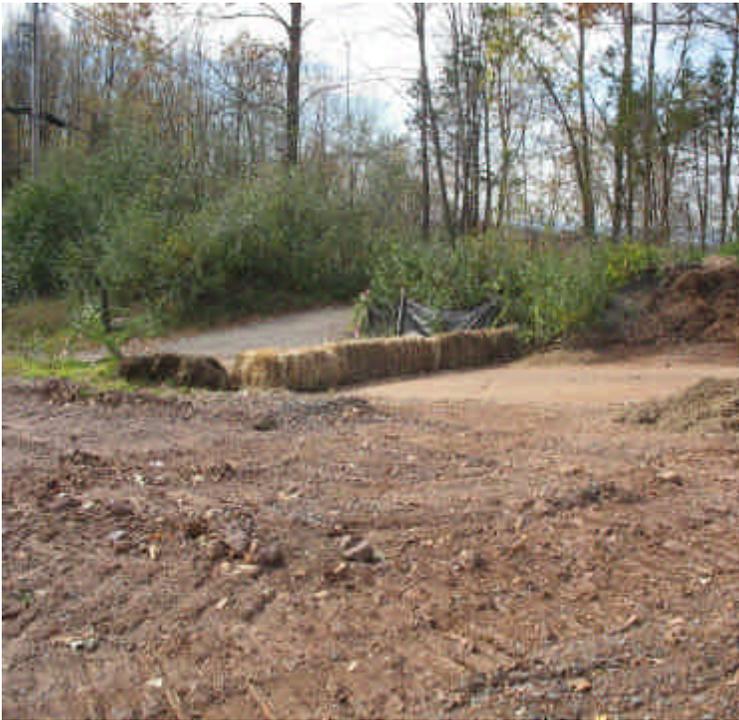
Old Zolnik entrance at Carpenter Lane. New haybales were added as the area is being graded.

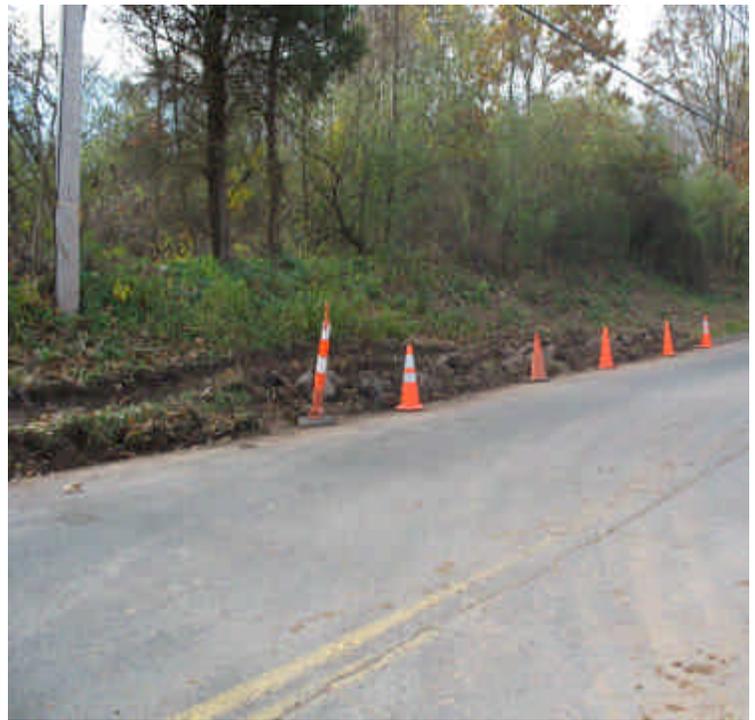
Asphalt curbing will be replaced across Carpenter Lane.

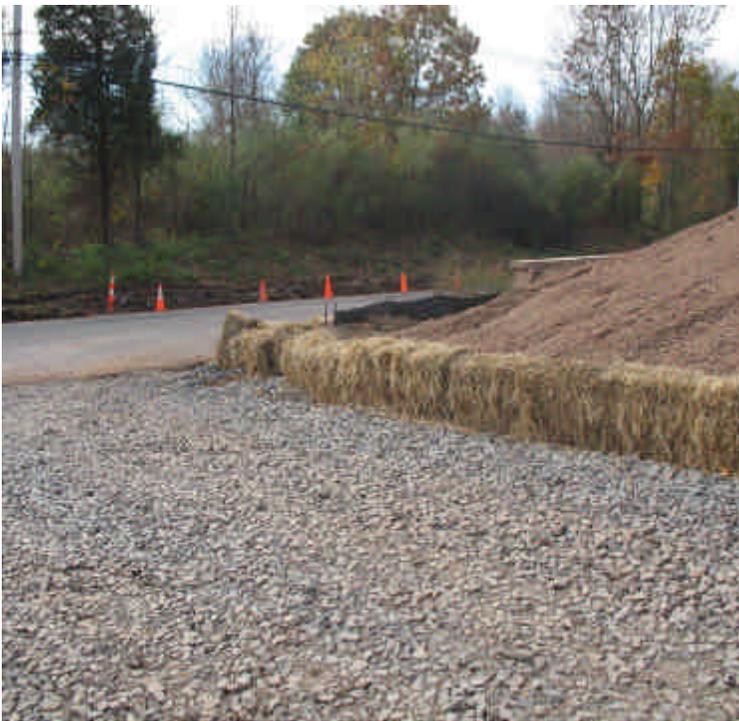
Stone site entrance at Carpenter Lane. Stone is clean of sediment.

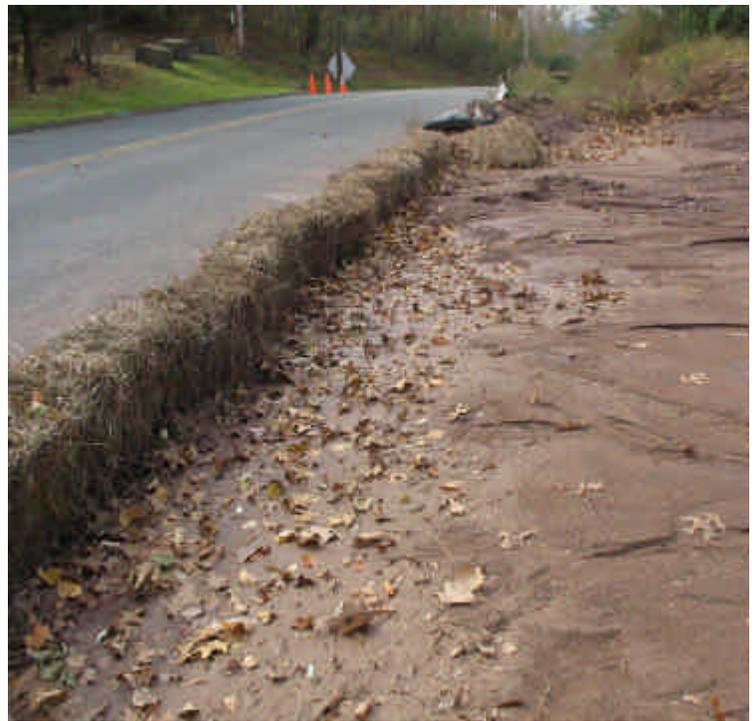
New site entrance has a buildup of sediment from the storm this week. Haybales have stopped majority of sediment from reaching Carpenter Lane. Begin to pull this back and stabilize to prevent it overwhelming the controls next rain event.

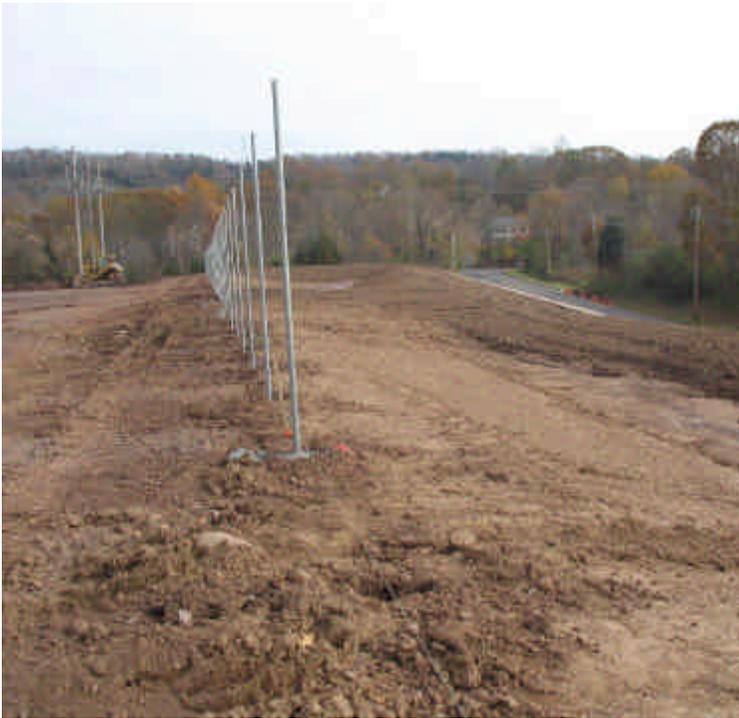
View of final grading of detention basins above the new retaining walls along Carpenter Lane. Fence installation is underway.

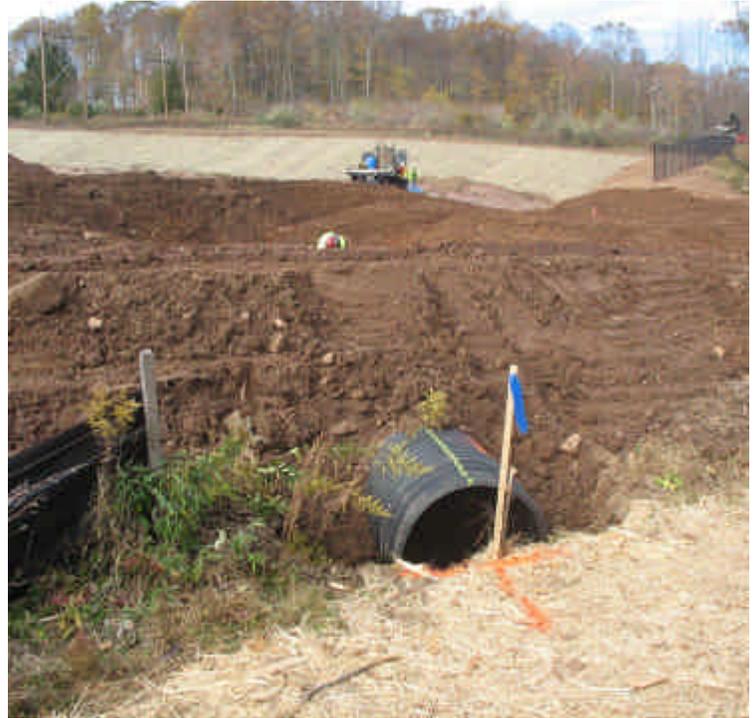
A culvert was being installed under the new access road. This connects the Beseck entrance to the ROW and will be used jointly.

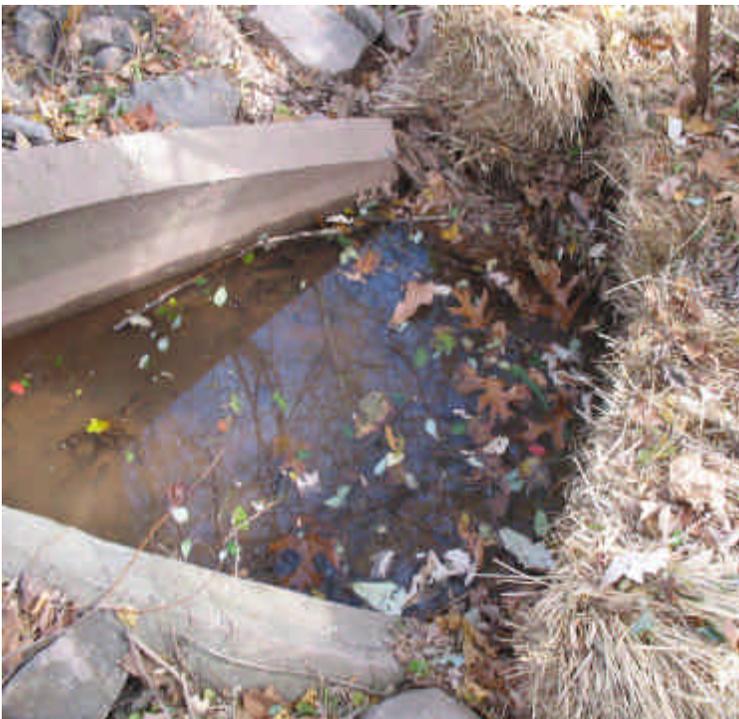
Sediment has settled out in the bottom of the storm drain outlet. A good haybale barrier is in place.

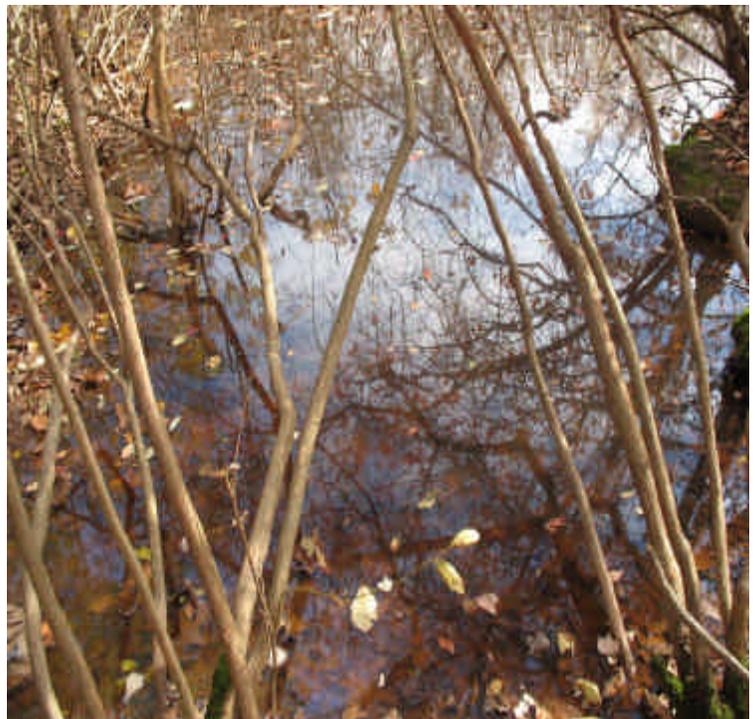
No new sediment or turbidity was observed in the wetlands following the rain event.
