**Docket No. 272 – Development and Management Plan Inspection**

**Beseck Switching Station Inspection**

**Date:** August 3, 2006

**Location:** Scovill Rock Switching Station

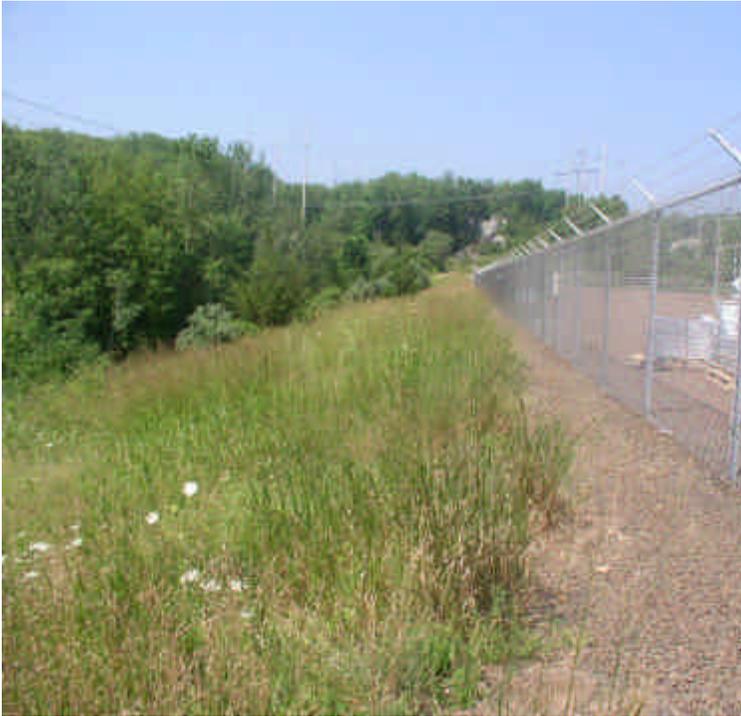
**Southern perimeter fence looking west at the vegetated buffer to a small pond, on the south side of the site.**

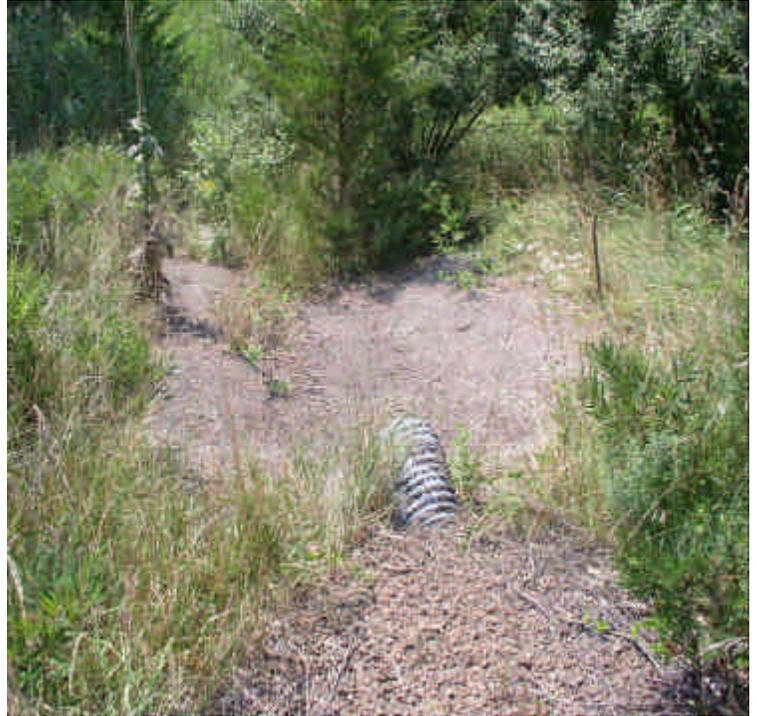
<b>Areas of Inspection</b>	<b>Observation</b>	<b>Recommended Action</b>	<b>Corrected Action</b>
<b>Inland Wetland and Watercourse encroachment and mitigation</b>	<b>Wetland is located on the south side of site and did not have sedimentation issues. 8/3/06</b>	<b>Continue to monitor. The storm drain pipe does outlet here. 8/3/06</b>	NA
	<b>Storm drain pipe needs haybales. No water was flowing from the pipe during the inspection. 8/3/06</b>	<b>Monitor storm water flows from the pipe to ensure haybales are working properly. 8/3/06</b>	NA
<b>State species of concern, threatened and endangered species.</b>	<b>According to the D&amp;M plan, state-listed species are not located in this work area.</b>	None	NA
<b>Vegetative clearing or stabilization</b>	<b>No vegetative clearing is proposed at this time. 8/3/06</b>	None	NA
<b>Dewatering</b>	<b>Dewatering is not being performed at this time. 8/3/06</b>	None	NA

**Storm water outfall pipe upgradient of wetland, south side of the site.**

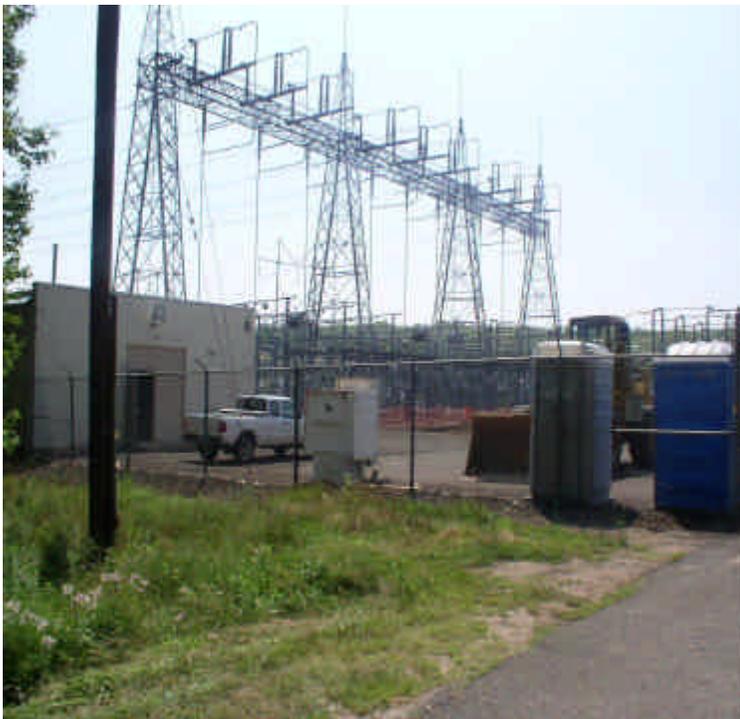
**Existing switching station structures, north side of site.**

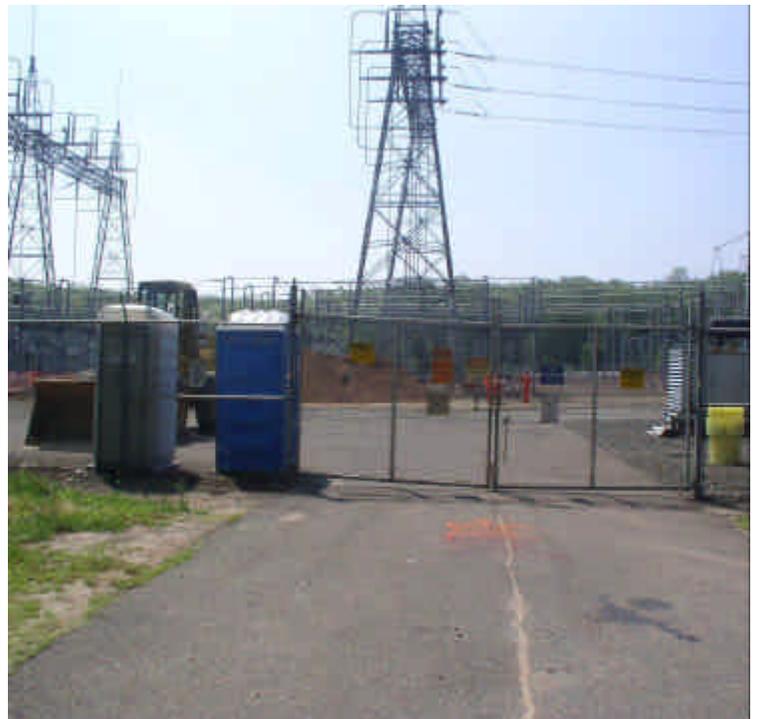
<b>A small stockpile was present on site but remains contained. 8/3/06</b>	<b>Any soil stockpiles onsite should be located away from the south side of the site, and seeded for temporary stabilization if left unworked for more than 14 days. 8/3/06</b>	<b>NA</b>

**Entrance to the switching station with stockpile location and spill kit, north side of site.**
