Docket No. 272 – Development and Management Plan Inspection

Scovill Rock Switching Station Inspection

Date: August 17, 2006

Location: Scovill Rock Switching Station

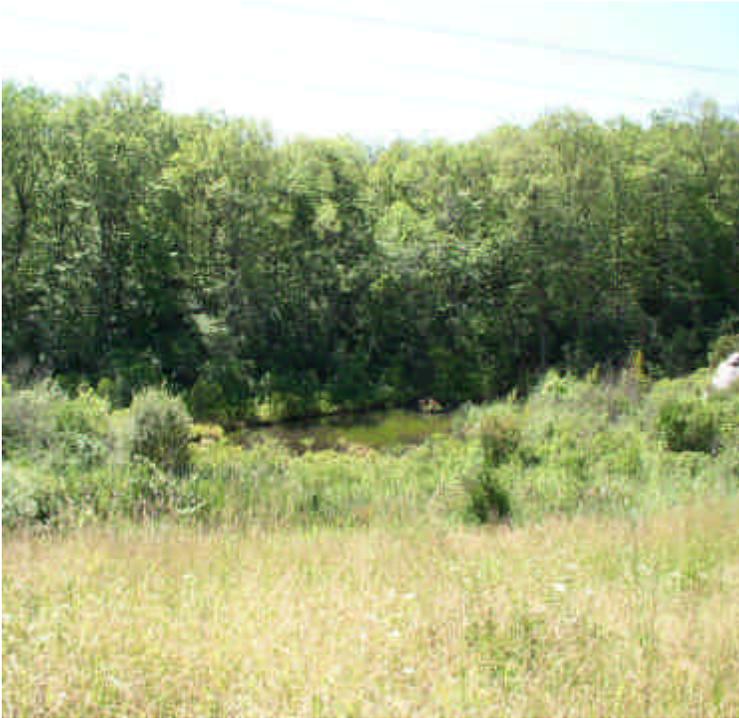
Looking from the southern station fence at the vegetated buffer to a small pond, located south of the site.

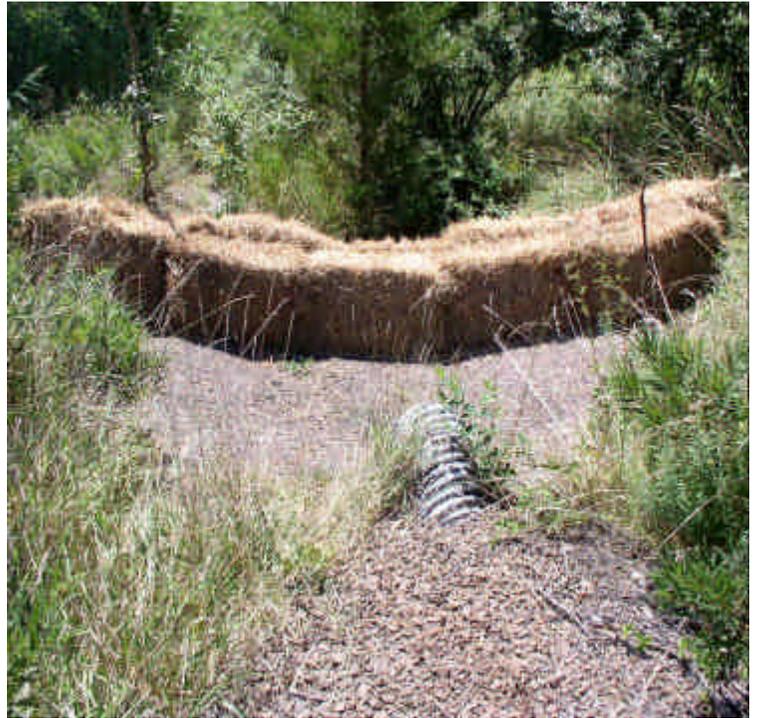
Haybales installed at the 12" storm drain pipe look good. No water was flowing. 8/17/06	Monitor storm water when flowing to ensure haybales are working properly. 8/17/06	NA

Storm water outfall pipe upgradient of the wetland, on the south side of the site. Controls are in place.

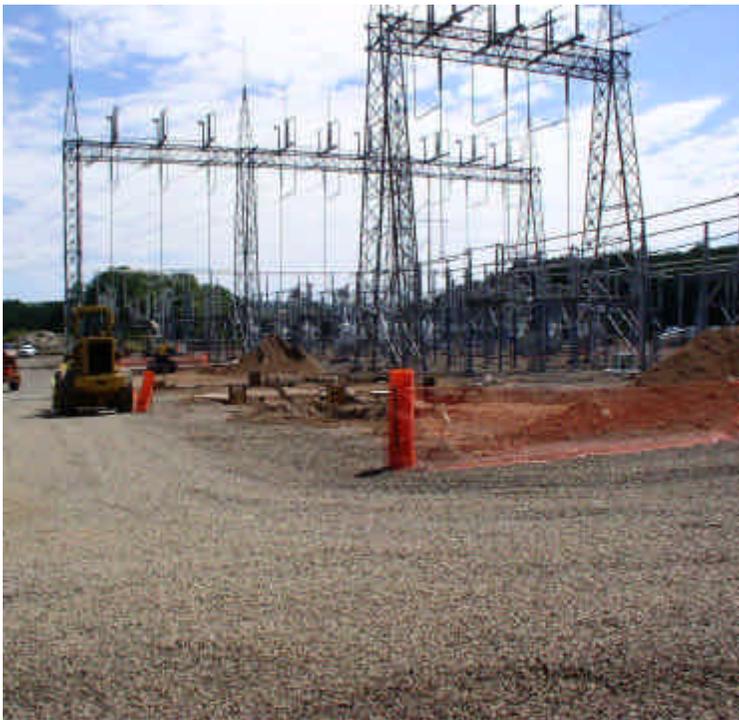
New foundations being installed in the yard. Small stockpiles remain contained.

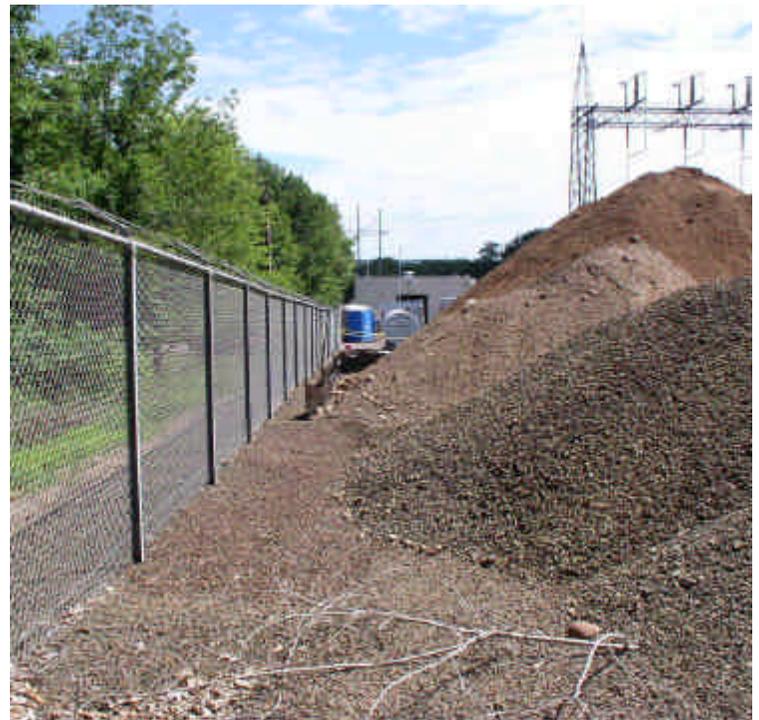
New silt fence added along stockpile at the northeast side of site.
