Docket No. 272 – Development and Management Plan Inspection

Scovill Rock Switching Station Inspection

Date: September 13, 2006

Location: Scovill Rock Switching Station

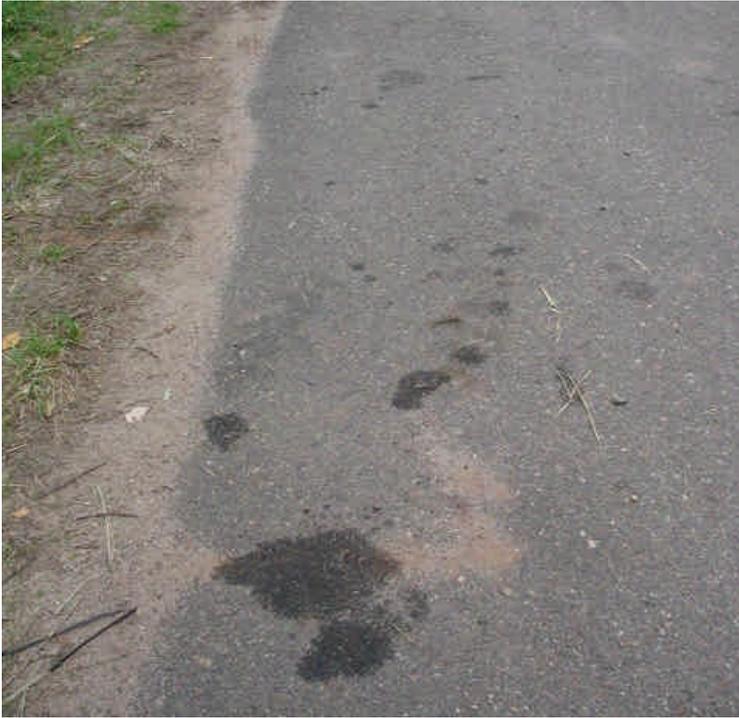
Areas of Inspection	Observation	Recommended Action	Corrected Action
<p>Erosion and sediment controls (continued)</p>	<p>Haybales installed at the 12" storm drain pipe look secure. No water was flowing. 9/13/06</p> <p>The small stockpiles resulting from foundation construction are contained within the yard and surrounded by a flat, stone surface. 9/13/06</p> <p>A small section of the silt fence installed along the stockpile in northwestern corner should be fixed. 8/24-9/13/06</p> <p>An existing culvert located off site under the access driveway had no water flow, and no sedimentation issues. 9/13/06</p>	<p>Monitor storm water when flowing to ensure haybales are functioning properly. 9/13/06</p> <p>All stockpiles should continue to be kept away from the south and northeast sides of the site, and temporarily stabilized if left unworked for more than 14 days. 9/13/06</p> <p>Maintain silt fence as needed, however the area remains contained to the yard. 8/24-9/13/06</p> <p>Closely monitor any work done on the access driveway above the culvert. 9/13/06</p>	<p>NA</p> <p>NA</p> <p>Needs attention when feasible.</p> <p>NA</p>

Small spill/drip located above the culvert on the access driveway.

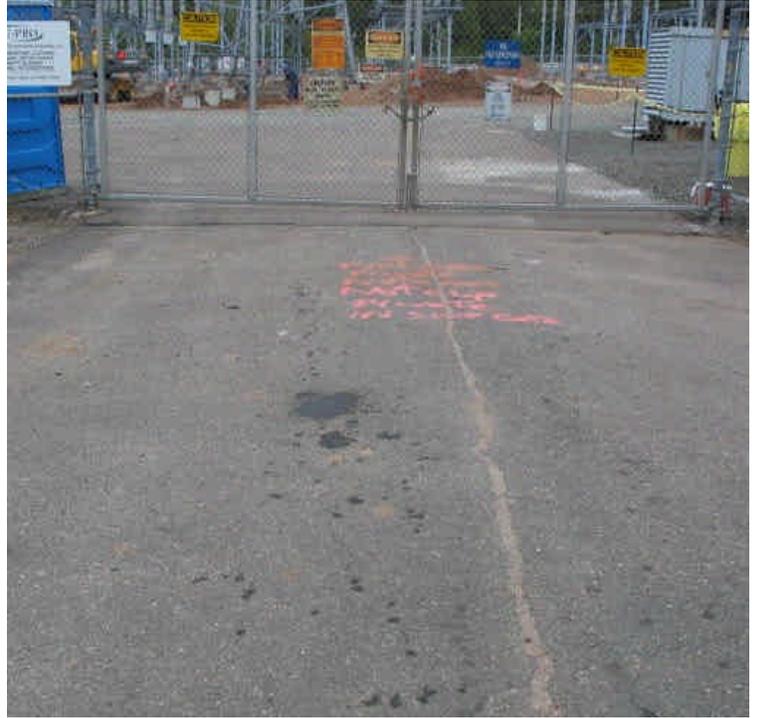
Areas of Inspection	Observation	Recommended Action	Corrected Action
Spills, soils and material storage	Several small soil stockpiles are in the center of the yard; a soil stockpile is located at the northwestern corner of the site against the fence, another near the western fence. 9/13/06	Monitor the stockpiles for erosion and stabilize if left unworked for more than 14 days. 9/13/06	NA
	Several small spills/drips (6-8" across) were found where the lube truck from last week was working on equipment, above the culvert under the northern access driveway. Areas are small and did not reach the wetland. 9/13/06	Always use spill control materials when working on equipment, including lubrication, and during refueling. Replace as needed. Consider doing all equipment work within the site fence and away from the wetland. 9/13/06	Needs attention.
	One 9"-diameter spill/drip was found just outside the gate to the site. Several 1-2" diameter drips were seen along the access driveway. These were likely caused by a delivery truck. 9/13/06	During off loading, check delivery trucks for leaks and use spill controls as needed. 9/13/06	Needs attention.

Spill/drip located at the entrance to the site, probably from a delivery vehicle.

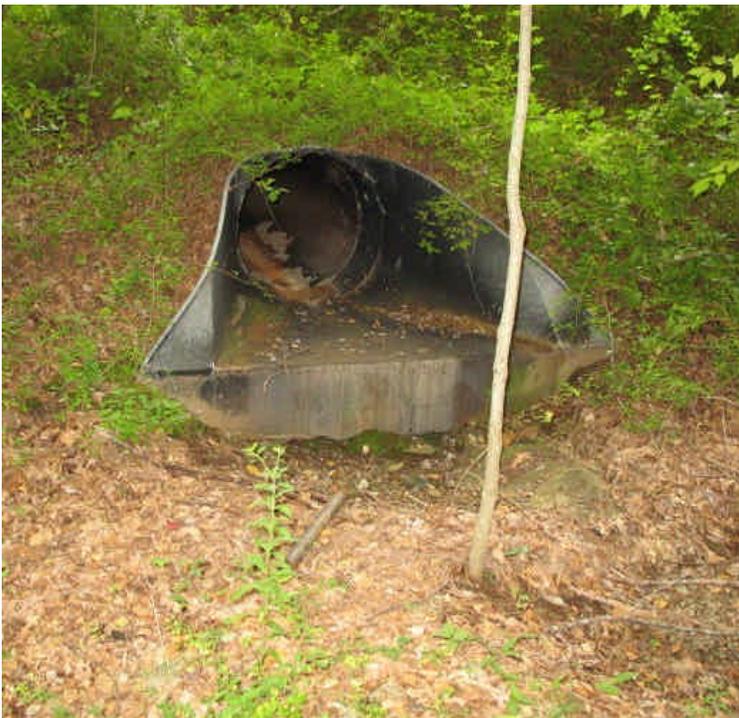
Culvert located under the access driveway to the site.

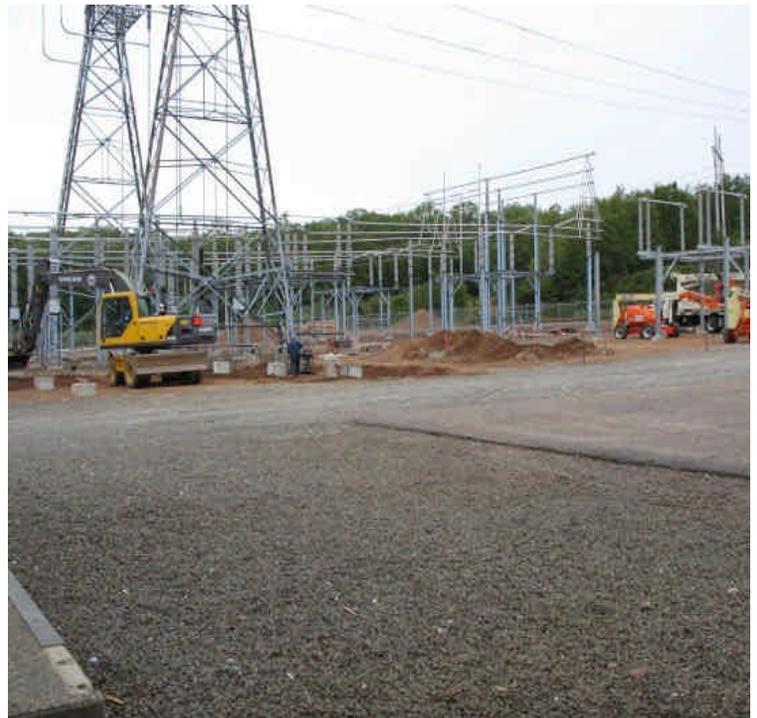
New foundations being installed in the yard. Small stockpiles remain contained.
