Docket No. 272 – Development and Management Plan Inspection

Scovill Rock Switching Station Inspection

Date: September 21, 2006

Location: Scovill Rock Switching Station

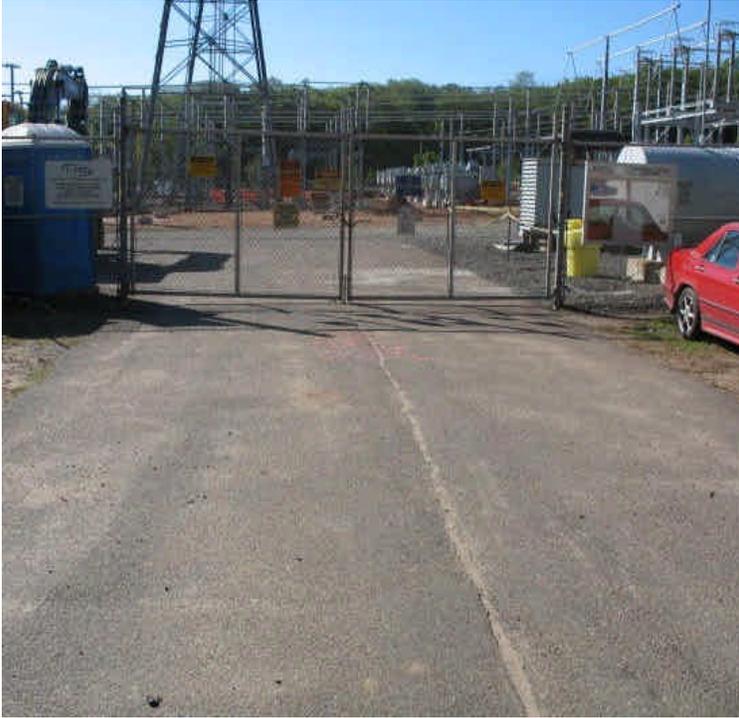
Site entrance, no new spills, spill kits onsite.

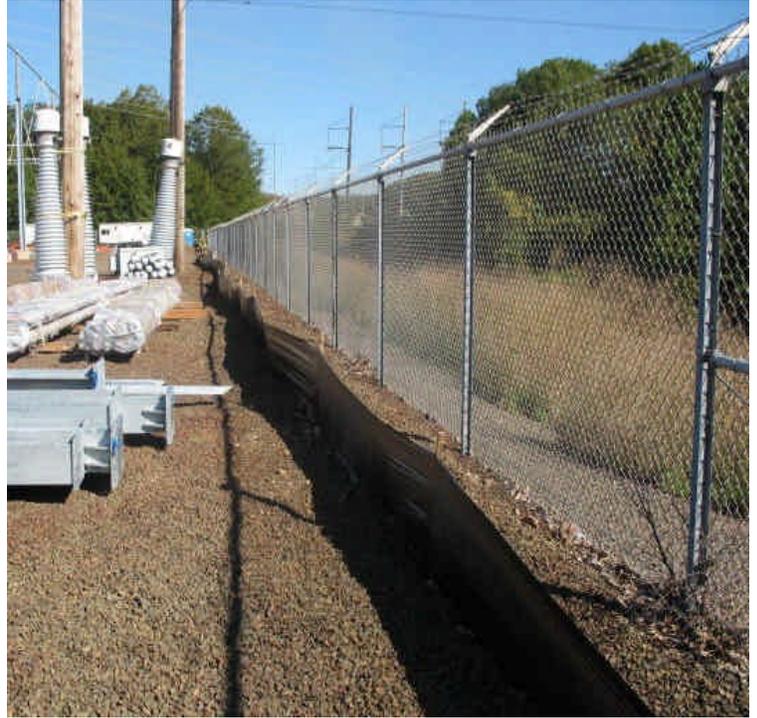
Silt fence along the eastern fence looks good.

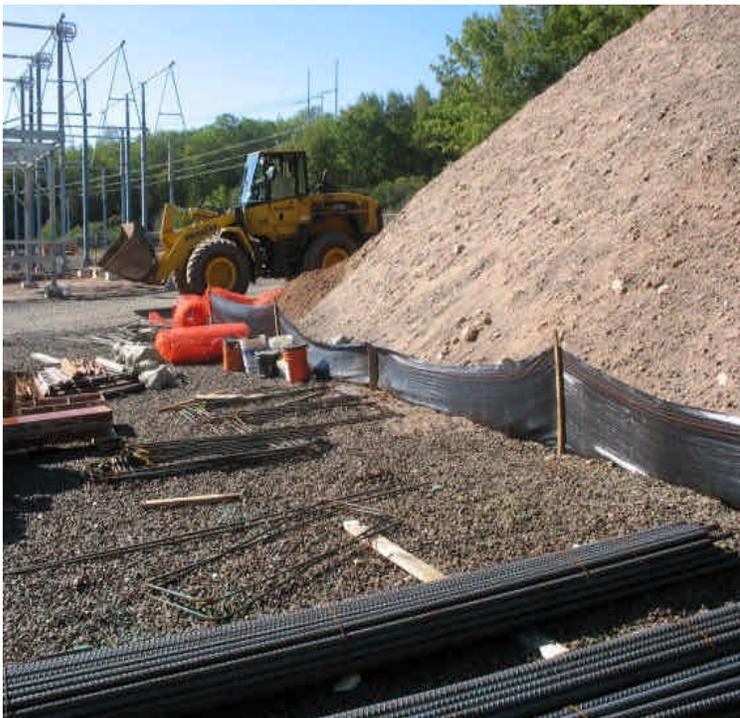
Repaired area of silt fence in the northwestern corner of the site.

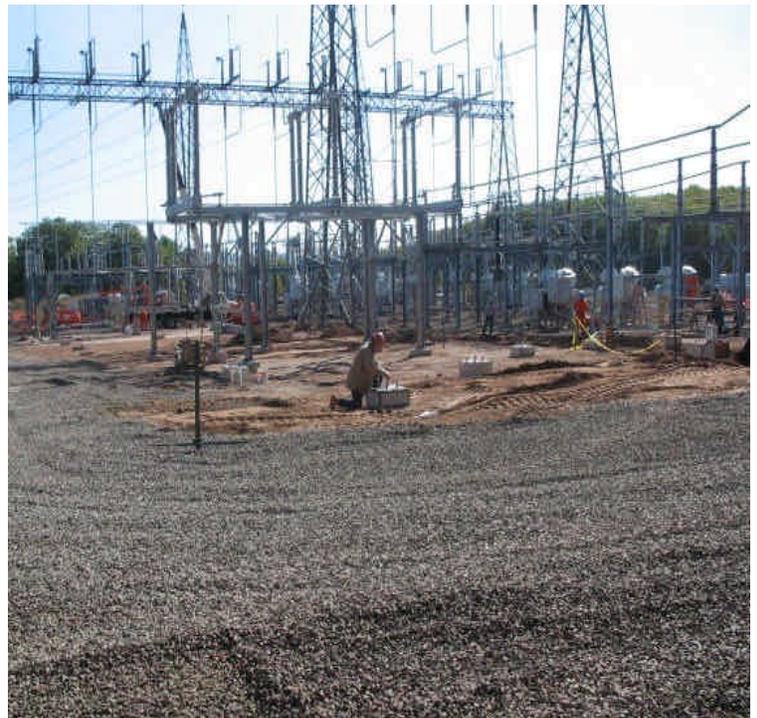
New foundations being installed in the yard. Small stockpiles remain contained.
