**Docket No. 272 – Development and Management Plan Inspection**

**Scovill Rock Switching Station Inspection**

**Date:** October 5, 2006

**Location:** Scovill Rock Switching Station

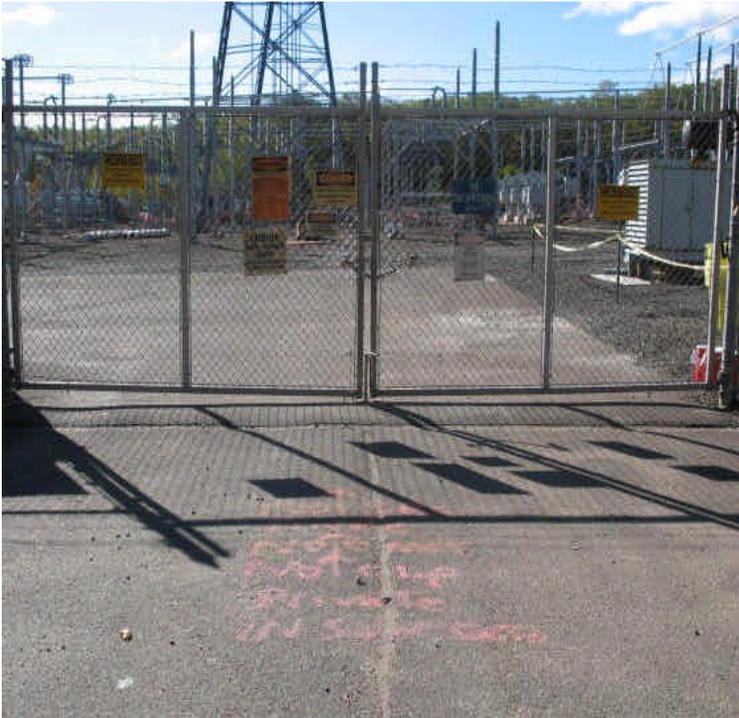
**Site entrance, no new equipment spills or leaks, spill kits are onsite.**

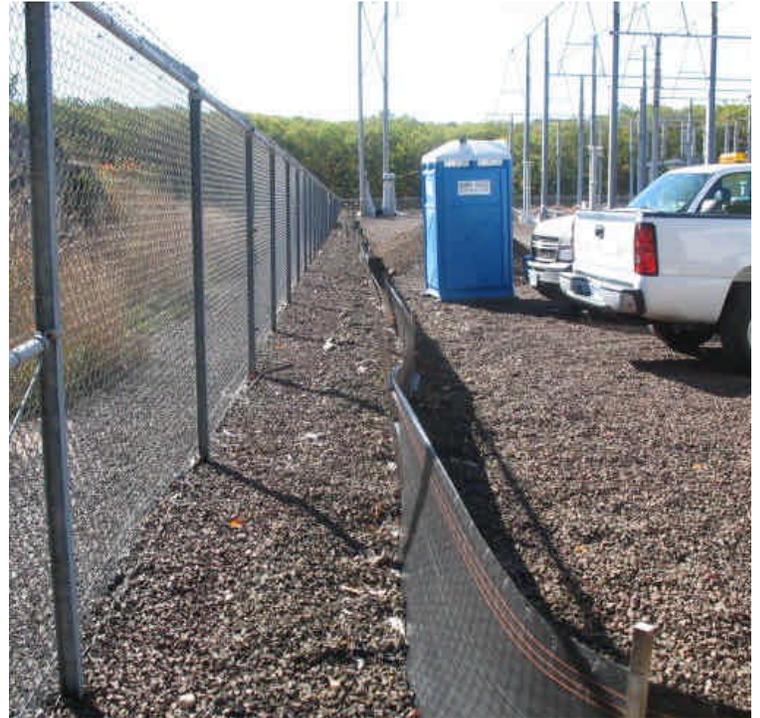
**Silt fence along the eastern fence looks good.**

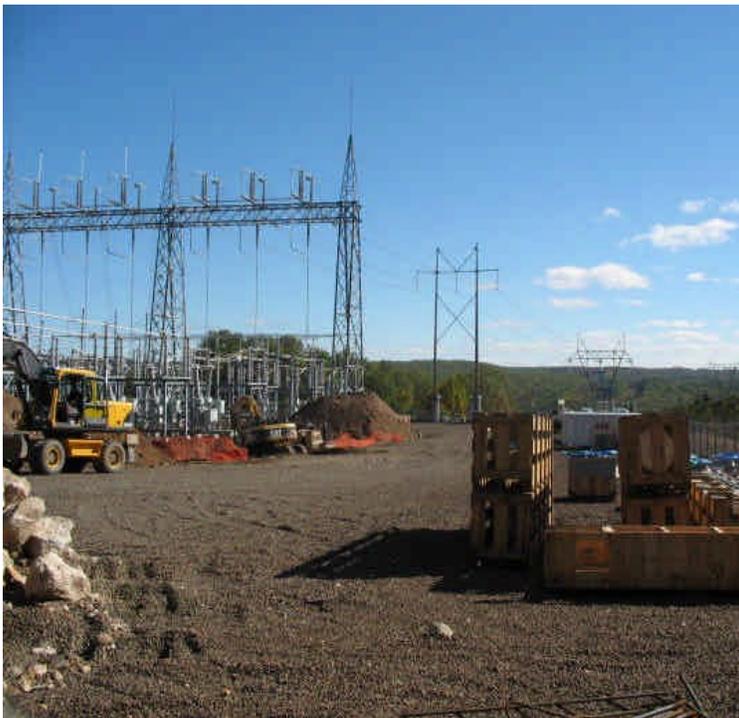
**New foundation excavations, stockpiles are internal to the yard and remain contained.**

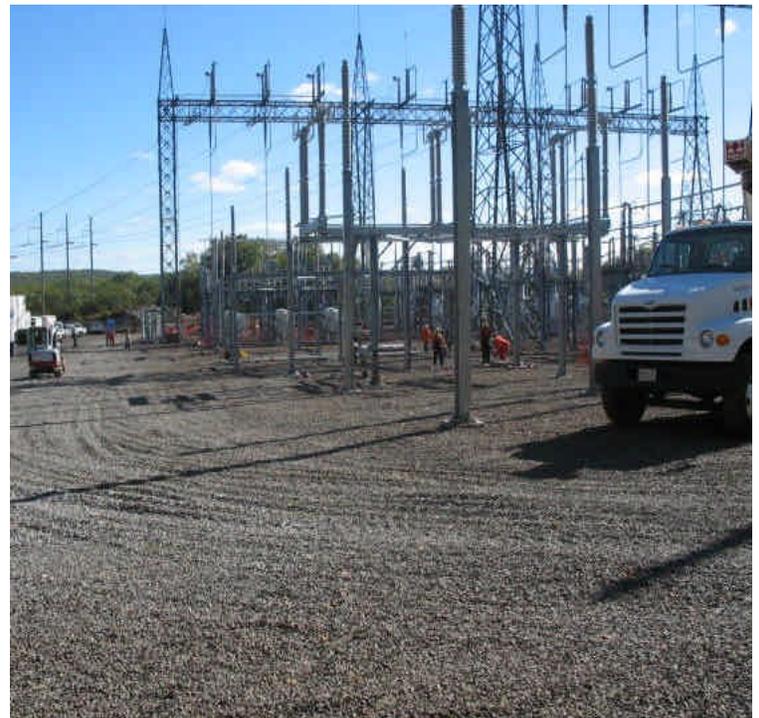
**New foundations installed, site graded and stabilized.**
