Docket No. 272 – Development and Management Plan Inspection

Scovill Rock Switching Station Inspection

Date: October 19, 2006

Location: Scovill Rock Switching Station

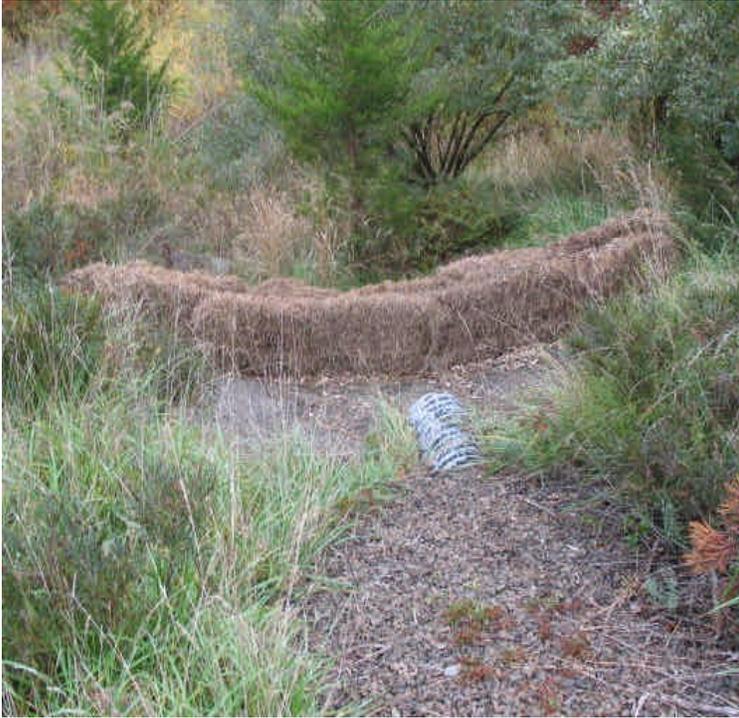
Haybales installed at the 12" storm drain pipe look secure. No water was	Monitor storm water when flowing to ensure haybales are functioning	NA

No water flow reported from outlet, haybales look good.

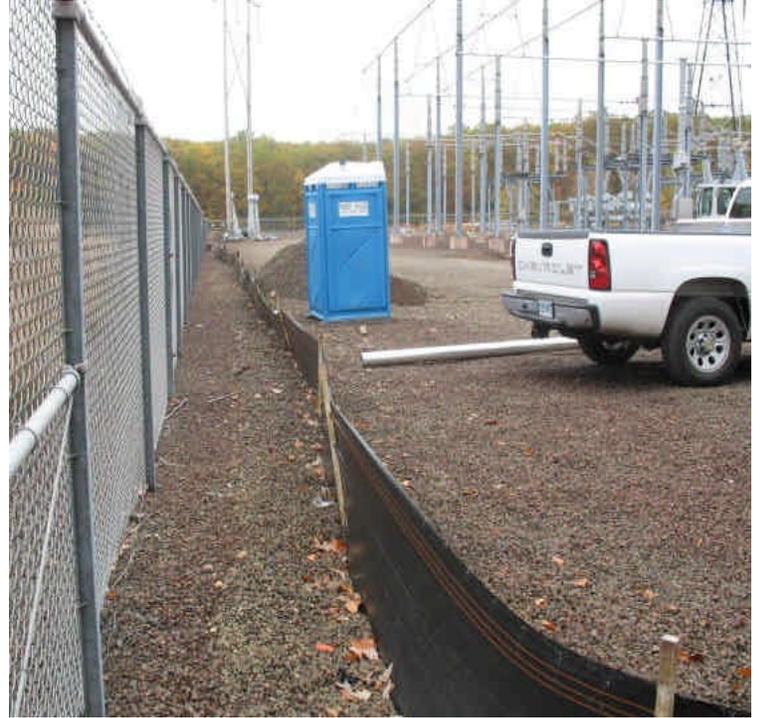
Silt fence along the eastern perimeter fence looks good.

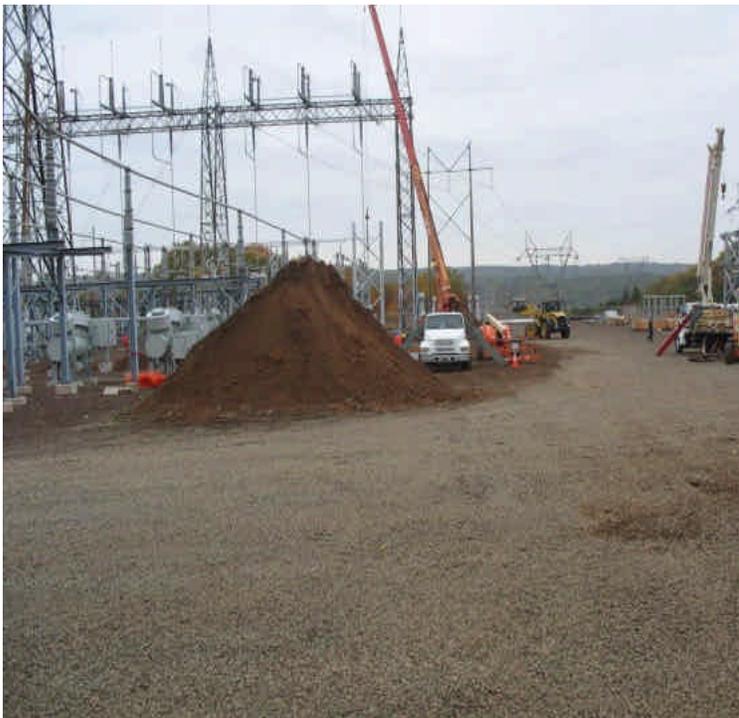
New excavations for foundations; stockpiles are internal to the yard and remain contained.

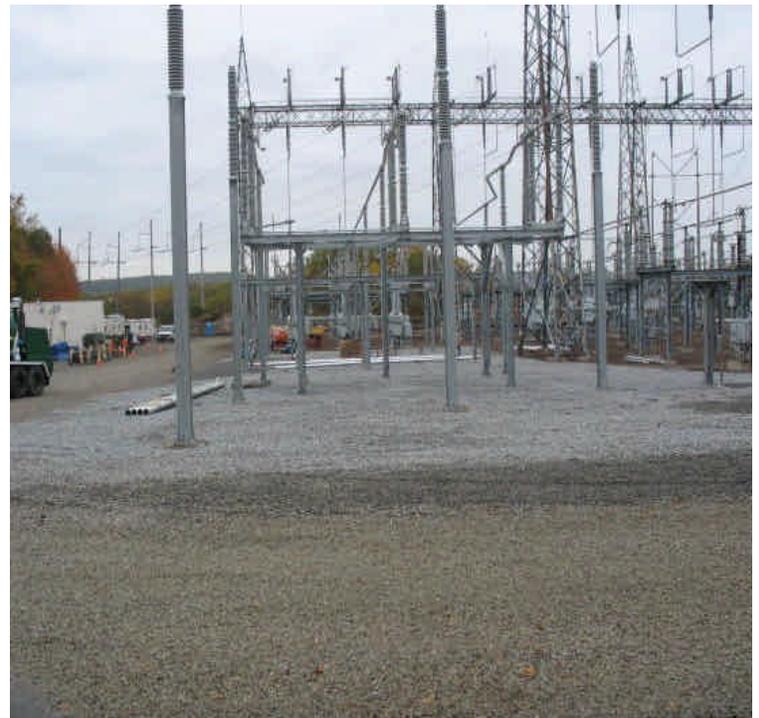
New foundations installed, these portions of the site are graded and stabilized with stone.
