Docket No. 272 – Development and Management Plan Inspection

Scovill Rock Switching Station Inspection

Date: October 26, 2006

Location: Scovill Rock Switching Station

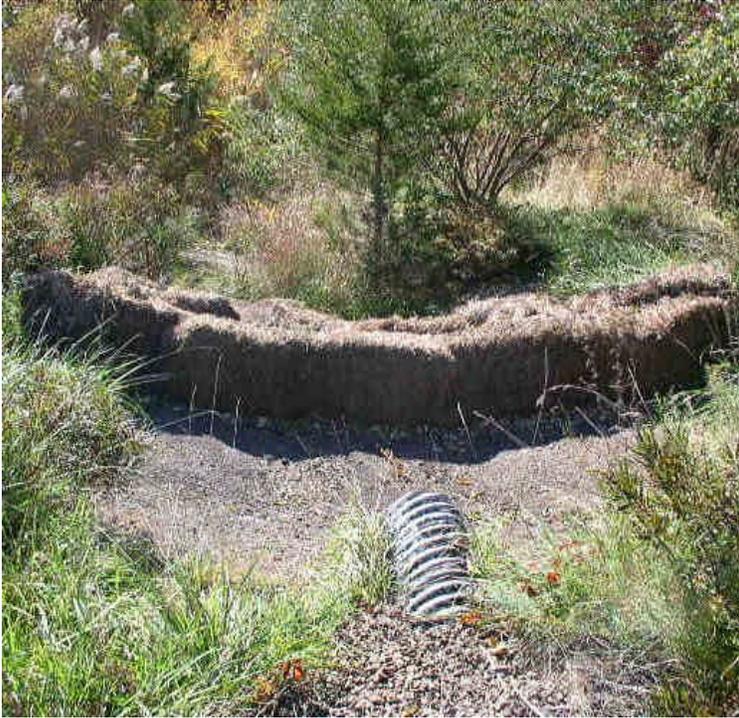
No water flow has been observed from the outlet; haybales look good.

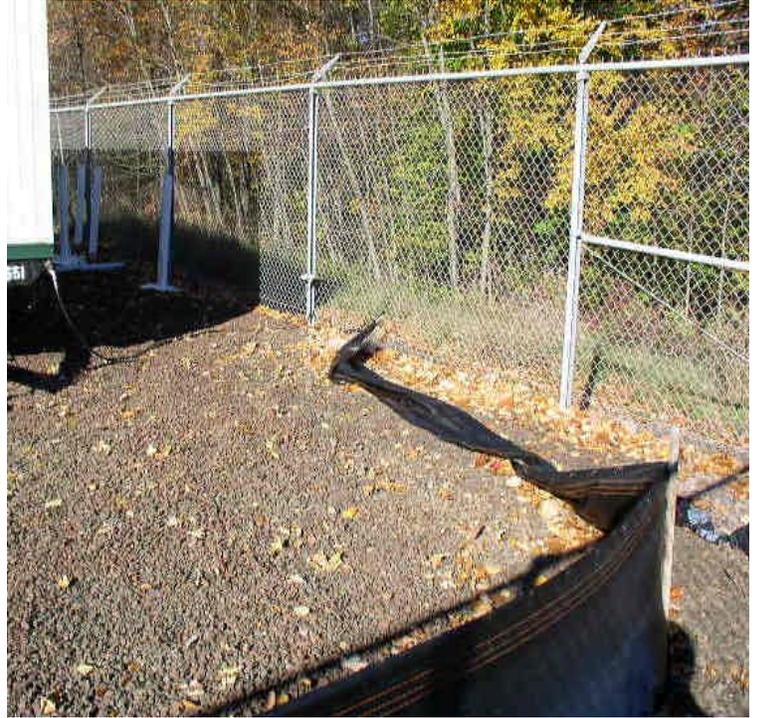
Repair the fallen section of silt fence when feasible. Disturbed soil is not immediately adjacent.

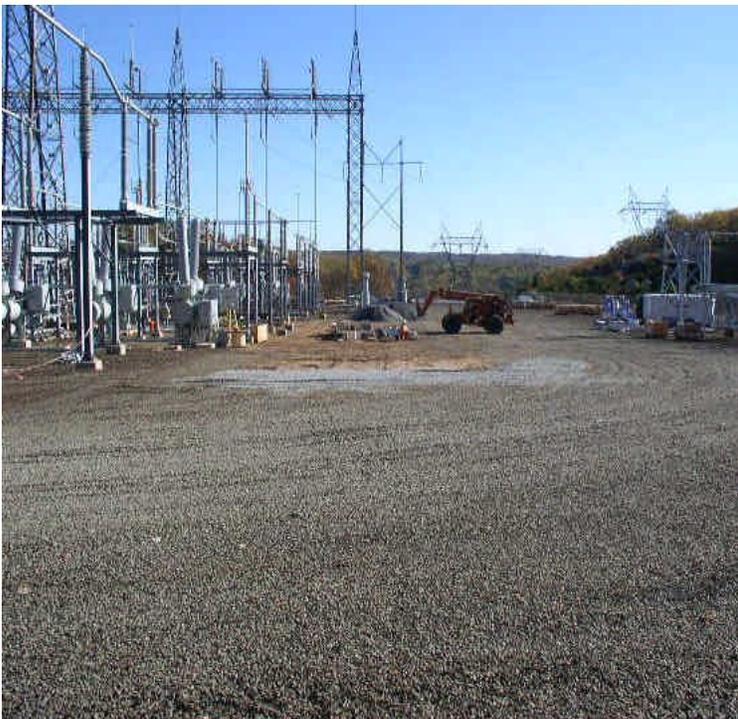
Excavations for foundations have been graded and soil remains contained.

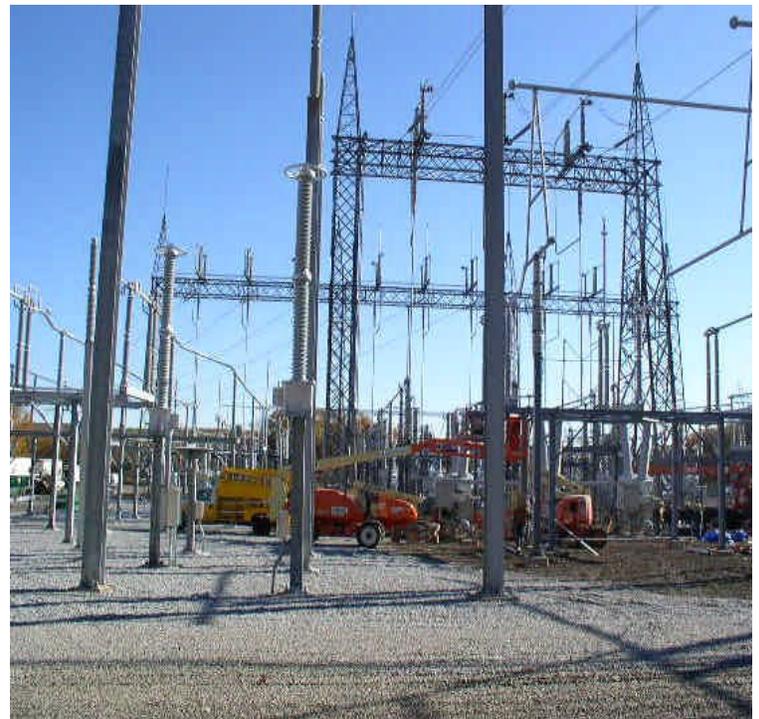
New foundations have been installed; surrounding areas have been graded and stabilized with stone. Work continues on structures.
