Docket No. 272 – Development and Management Plan Inspection

Segment 2a Inspection

Date: September 21, 2006

Location: Segment 2a- Beseck Switching Station to Cheshire/Handen Town Line

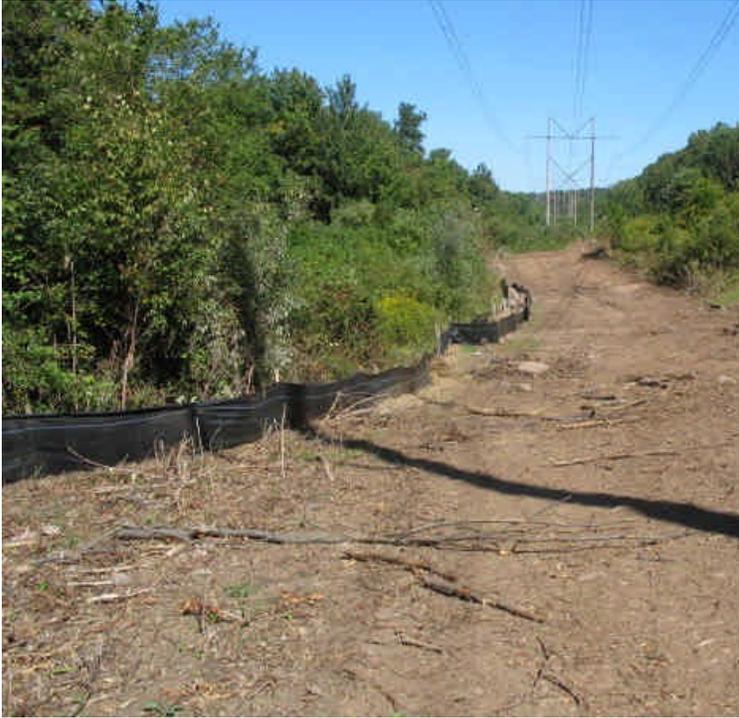
Erosion and sediment controls adjacent to the southern wetland at High Hill Rd.

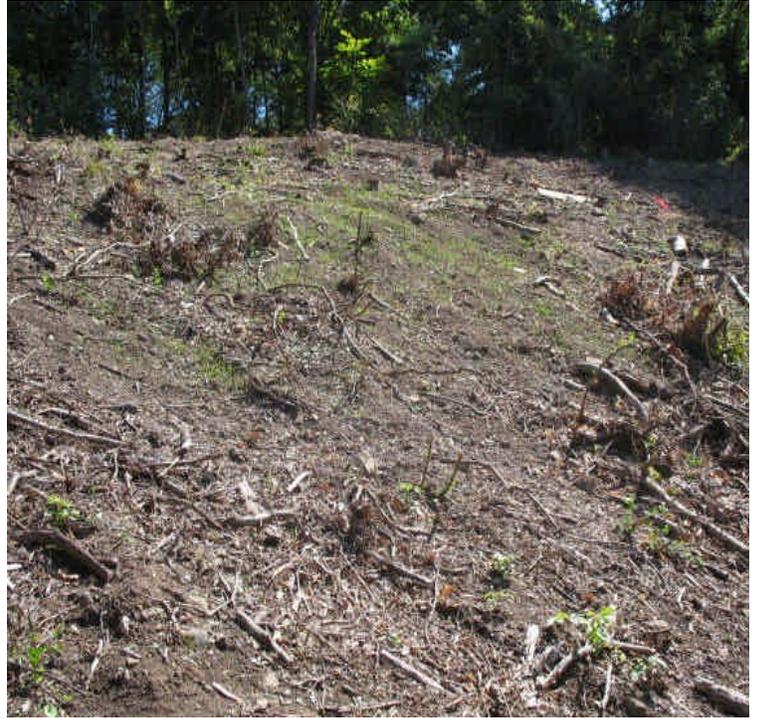
Recently seeded slope off High Hill Rd. Some grass growth noted.

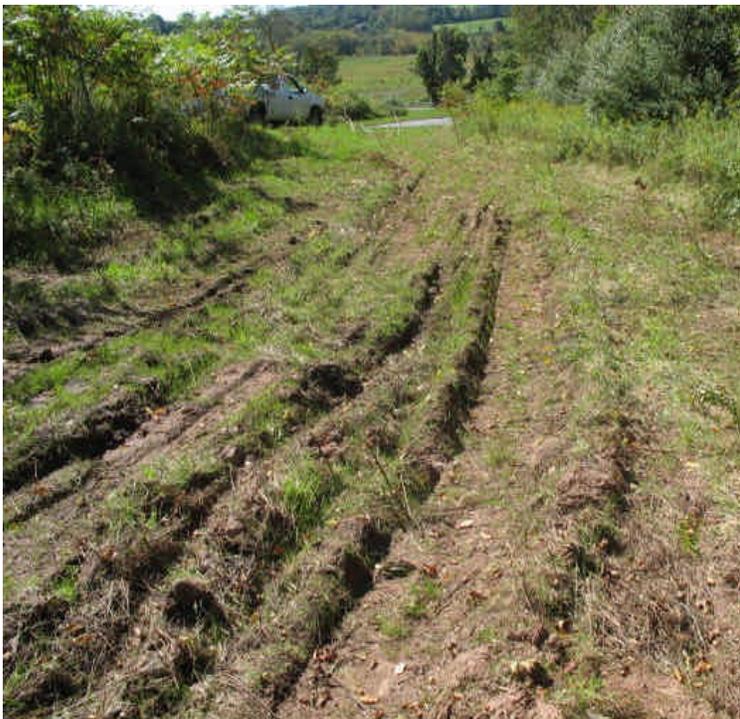
Disturbed site entrance off Stony Brook Rd.

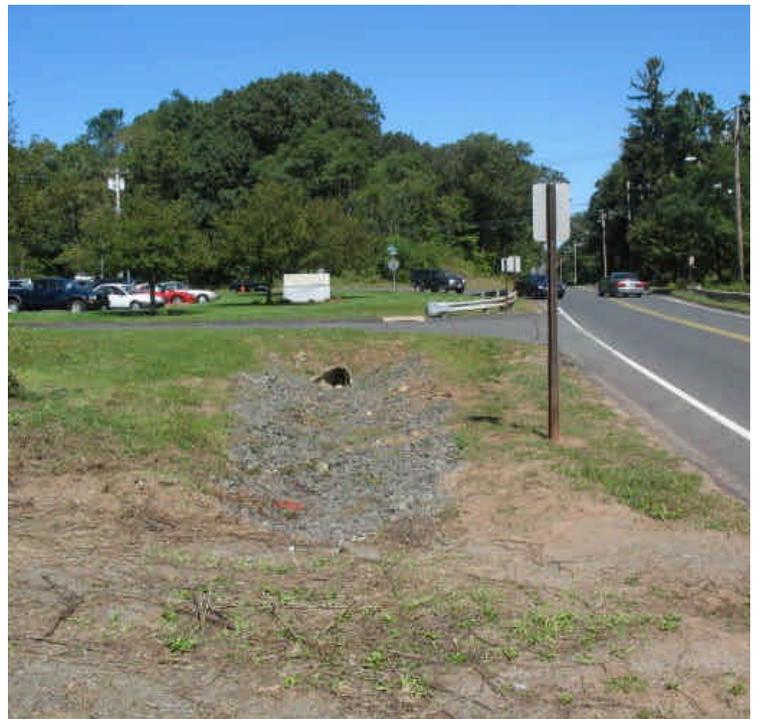
Sign replaced along South Turnpike.

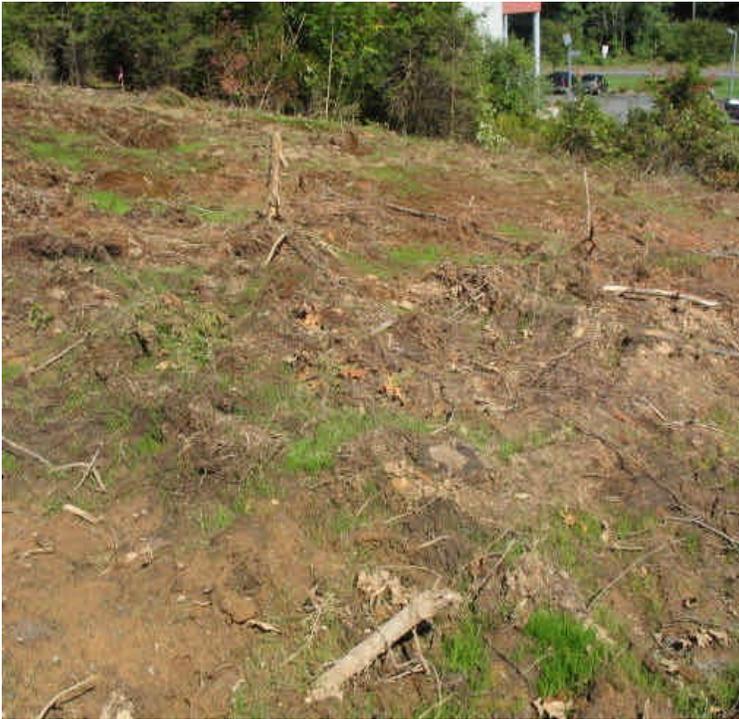
Some grass growth noted off South Turnpike

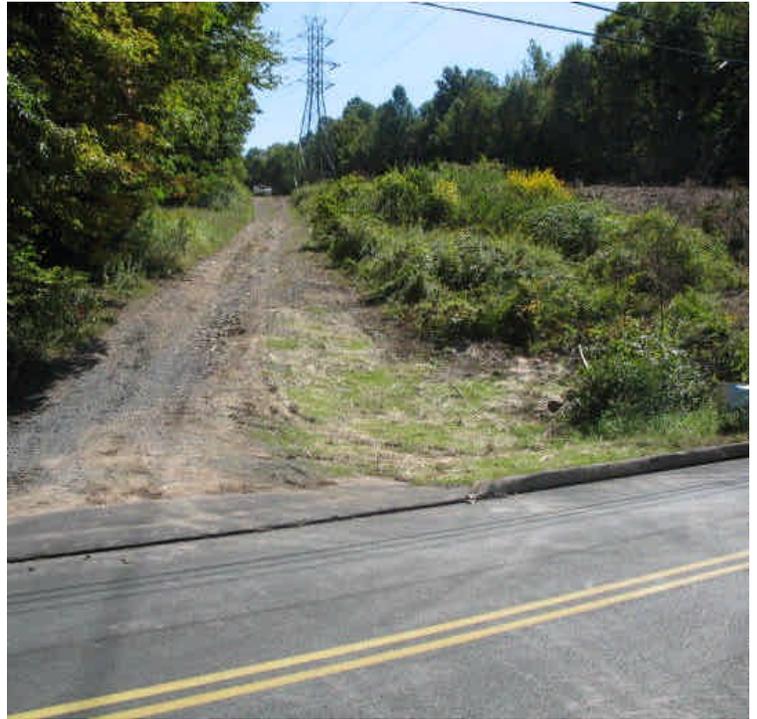
Some grass growth along Mansion Rd.

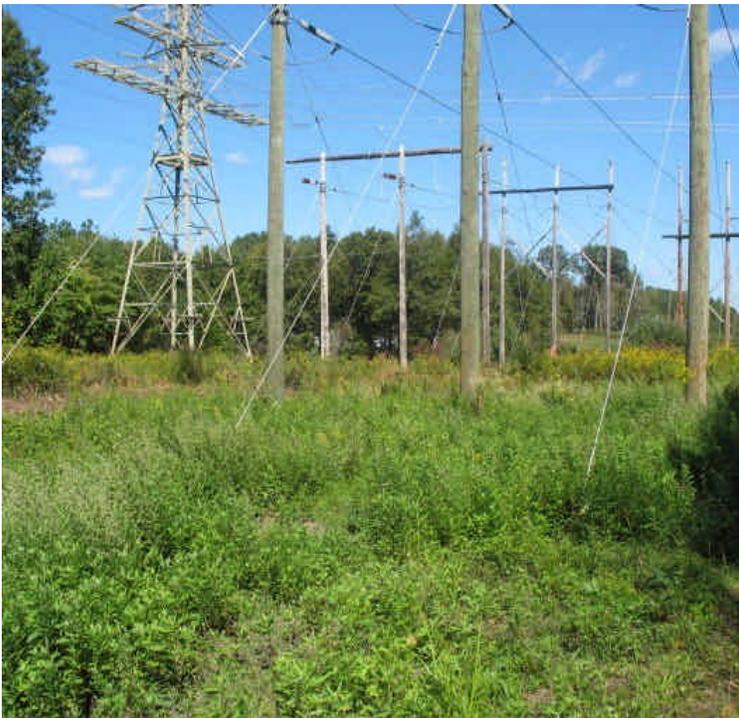
Selective cutting has left most of the vegetation along Old Farm Rd.

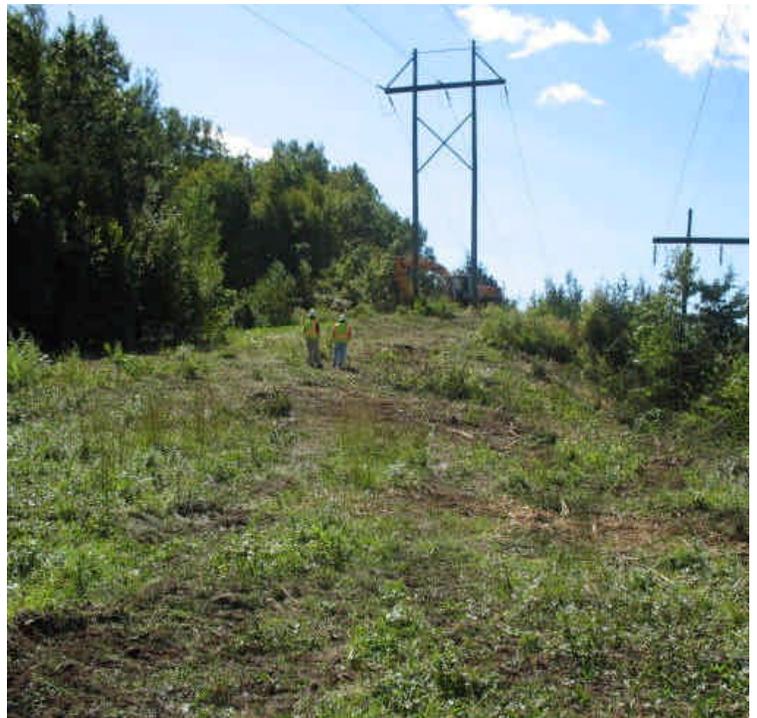
Example of the selective cutting along Old Farm Rd.
