**Docket No. 272 – Development and Management Plan Inspection**

**Segment 2a Inspection**

**Date:** October 26, 2006

**Location:** Segment 2a – Beseck Switching Station to Cheshire/Hamden Town Line

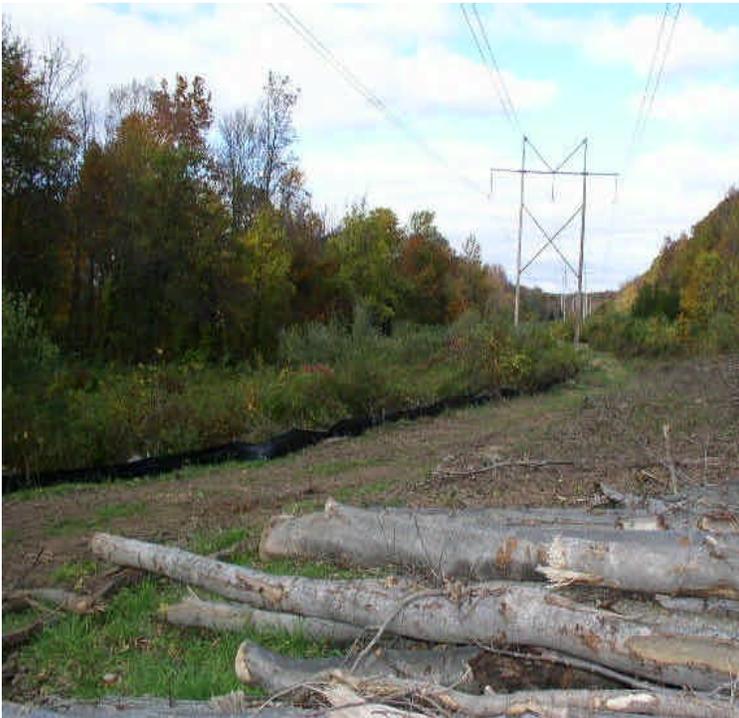
**Silt fence off High Hill Rd.**

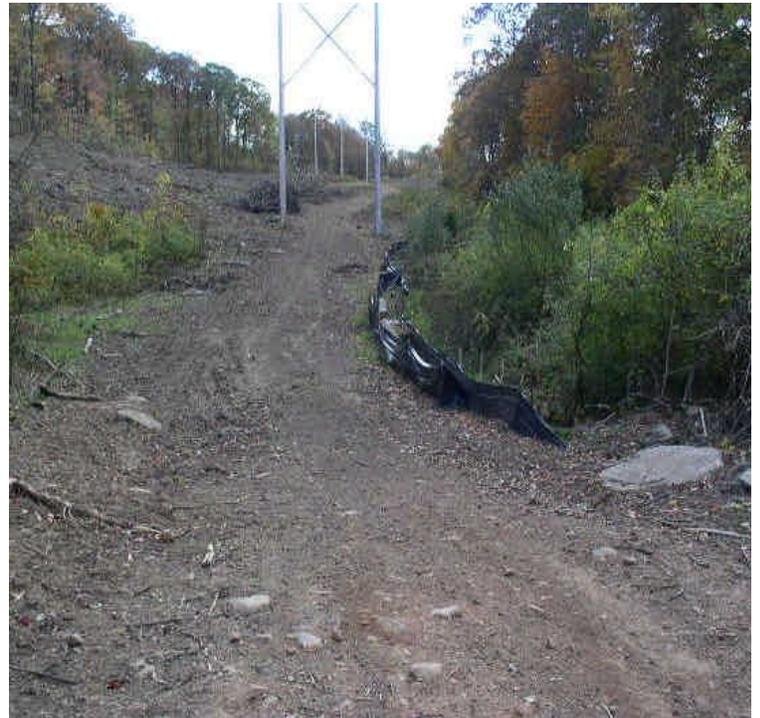
**Silt fence above wetland off High Hill Rd.**

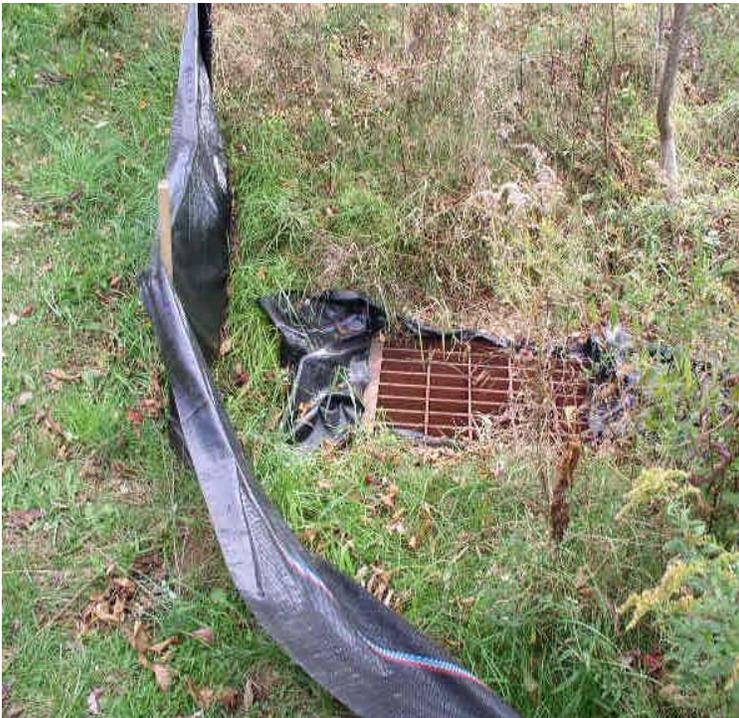
**Catch basin controls in place off Stony Brook Rd.**

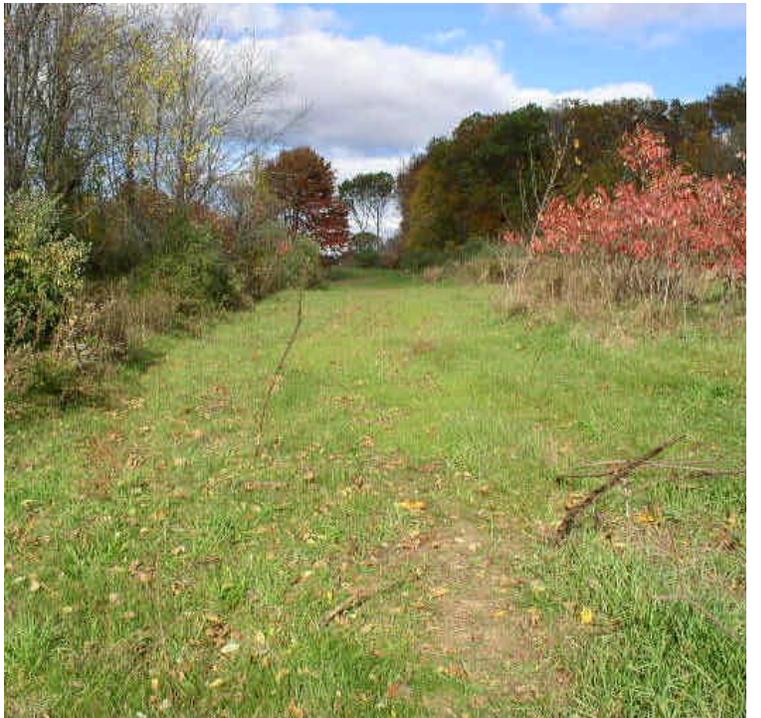
**Site entrance off Stony Brook Rd. with established grass cover.**

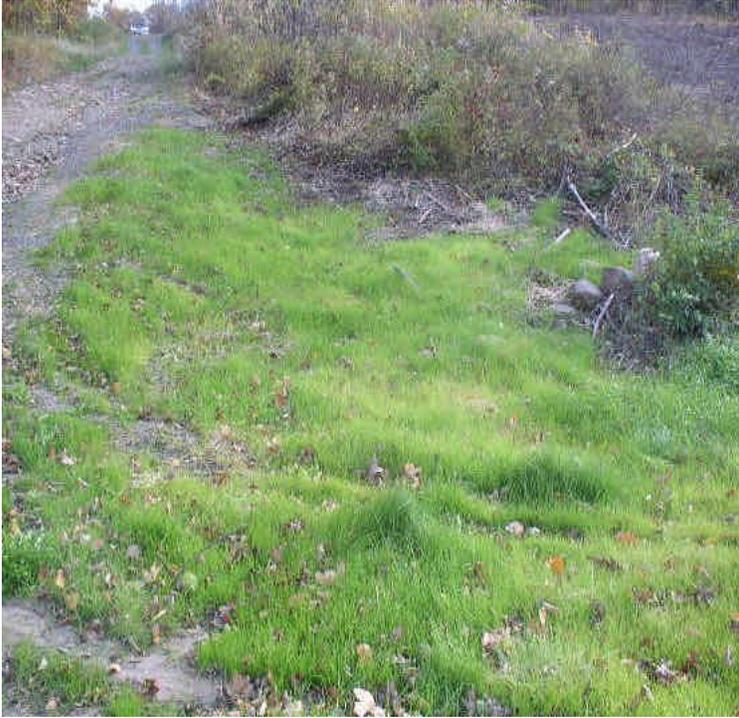
**Increased grass growth noted off Mansion Rd.**

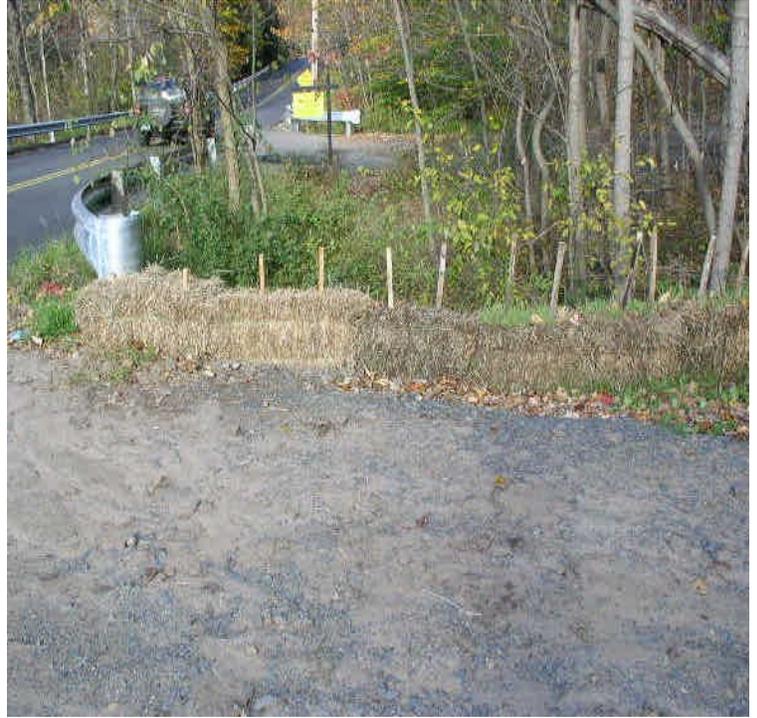
**Extra haybales added to prevent runoff at Mansion Rd. entrance.**

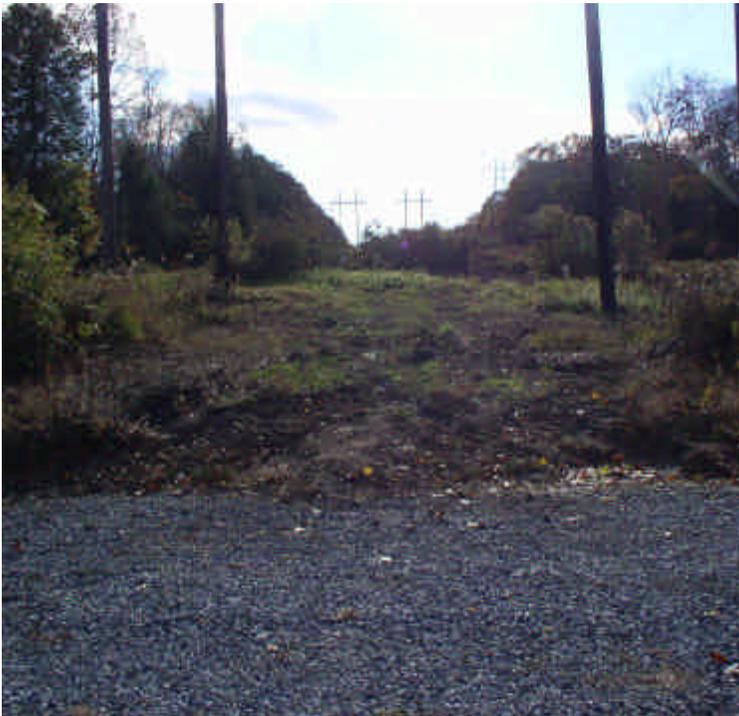
Old Farm Rd.	The piece of equipment parked off Old Farm Rd. has been removed from the site. This equipment had been leaking and the spill was cleaned. 10/26/06	In general, check and maintain equipment regularly. 10/26/06	Equipment moved and spill cleaned.
Additional Observations	NA	NA	NA

**Equipment off Old Farm Rd. has been removed.**

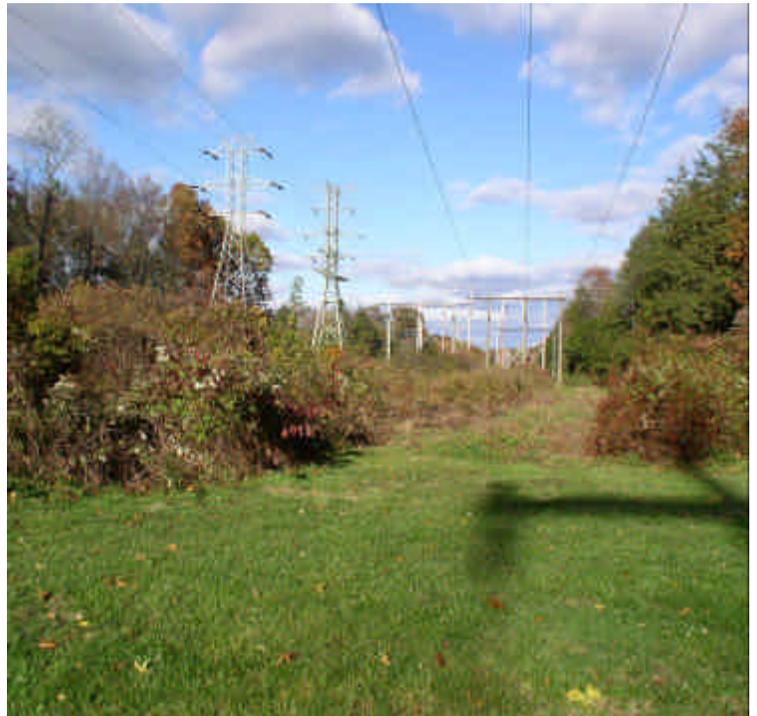
**Vegetation left in place for stabilization off Old Farm Rd.**
